Pier 91 Tune-Up Audit Report

Final Draft

Prepared for: Puth Eang, Cruise Terminals of America

October 25, 2024, updated November 13, 2024

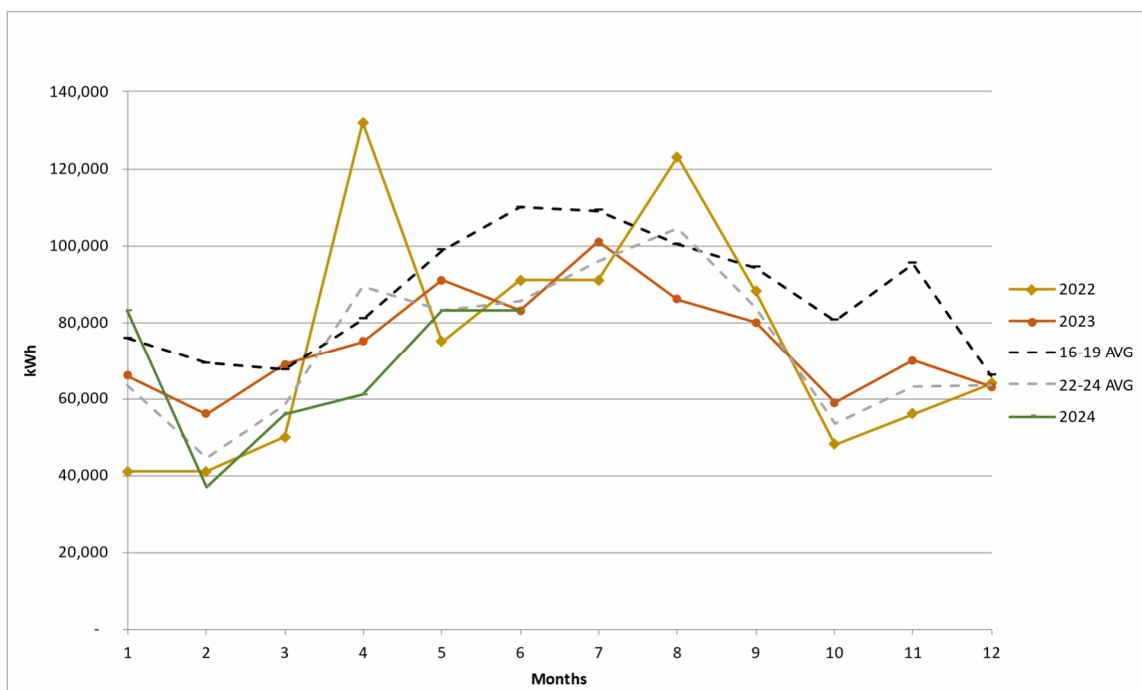
Figure 1: Average Monthly Electricity Use for Pier 91

The average electric EUI for the building is 24 kBtu/sf/yr which is lower than the first tune-up. As with our first tune-up, there is a significant summer energy peak, which would normally be attributed to cooling energy, but is due to very low occupancy during the winter (November-March). Also, we compared the winter consumption with the previous tune-up, shown in Figure 1 as “2016-2019 average”. The recent winter consumption has been 30-35% lower in the off-season. It seems that the energy efficient lighting controls and space conditioning schedules have been very effective. We note that the consumption during December has been constant every year (except 2020 and 2021). This is likely due to holiday event rentals.

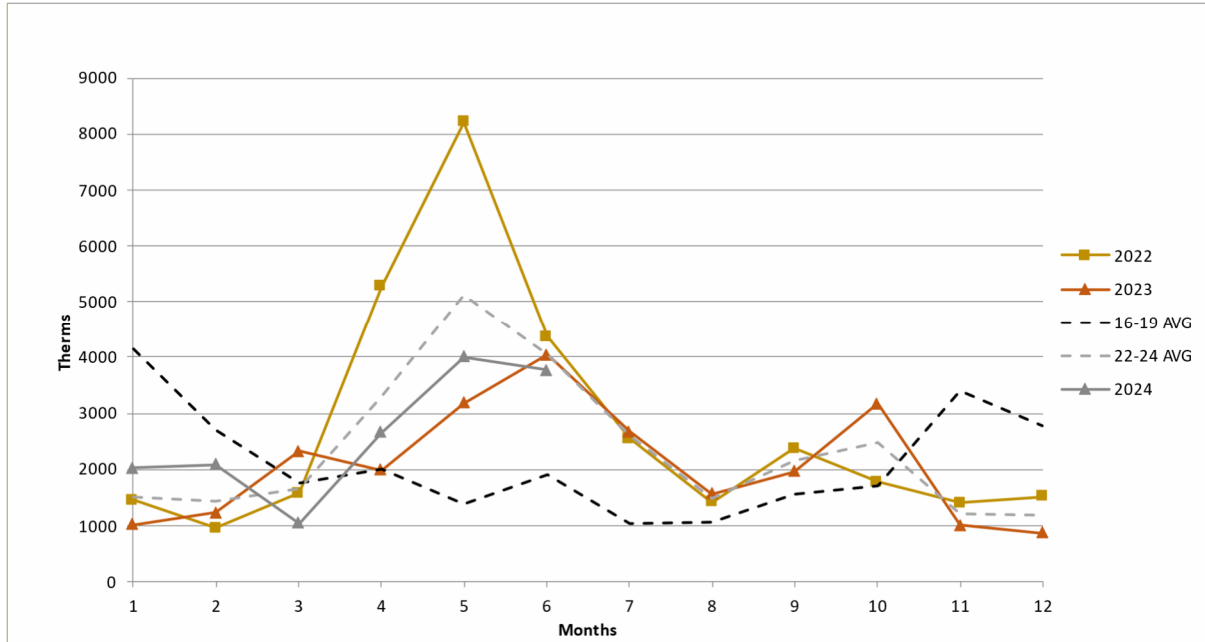
Figure 2: Average Monthly Gas Use for Pier 91

The 2023 natural gas EUI for the building is 20 kBtu/sf/yr which is higher than the first tune-up. Like the electricity, the gas energy during the off-season is lower than the first tune-up cycle, likely due to efficient HVAC schedules. However, there has been a dramatic increase in on-season gas use, with **recent use higher for every month of cruise operation** and particularly high in May, June, and July. Possible reasons why the cruise season natural gas use is high include:

- How doors are managed during baggage handling and ship embarking/debarking, especially during early morning hours after the HVAC is turned on
- Heated air leaking out of the roof via skylights
- A control change that allows too much heating to occur during summer months. For example, this can happen when “optimum start” is enabled on a system or when the system is started in the early morning with normal occupied temperature setting but without an actual requirement for heating.
- Outside air control, where more airflow is processed now than it was during the first tune-up. This is unlikely because we reviewed the outdoor air controls during the tune-up and did not find an issue. Also, increased outdoor airflow would also show in the electricity data.

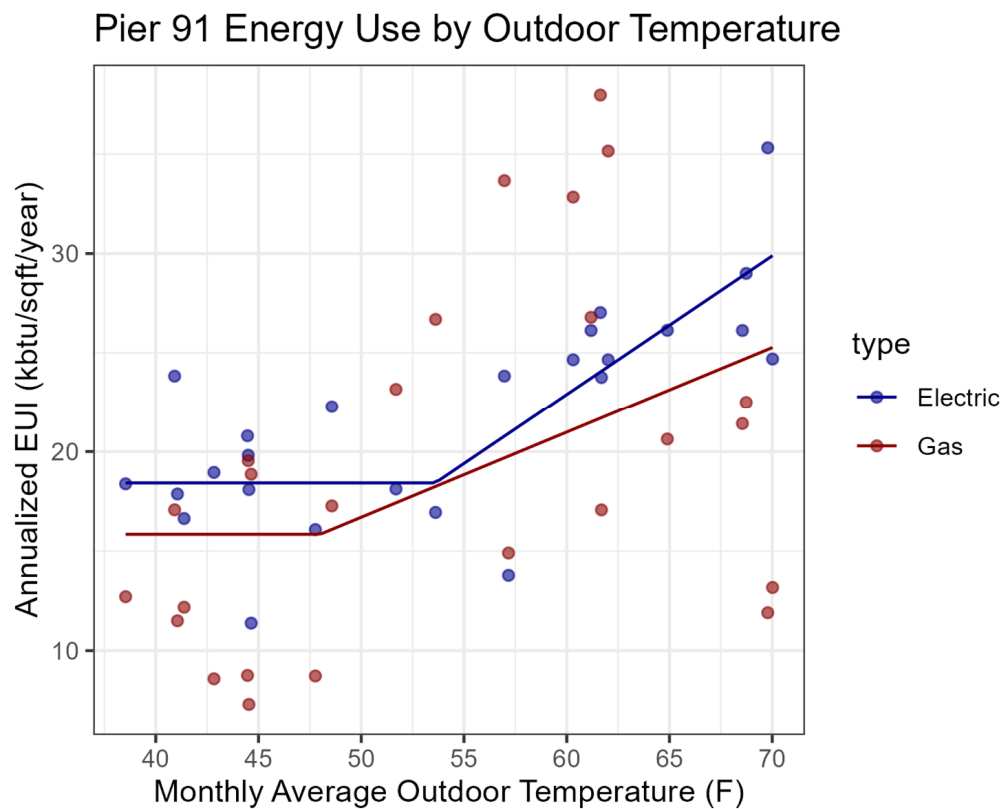
Figure 3: Electric and Gas Energy versus Temperature, June 2022 to June 2024

The EUI for the facility for 2023 is 43 kBtu/SF/yr. Billing regression analysis compares the average monthly temperature during each billing period to the bills to tease out the amount of temperature dependence in the utility energy consumption. For electricity & cooling energy, this chart tells a better story than the first tune-up. The electrical correlation with outdoor air temperature is stronger now than it was during the first tune-up with a confidence interval (R^2) of 0.6.

There is a much larger difference between the current chart, above, and the 2020 chart below: the natural gas curve is inverted. The older chart shows the correct correlation for heating (gas) where the gas decreases with increasing temperatures. The current chart shows the opposite – more gas is used during warm weather than during cold weather. The potential reasons for this are listed in the previous section. The confidence interval (R^2) value is very low 0.16 meaning that the gas use is not correlated with warmer monthly temperatures. It seems to be correlated with occupancy: summer cruise season.

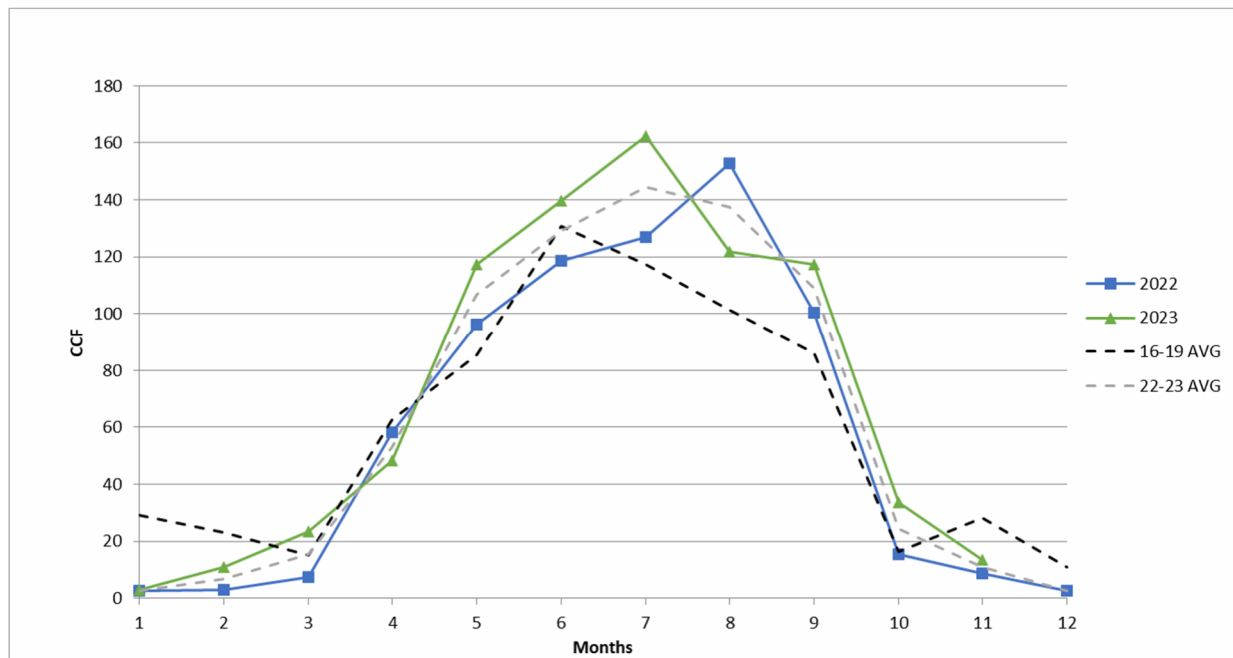
Figure 4: Monthly Water Use (CCF)

Water bills are shown in Figure 4. Water use has been largely consistent year after year, with an annual peak in July or August. Higher summertime use is predominantly due to cruise passenger consumption, as there is little to no landscaping on site. There are no cooling towers.

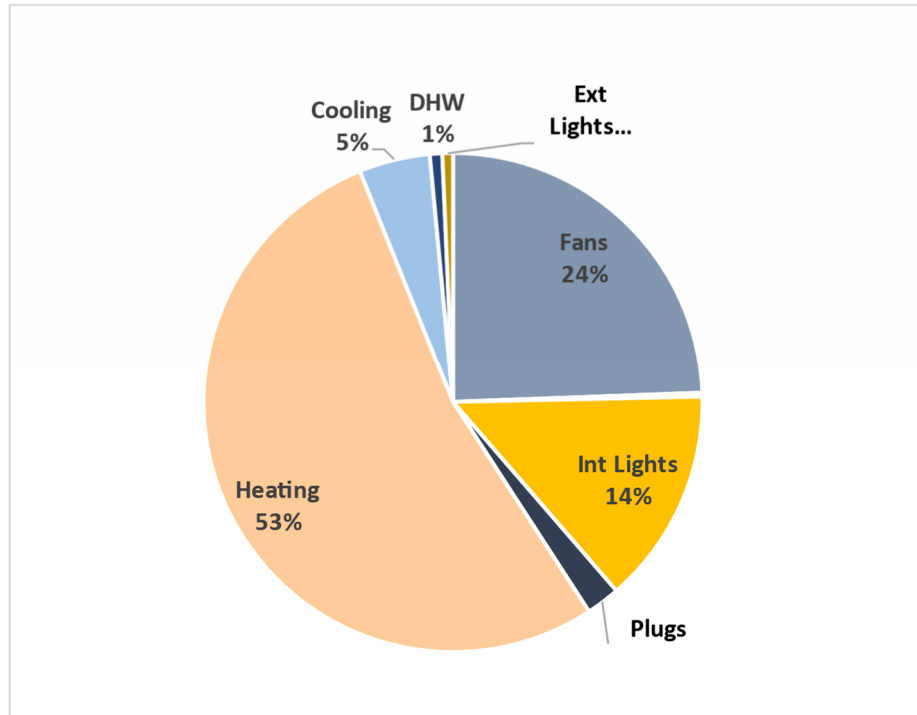
Figure 5: Total Energy End Use Estimate

The end uses estimate is built up from site observations of equipment sizes, actual control logic, lighting power, actual operating schedules, actual base loads during non-cruise season, etc. The result is based on actual utility bills for 2023.

Heating dominates energy consumption. The heating end use include all the natural gas plus fifteen percent of the electricity use. Summertime natural gas use doubled from the previous tune-up cycle.
