# Salmon Bay Marina Docks A, B, C Closure

## Supporting Documentation

# **SALMON BAY MARINA: SITE OBSERVATIONS**

## **SITE OBSERVATIONS, LITERATURE REVIEW, AND DISCUSSION**

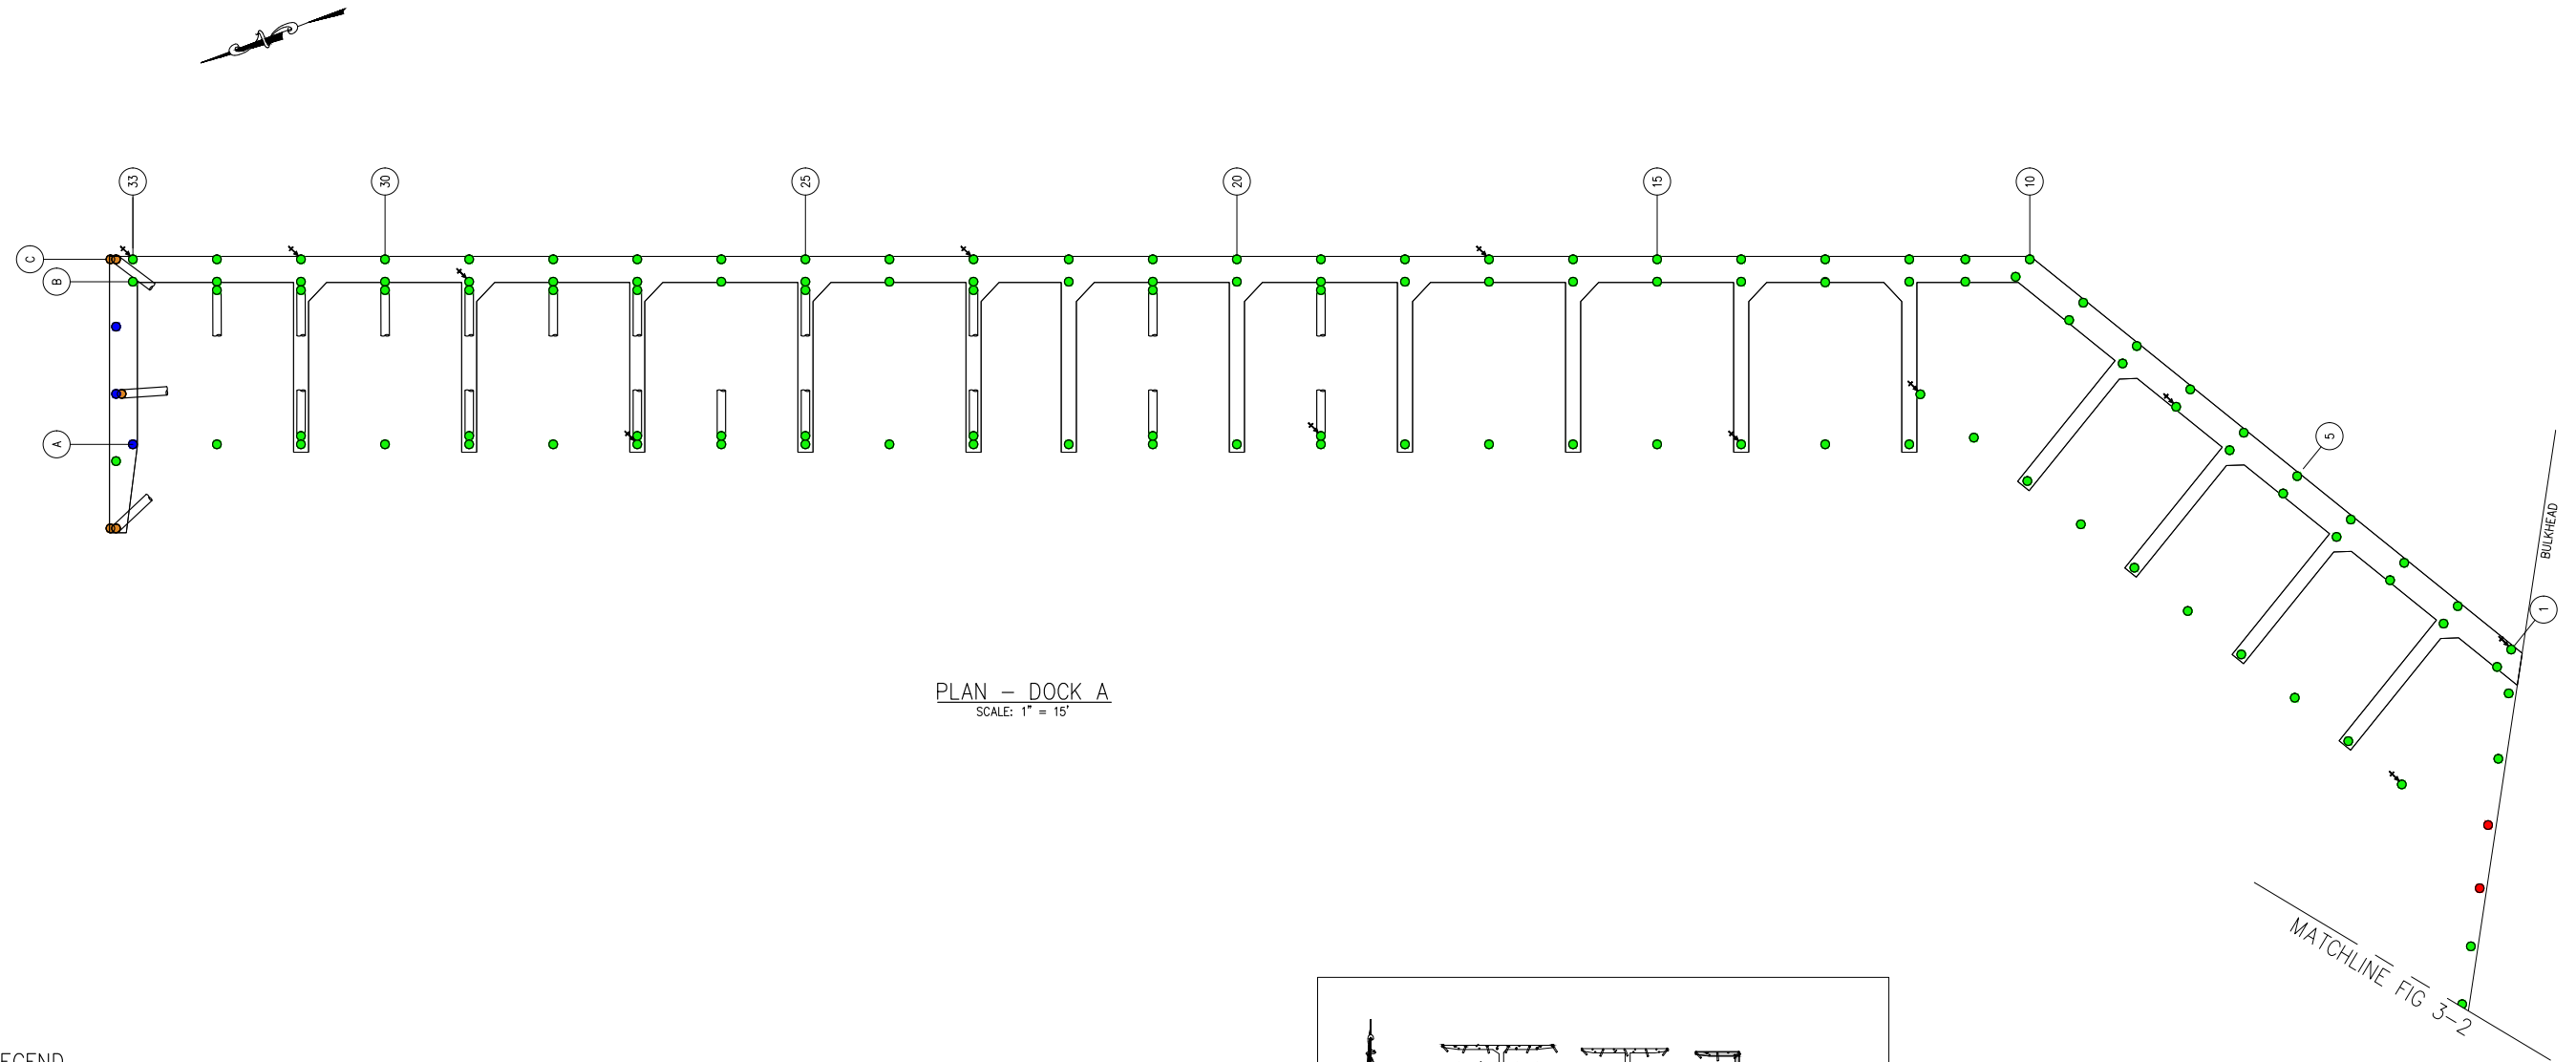
PLAN – DOCK A  
SCALE: 1" = 15'

DESIGNED BY G.L.	PORT OF SEATTLE MARINE FACILITIES	SCALE 1" = 15'	REVISION
DRAWN BY G.L.		DATE	
CHECKED BY	SALMON BAY MARINA	DRAWING NO.  FIG 3-1	
PROJECT ENGR	PILE DEFICIENCY PLAN SHEET 1 OF 3

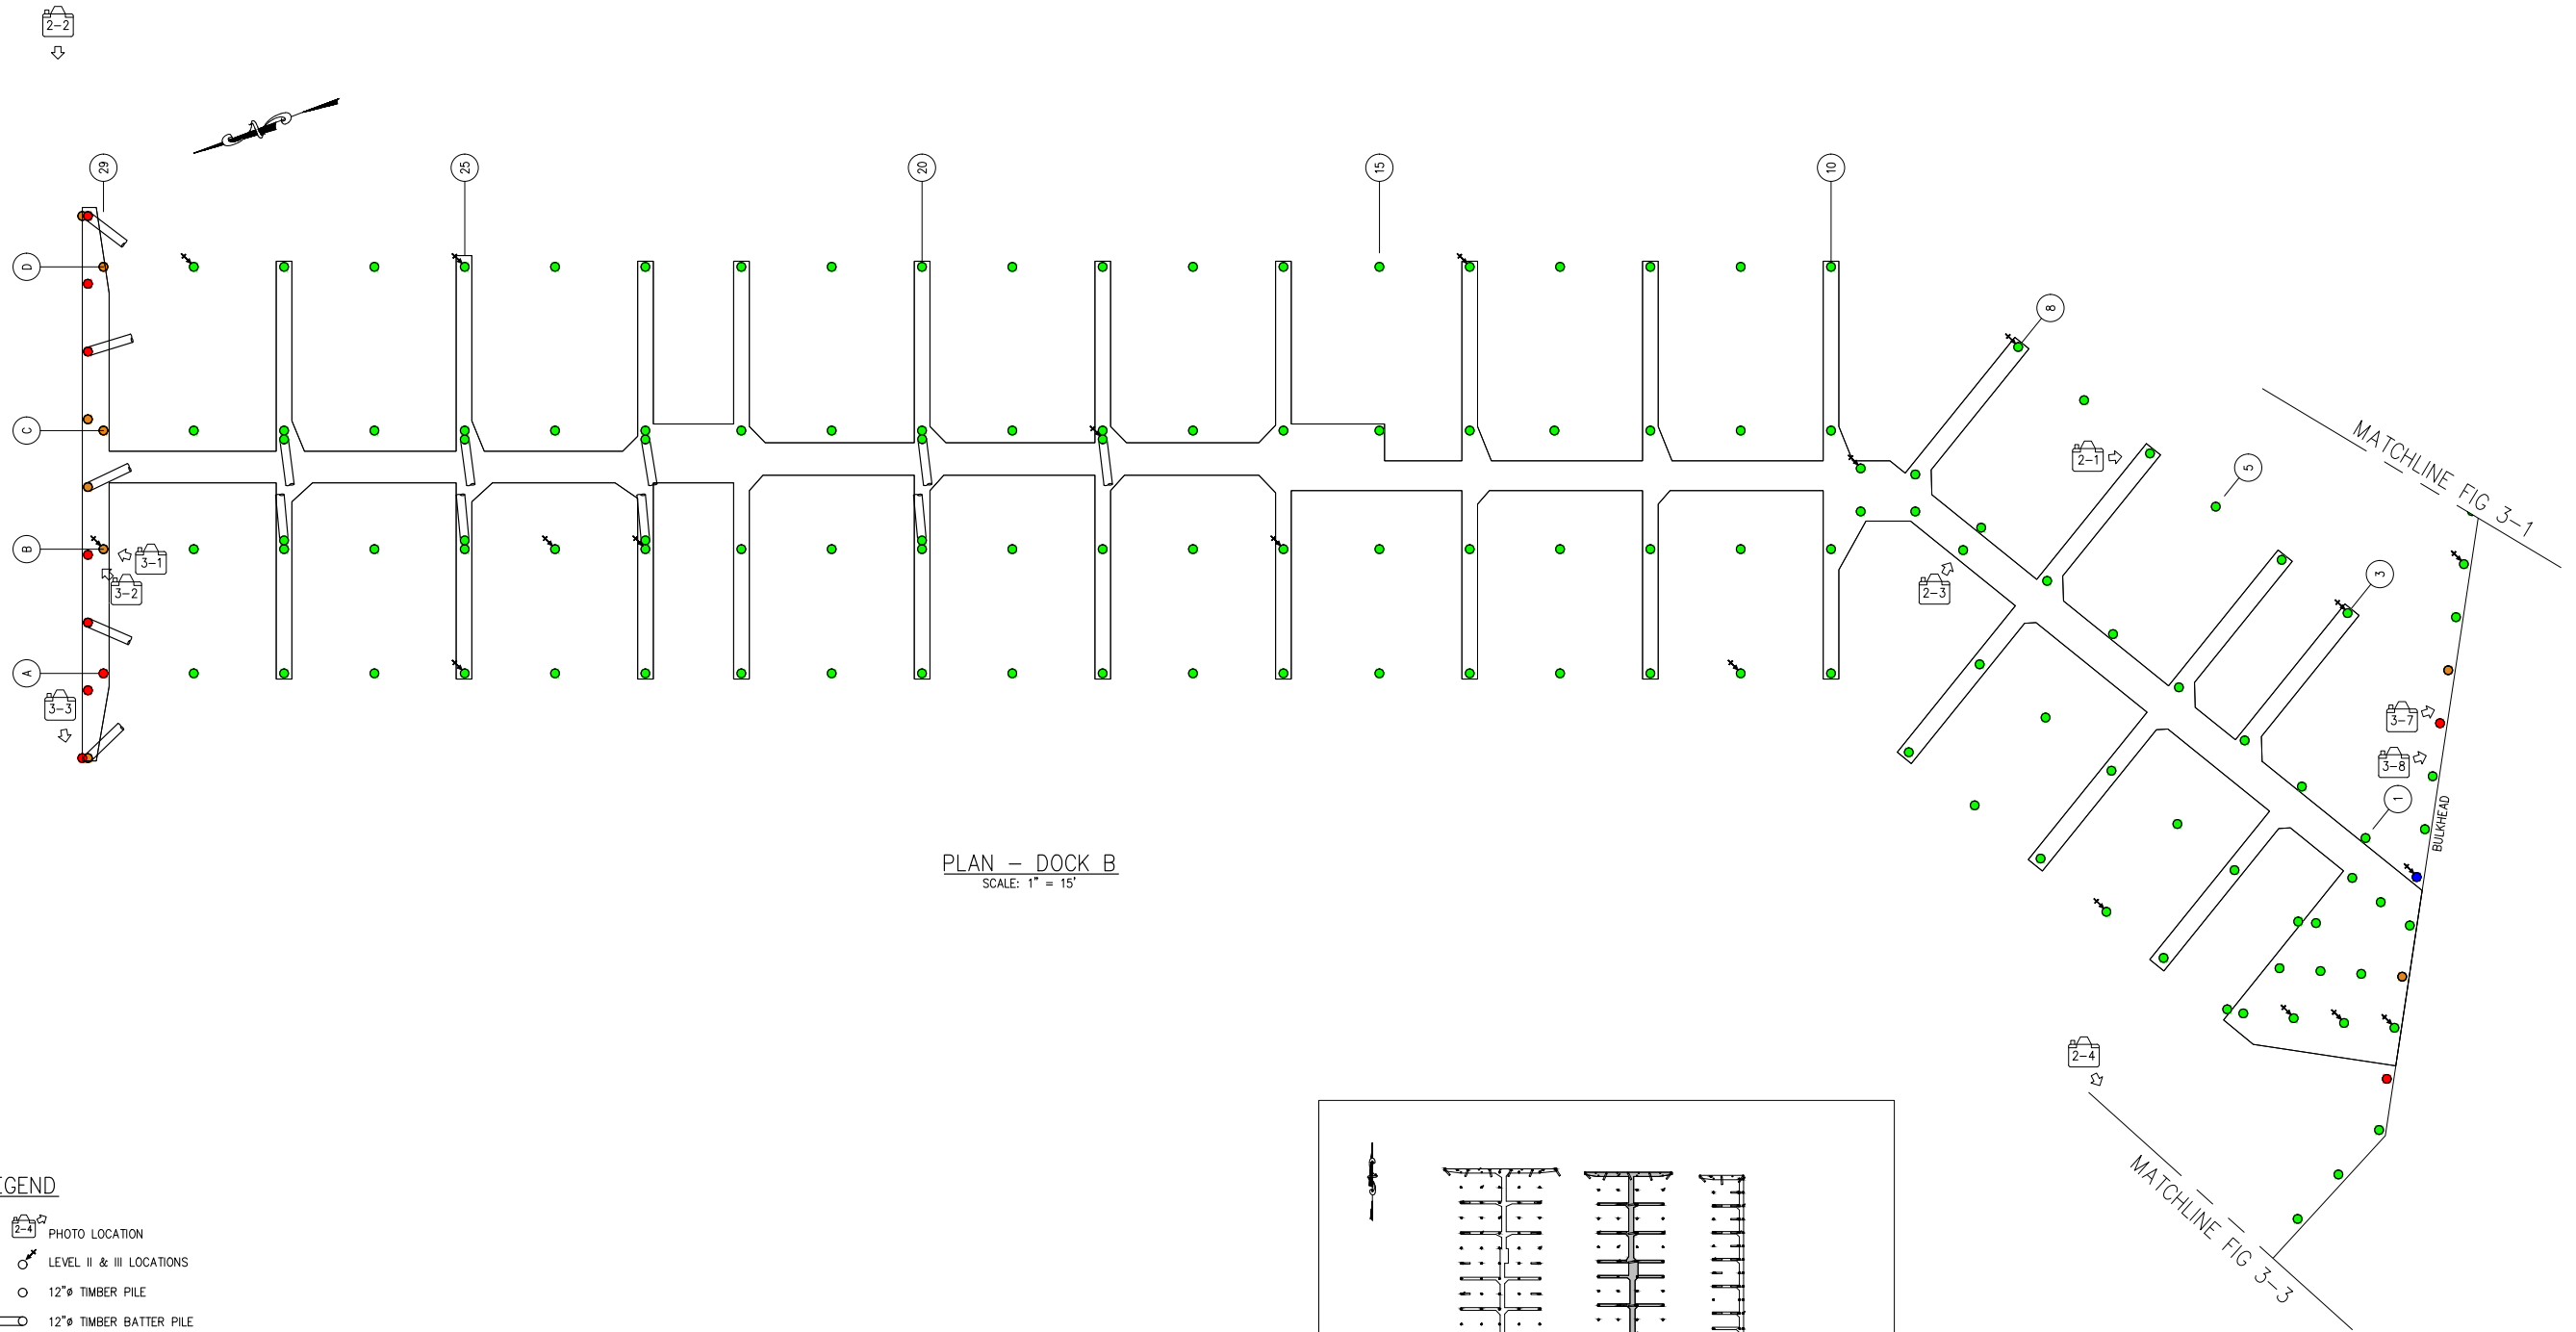
PLAN — DOCK B  
SCALE: 1" = 15'

DESIGNED BY G.L.	PORT OF SEATTLE MARINE FACILITIES	SCALE 1" = 15'	REVISION
DRAWN BY G.L.		DATE	
CHECKED BY	SALMON BAY MARINA	DRAWING NO. <b>FIG 3-2</b>	
PROJECT ENGR	PILE DEFICIENCY PLAN SHEET 2 OF 3
