## Salmon Bay Marina Docks A, B, C Closure FAQ

**RE: Investigation & Condition Memo**

**DATE:** November 4, 2022  
**TO:** Danny Good, WPM Facilities Project Manager  
**FROM:** Taesan Hose P.E. S.E., Phoebe Williams  
**SUBJECT:** SaBM Covered Moorage Docks A, B, & C – Roof Structure Condition Assessment

PROJECT: SALMON BAY MOORAGE ROOF CONDITION ASSESSMENT

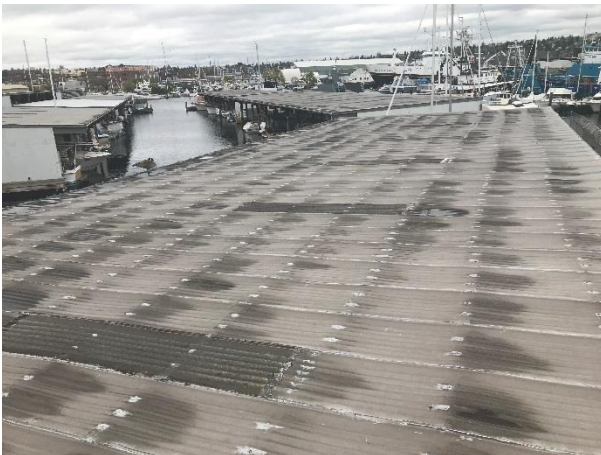
1. Fastener connection failure
2. Failed attempted sealant repair at EACH fastener
3. Severe roof deflection which leads to ponding water between each purlin
4. Light gauge metal panels
5. 36-inch spaced purlins (insufficient for metal roof of this type)
6. Attempted misguided repairs (sealant of various types. Should be tested for asbestos)
7. Possible water damage at failed fasteners

Photo 1: Sealant at EVERY fastener

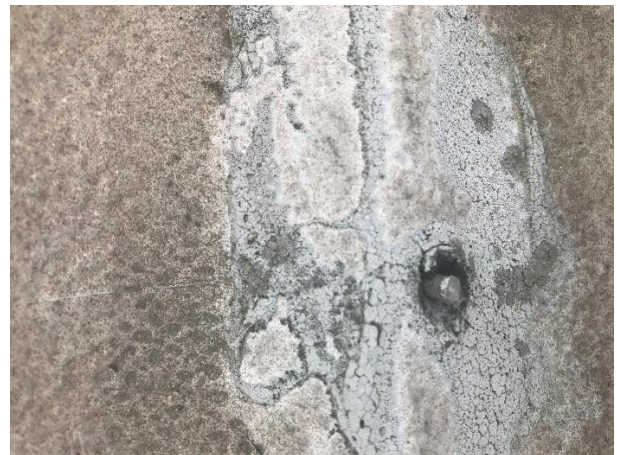
Photo 2: Typical fastener

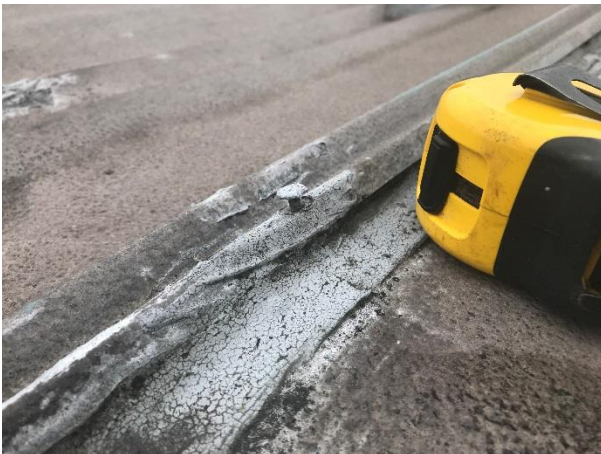
Photo 3: Fastener backout/Split

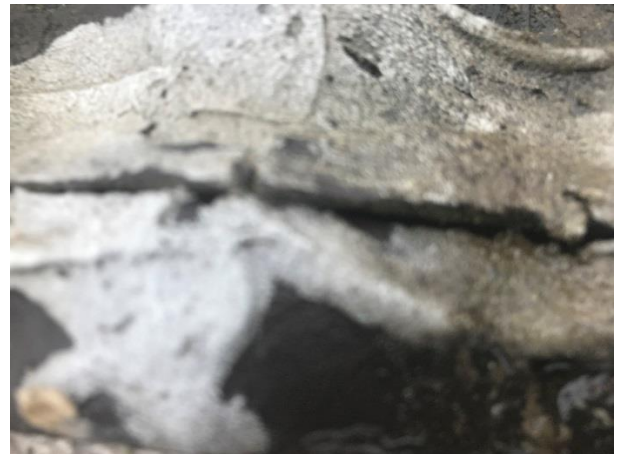
Photo 4: Failed sealant repair at seam

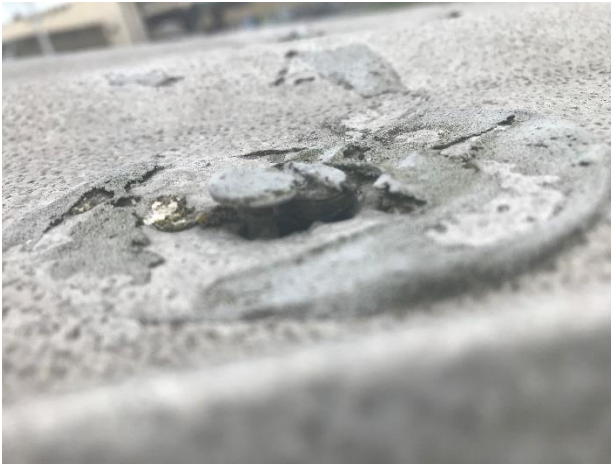
*Photo 5: Fastener backout*

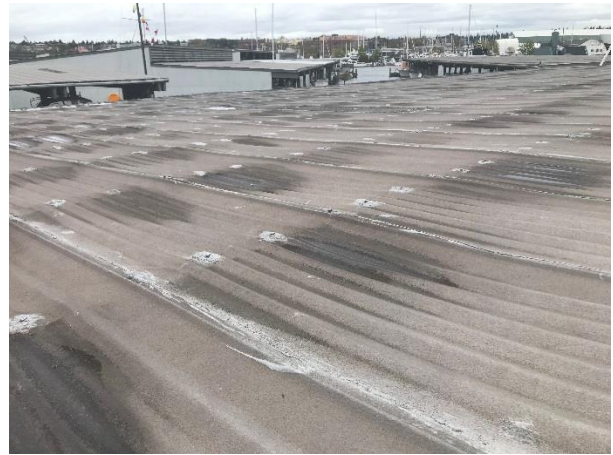
*Photo 6: Ponding/Deflection between Purlins*

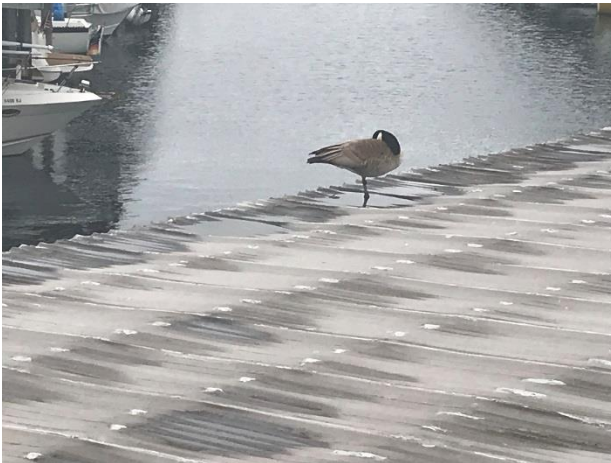
*Photo 6: Goose in a pond*

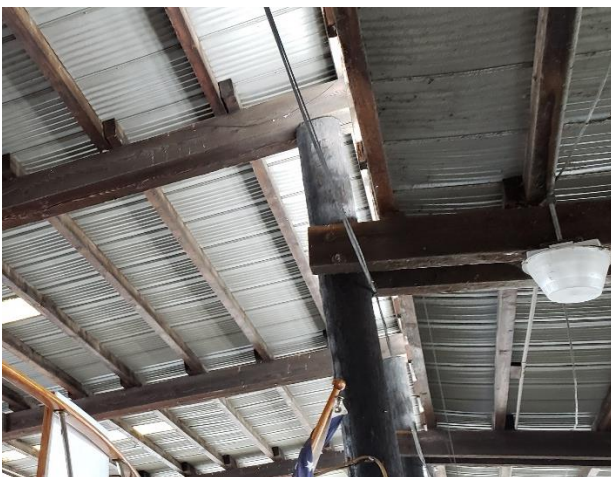
*Photo 8: No visible connection at column/beam*

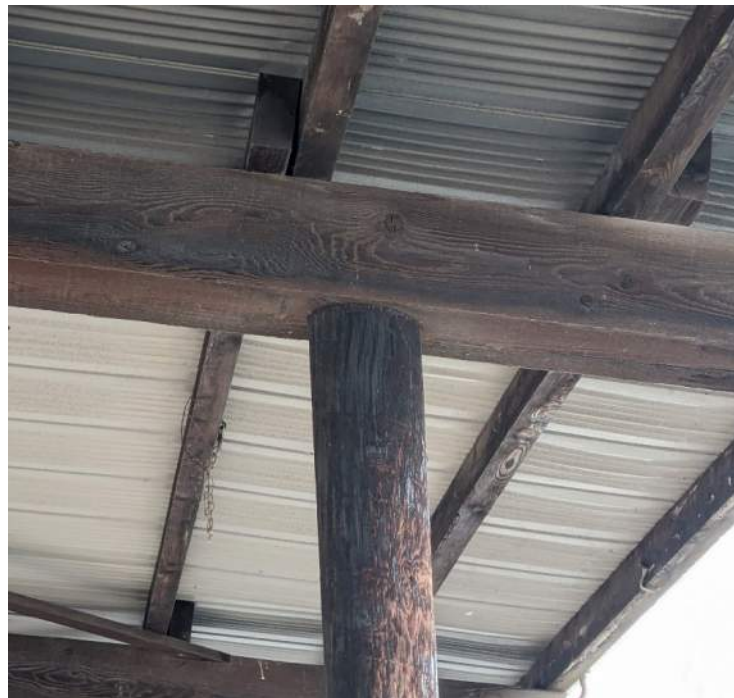
5. Where girders rest on top of existing piles, no visible connection can be seen.
  - a. Example of this issue: In July of 2018, a pile was impacted by a boat, which lead the girder above to be shifted. Once shifted, the girder was only bearing on approximately 40% of the existing pile. No indication of a hidden dowel connection was observed after the pile shifted. Port Engineering addressed the repair by shifting the pile back under the girder and using channels to create a positive attachment. See **Figure 12**.

**Fig 6 – Typical Girder Bearing on Pile Without Visible Connection**

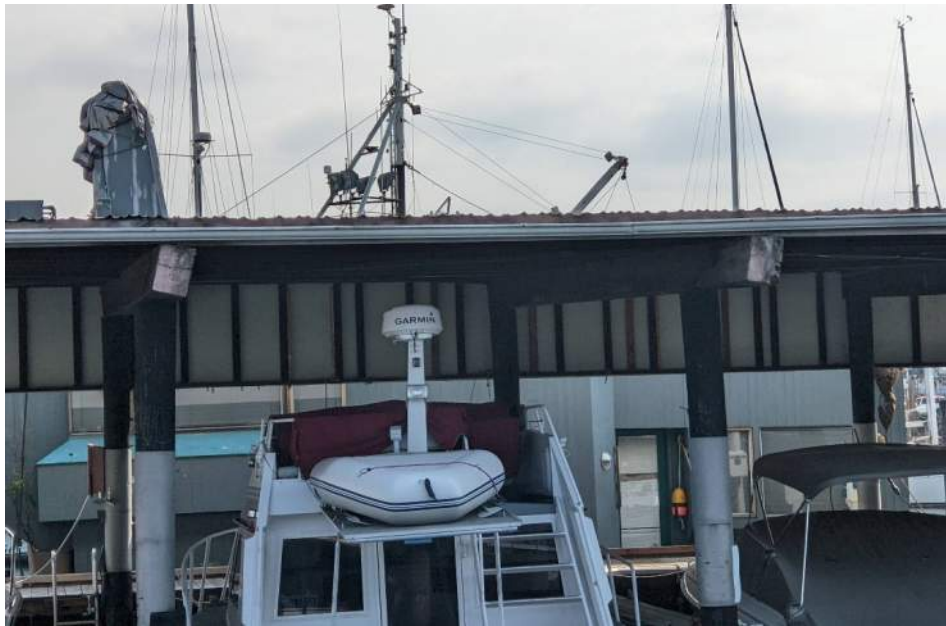
In general, the roof girders and joists are in **Good condition**. Occasional signs of splitting and warping were observed in the girder members (see **Figures 9 and 10**). Moderate weathering can also be seen at the ends of the girders where they are more exposed to rain and sun but does not appear to affect the primary spans of the girders.

**Fig 9 – Twisting/Warping of Girders**

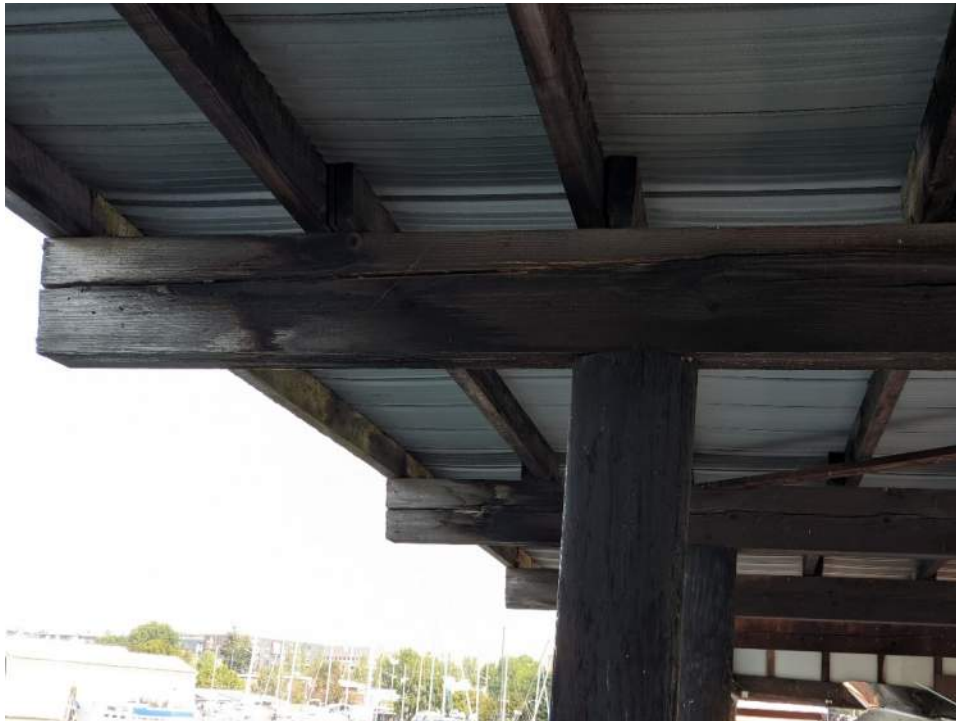
**Fig 10 – Splitting and Weathering at Exposed Girder End**

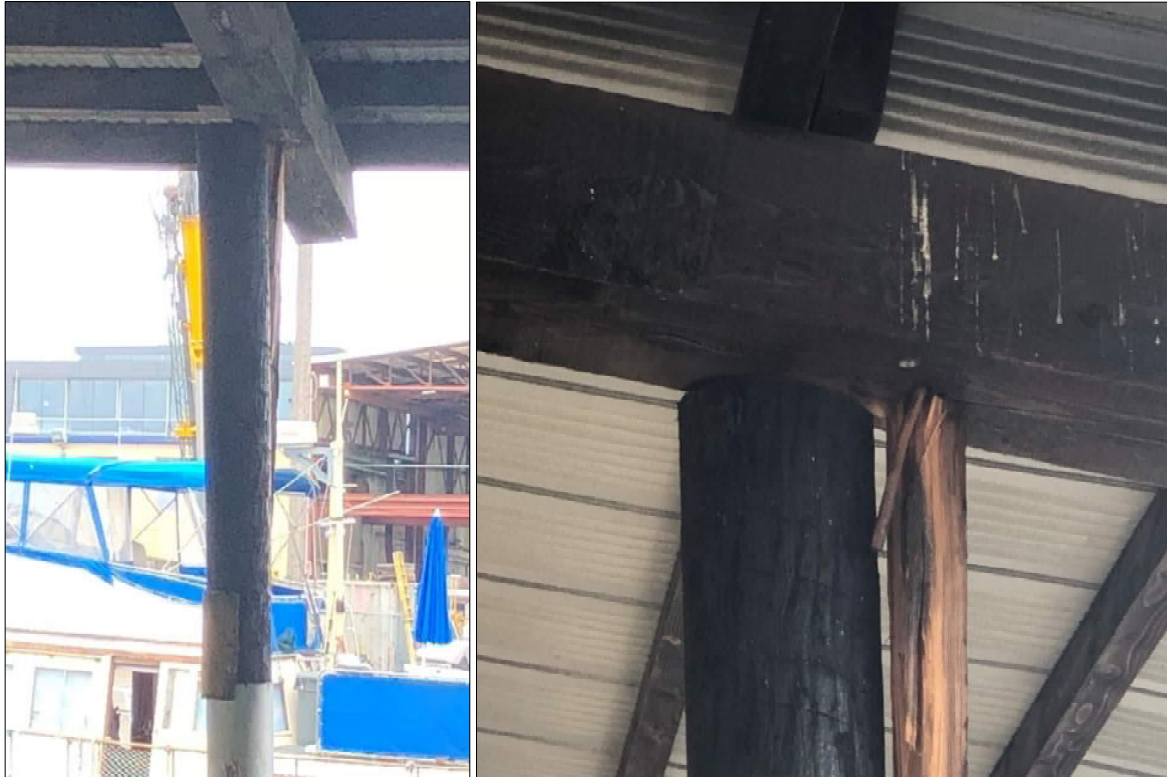
**Fig 11 – 2018 Boat Impact Incident with Less Than 50% Bearing at Top of Pile and No Visible Mechanical Connection (Repaired Shortly After Incident with Channels and Thru-Bolts)**

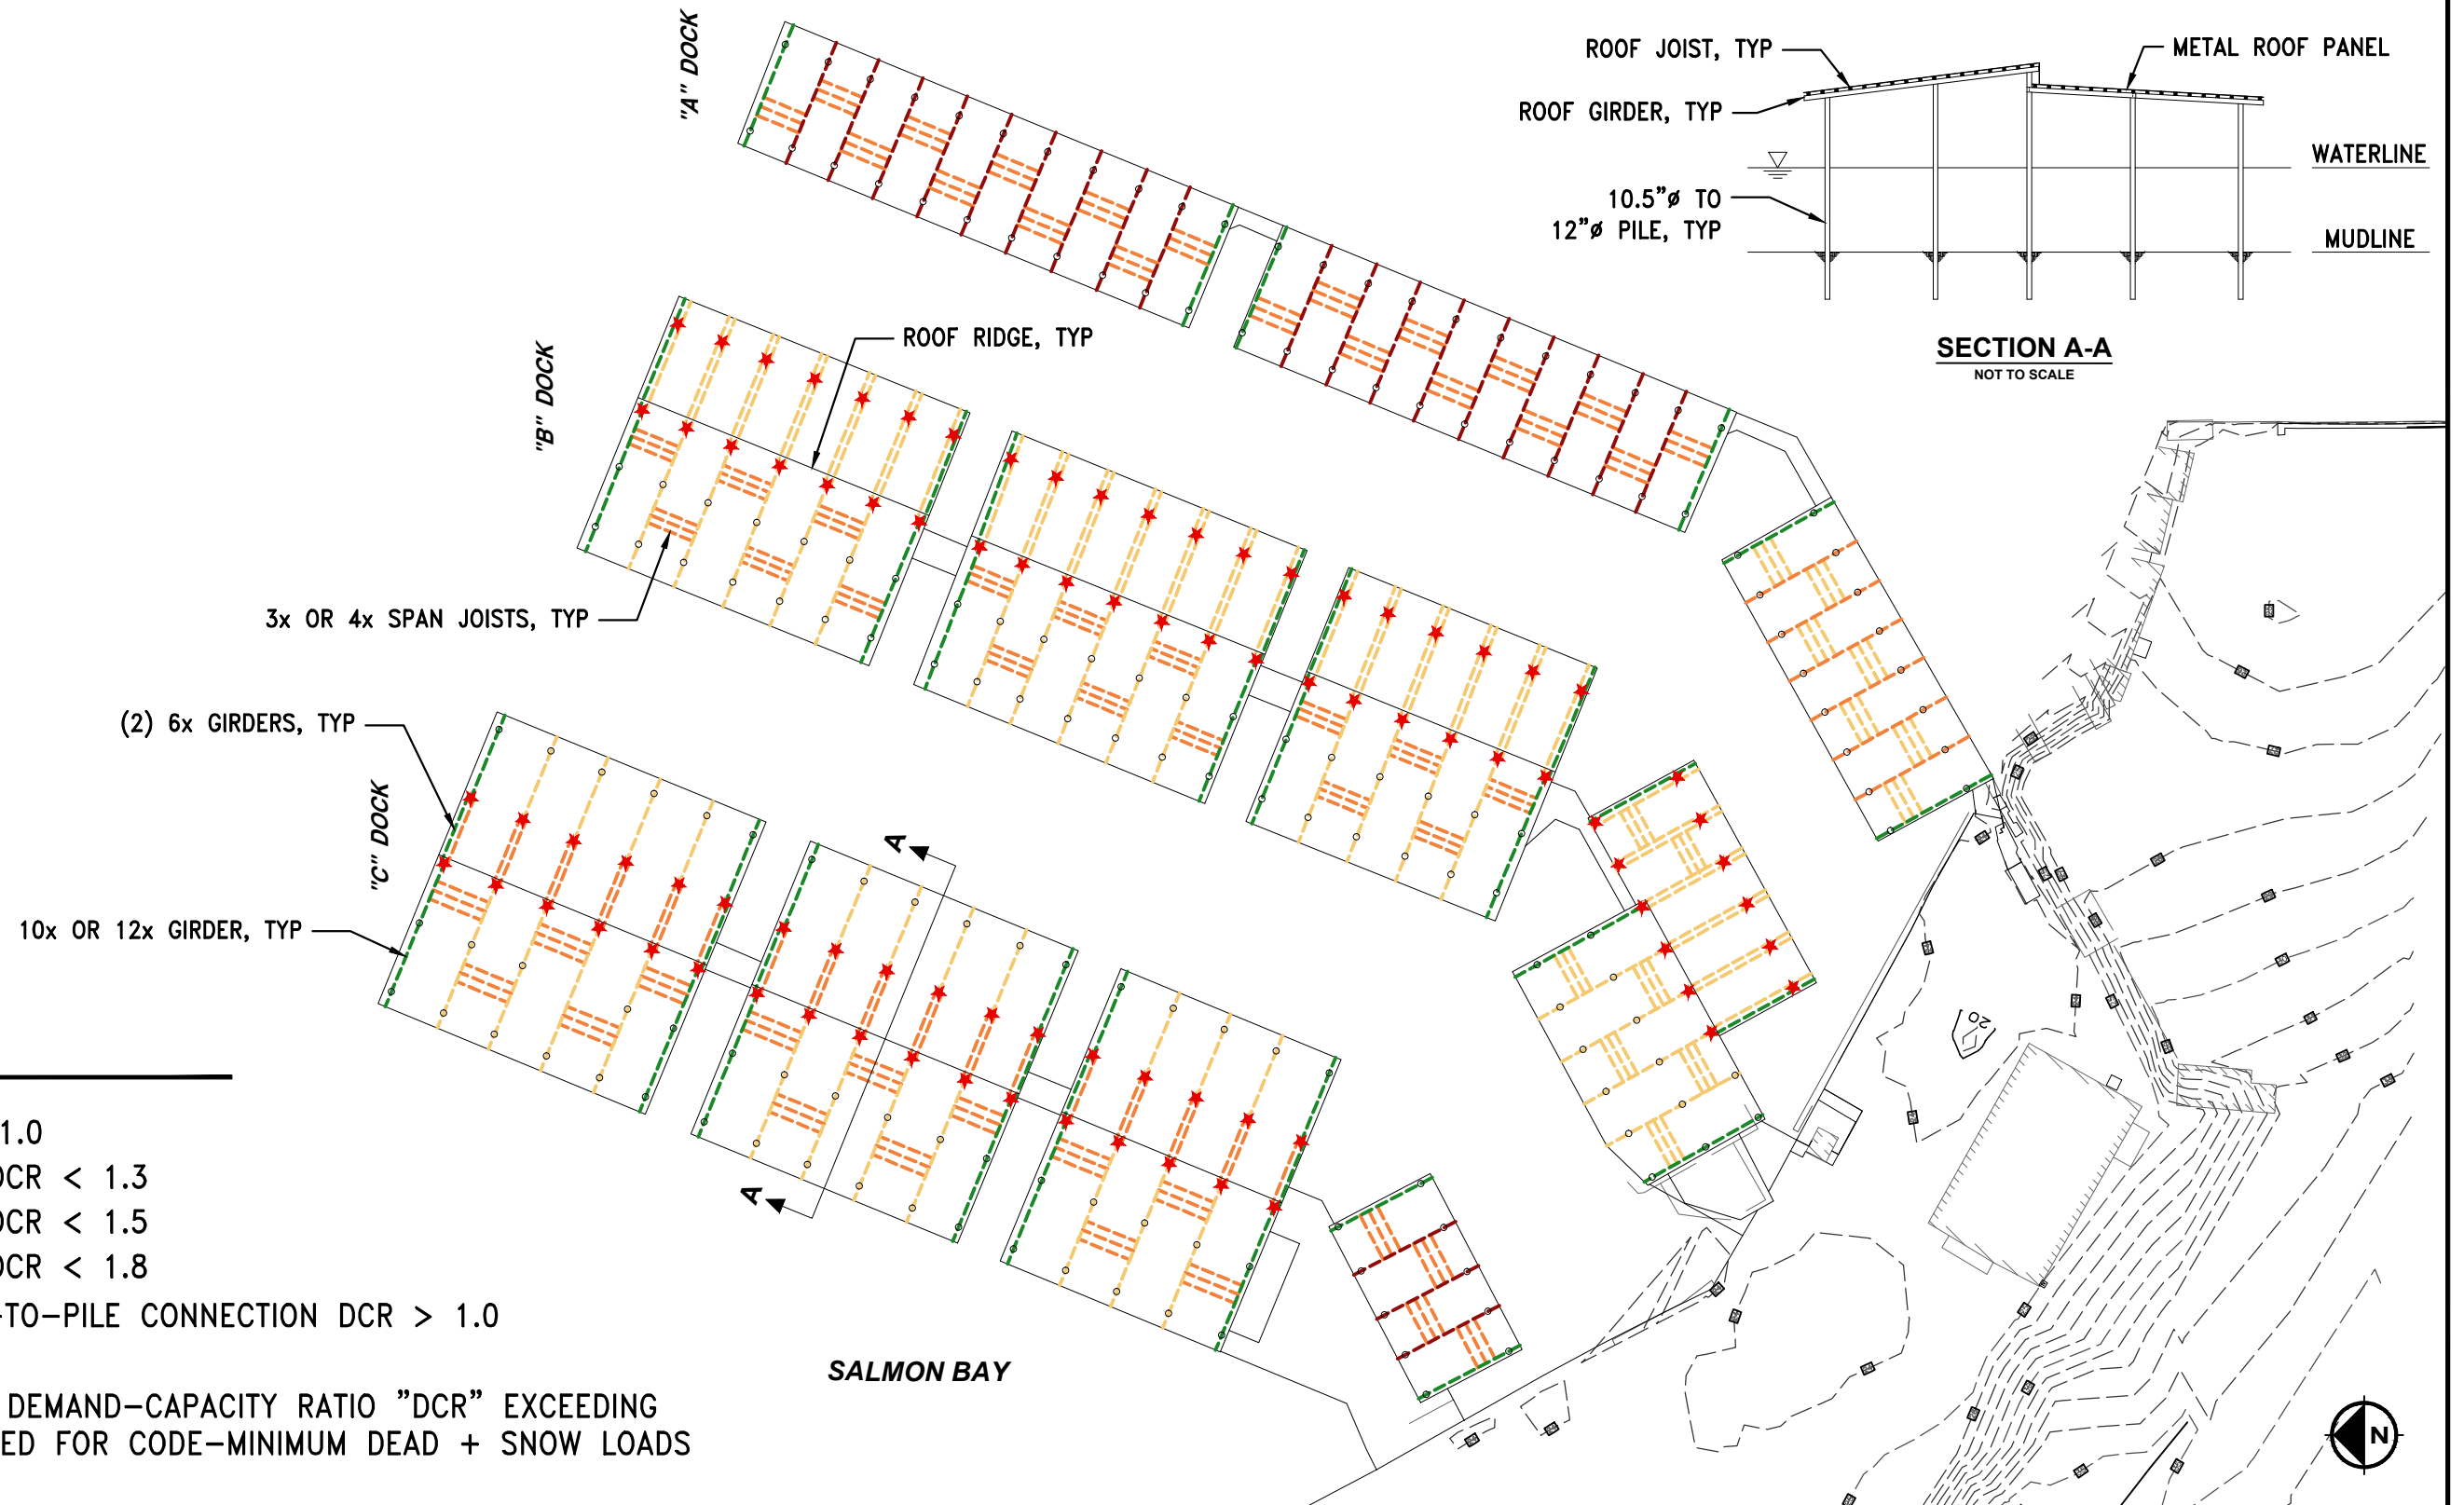
HEAT MAP

3. Joists members (generally N-S) range from 100% to 150% of their design capacity. See **DCR Heat Map**.
4. Thru-bolt connections from large double-girder members to the piles are inadequate. See **DCR Heat Map**.

The majority of existing girder and joist members are inadequate for current Code-based gravity loads (see **DCR Heat Map**). Connection retrofits will improve the basic safety of the structure but do not change the inadequacy of the primary roof-supporting members for Code-based dead and snow loads.

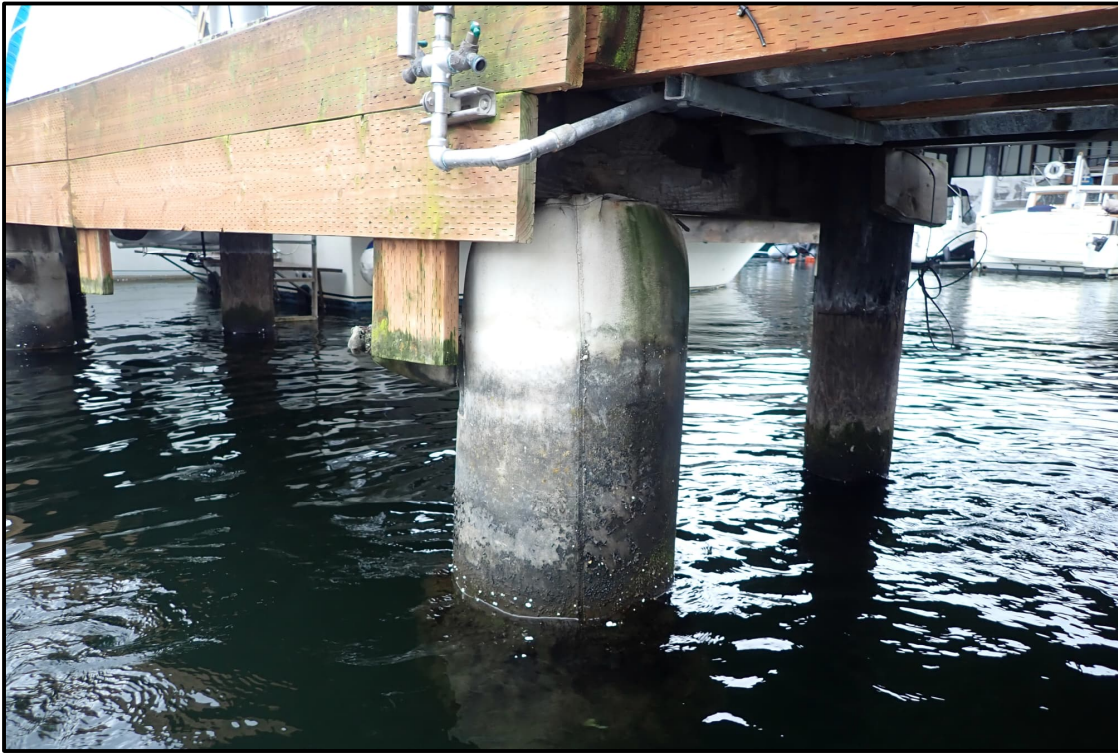
Photo 2-3: Typical concrete bag repair at Docks A, B, and C.

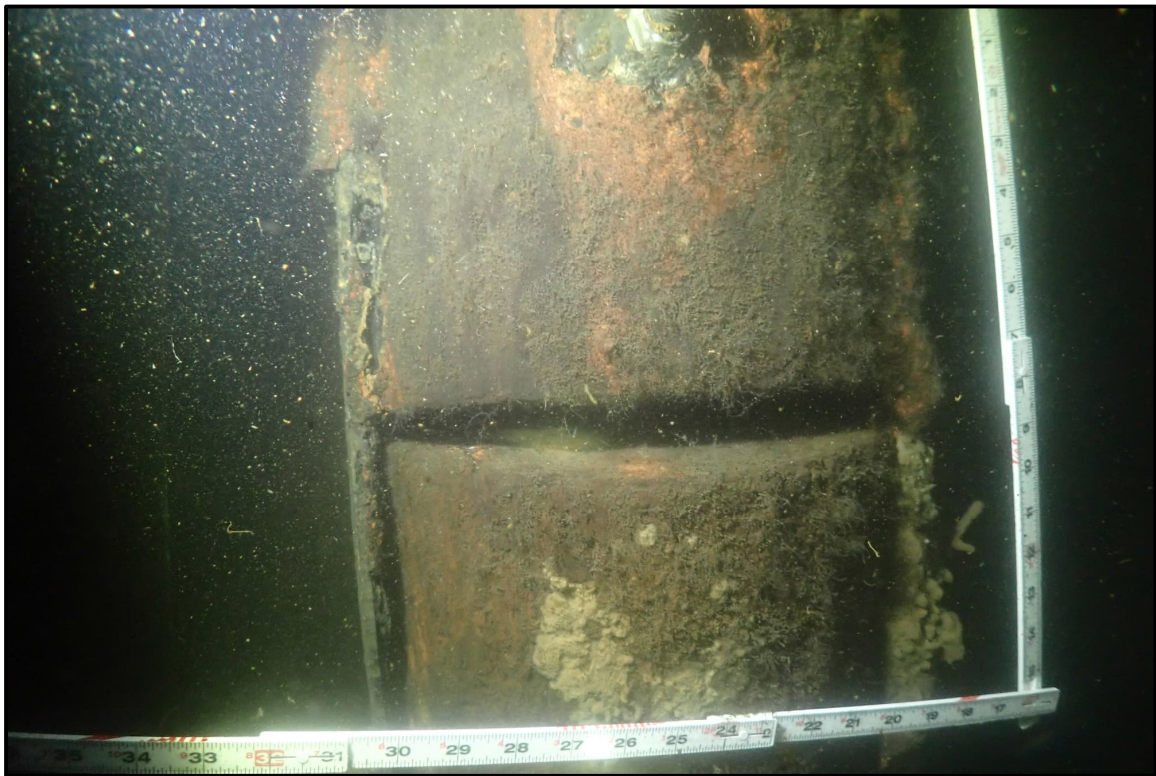
A total of 43 timber plumb and batter piles support the offshore wave screens located at the north end of each dock. Moderate to advanced deterioration was observed at 21 of these timber piles: including reduced bearing at the pile/post interface and corrosion of the steel fishplate and/or connection hardware. Severe deterioration was also observed at an additional 8 wave screen piles: including loss of bearing at the pile/post interface, severe corrosion of the fishplates and connection hardware, and failure of the bolted timber batter pile connection.

Photo 3-1: Loss of bearing at pile/post interface along the offshore wave screen.

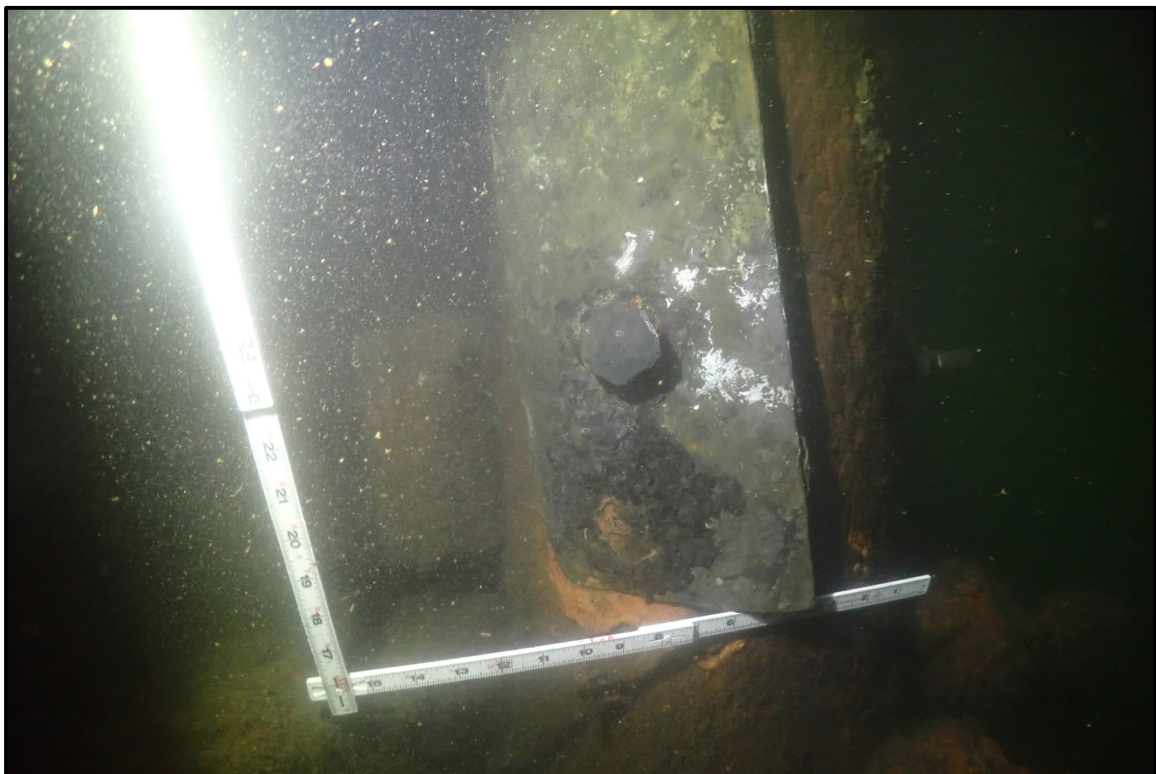
Photo 3-2: Corrosion through full thickness of steel fish plate at pile/post connection of timber pile at offshore wave screen.

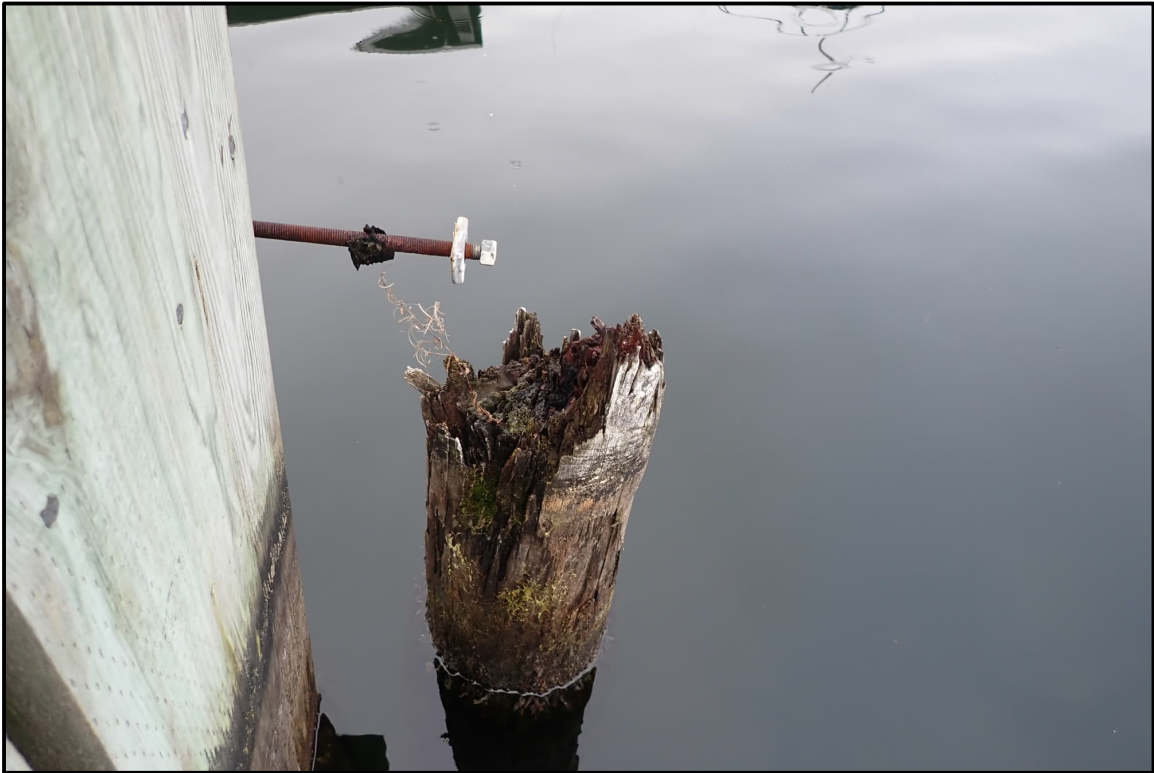
Photo 3-3: Failed connection at top of pile due to fungal rot at offshore wavescreen.

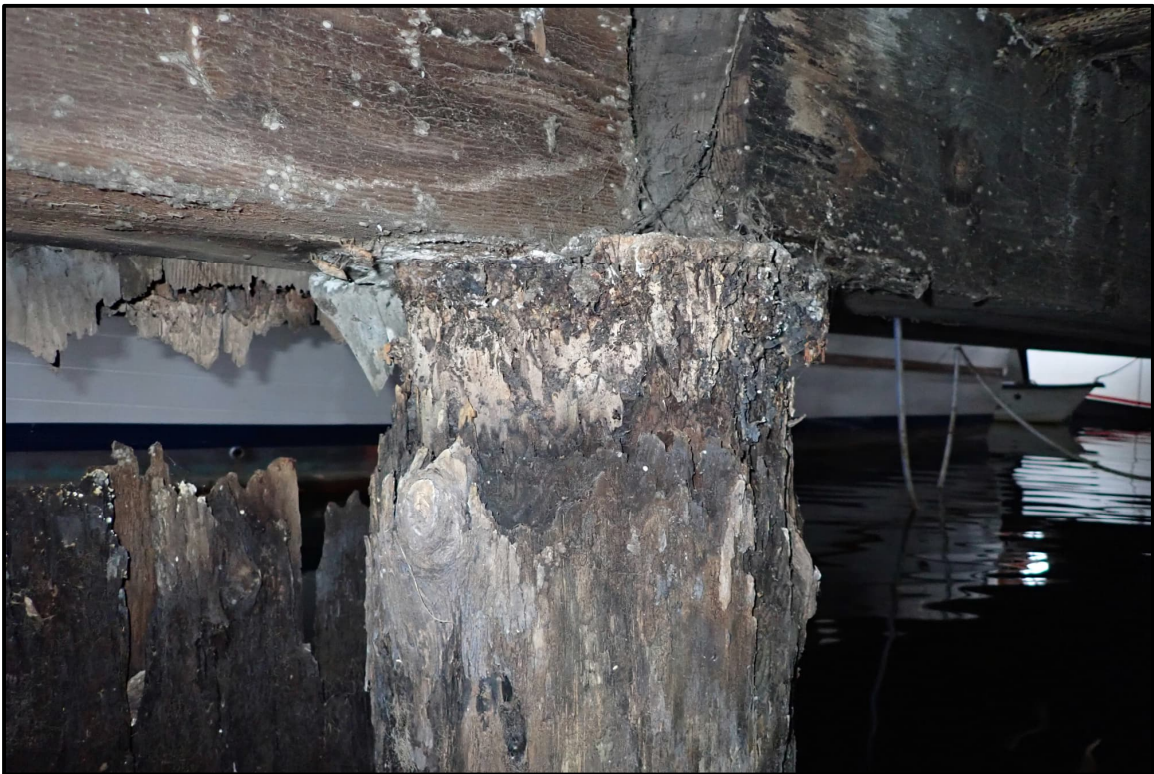
Photo 3-4: Timber pile with major section loss due to fungal rot at top of pile.

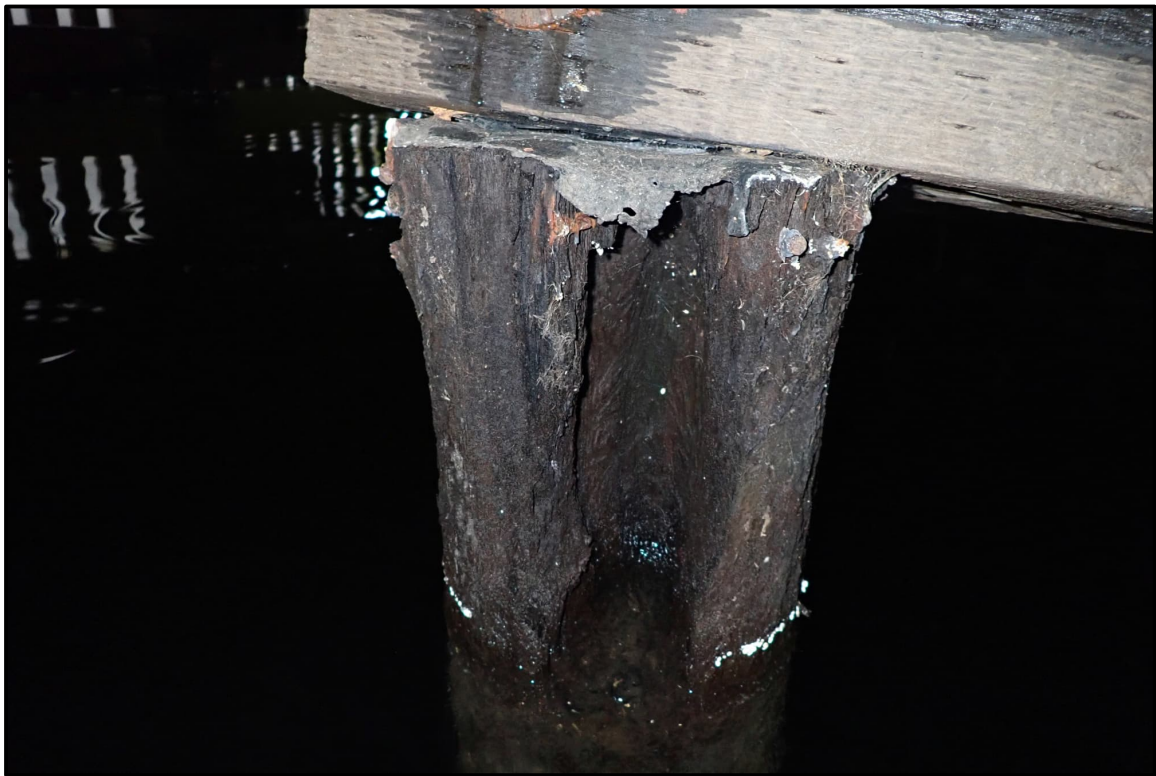
Photo 3-5: Timber pile with severe section loss due to fungal rot through core of pile.

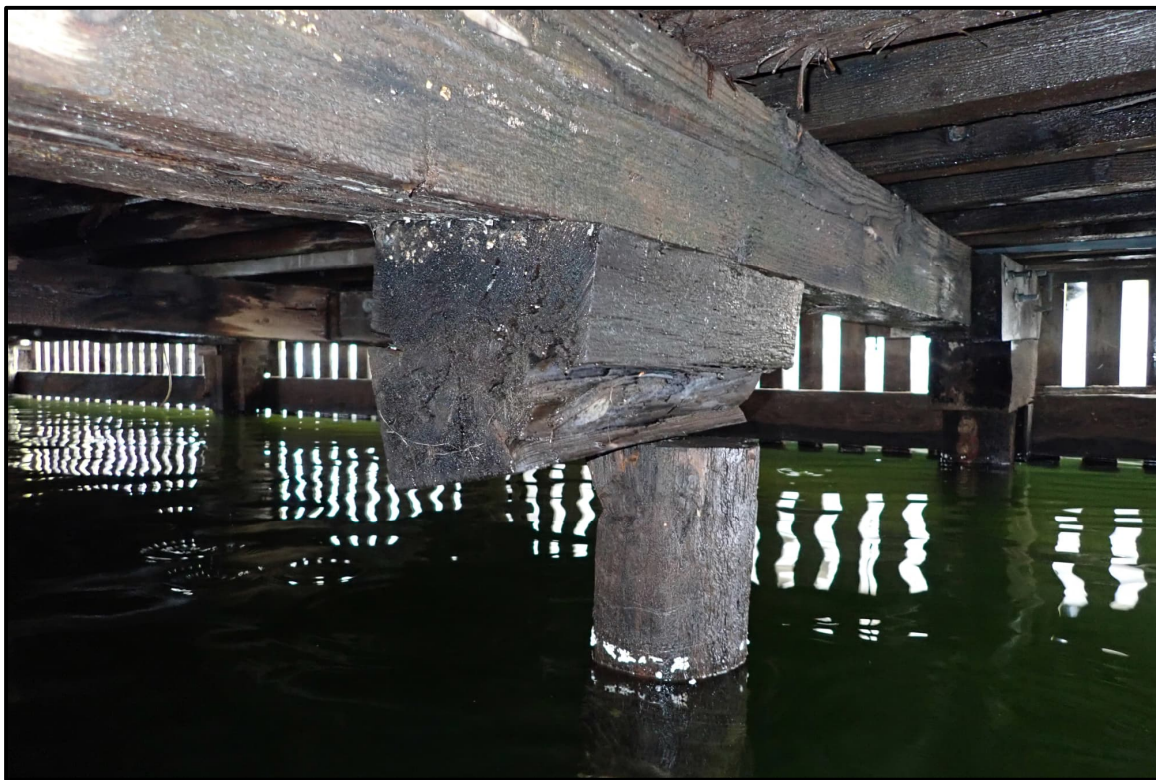
Advanced deterioration was also observed at the 27 timber piles supporting the inshore-most platform at Dock C, primarily due to fungal rot. Section loss up to 35 percent was observed at 15 timber piles, section loss between 35 and 50 percent was observed at two timber piles, and section loss greater than 50 percent was observed at an additional two timber piles. The presence of fungal rot at both the top of pile and bottom of pile cap resulted in reduced bearing at 6 pile locations. The most severe cases of bearing loss were accompanied by crushing and rotation of the lower 12 in. by 12 in. timber cap.

Photo 3-6: Severe reduction in bearing due to rotation and crushing of lower timber cap shimming the connection between the pile and pile cap.

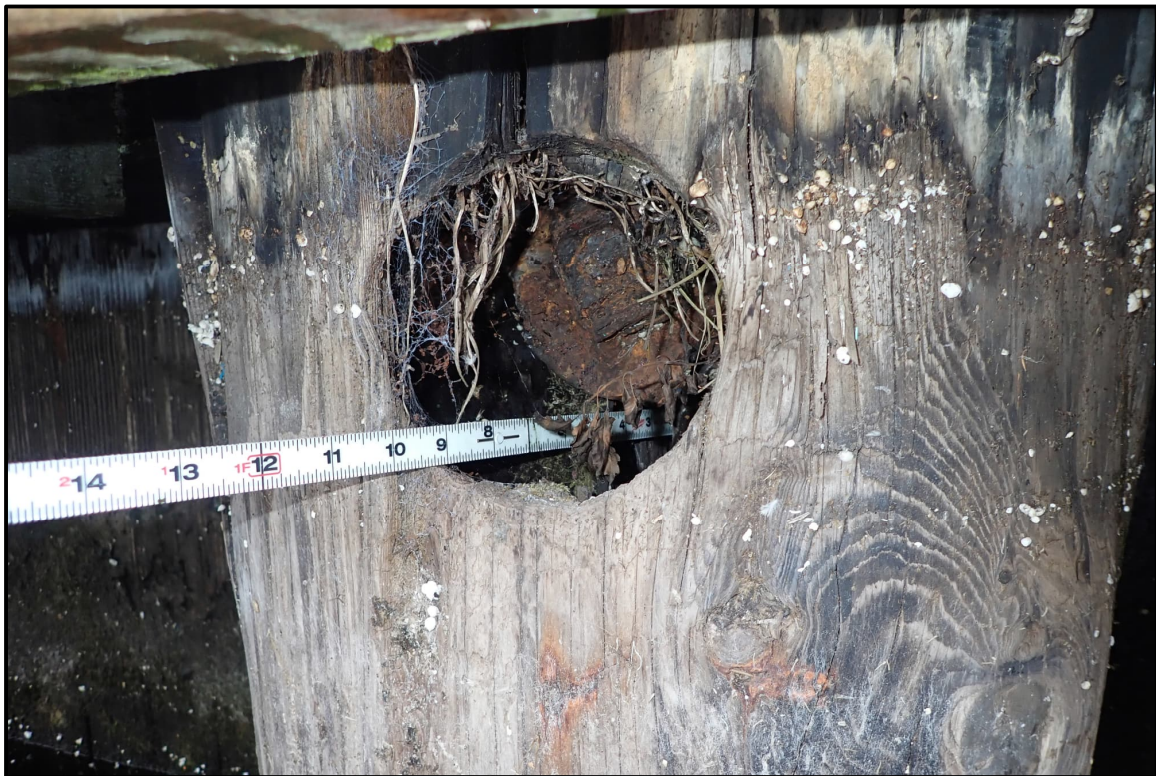
A total of 27 timber piles supports the timber walkway running the length of timber sheet pile bulkhead between Dock A and Dock C. The inshore timber piles exhibit minor fungal rot above and below water. Section loss up to 35 percent was observed at one timber pile, section loss between 35 and 50 percent was observed at two timber piles, and section loss greater than 50 percent was observed at an additional five timber piles. The timber piles with severe section loss exhibited other severe deterioration, including splitting and breakage within the top 54 in. of pile.

Photo 3-7: Timber pile with severe section loss due to fungal rot at top of pile along timber bulkhead.

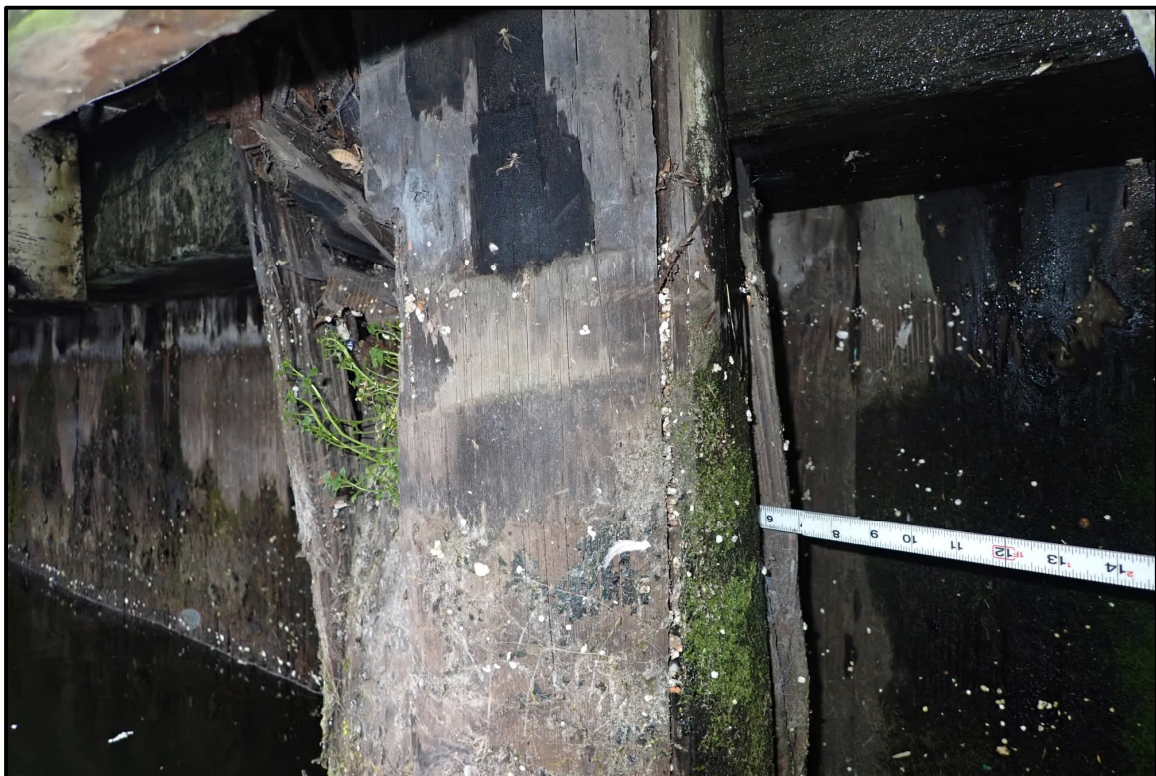
Photo 3-8: Timber pile with severe section loss and splitting at top of pile due to fungal rot along timber bulkhead.

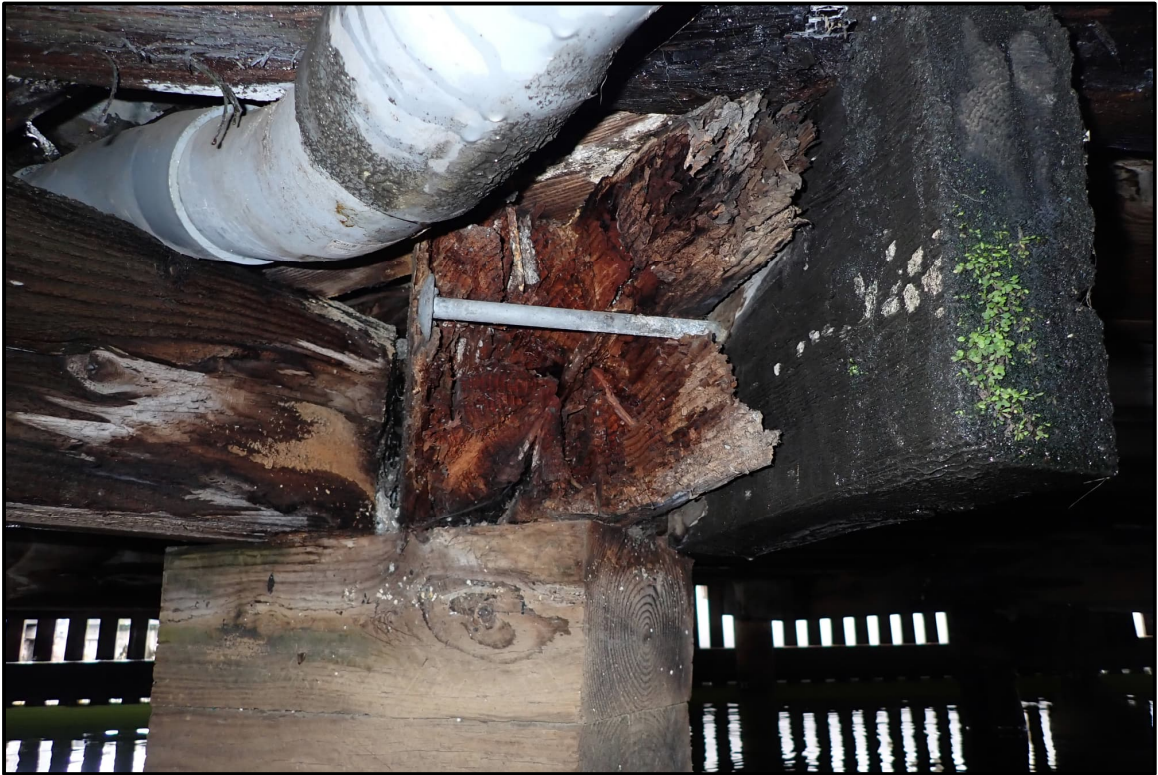
Photo 4-1: Dock C, Inshore Platform - Timber pile cap with severe section loss at its end due to rot.

Recommended Priority repairs include repair of nine timber piles with severe section loss supporting the walkway along the bulkhead and at the inshore platform at Dock C, replacement of severely corroded connection hardware at six locations along the wave screens, restoration of bearing at the pile/post interface at six locations along the wave screens, and replacement of crushing timber pile caps above three timber piles under the inshore platform at Dock C.

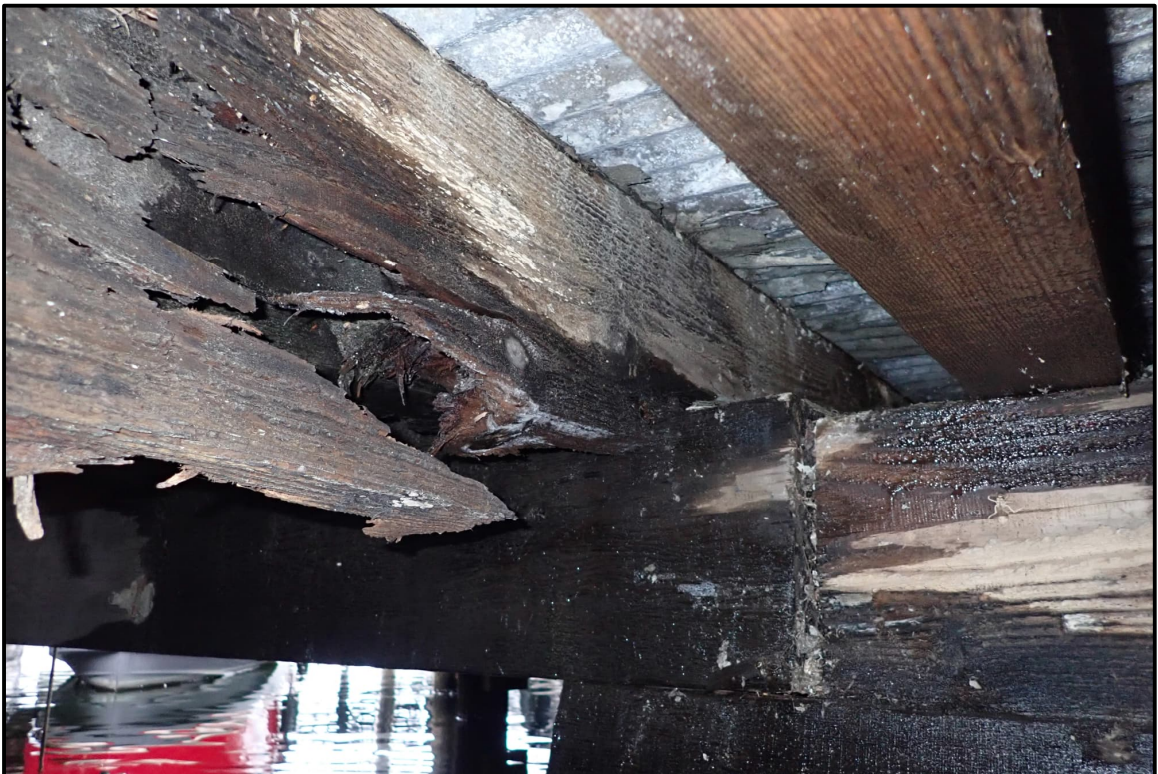
Photo 4-2: Dock C, Inshore Platform - Timber stringer crushing between the deck above and timber pile cap below due to rot.
