# Salmon Bay Marina Docks A, B, C Closure

## Supporting Documentation

# **SALMON BAY MARINA: SITE OBSERVATIONS**

## **SITE OBSERVATIONS, LITERATURE REVIEW, AND DISCUSSION**

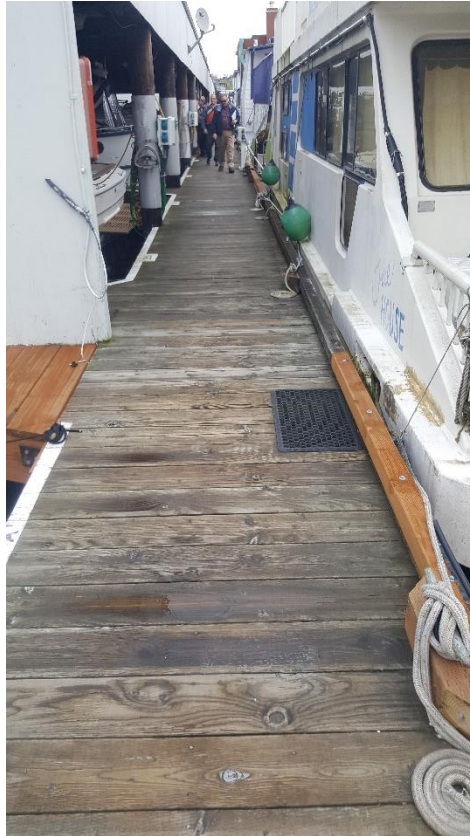
Figure A-1 - Typical Walkway Pier in Boathouse Pier A

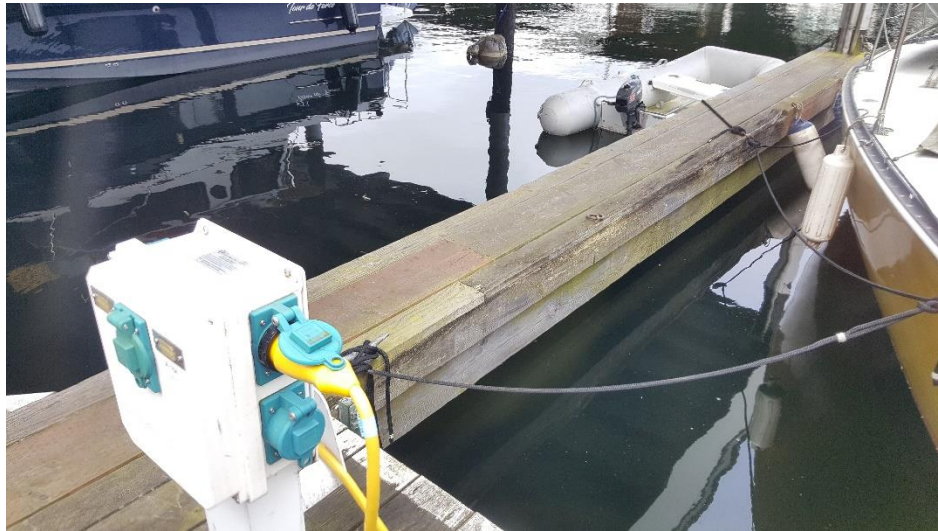
Figure A-2 - Typical Finger Pier in Boathouse Pier A

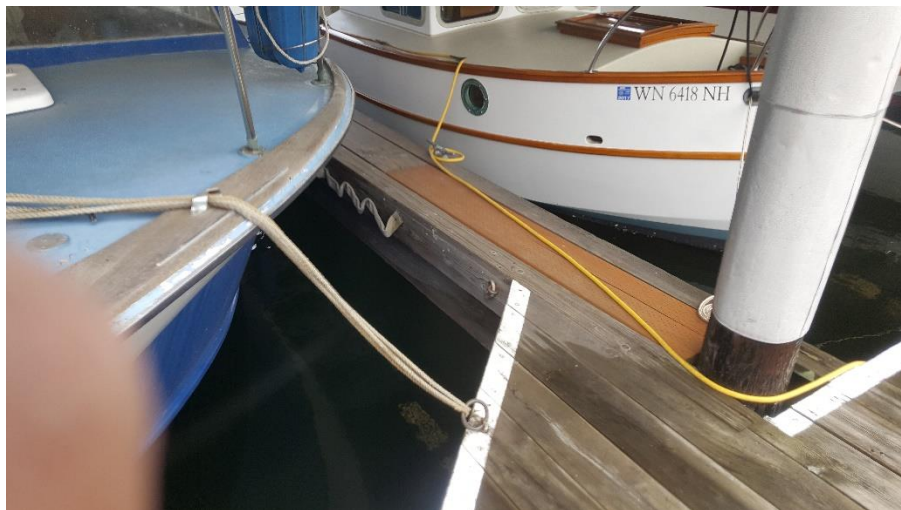
Figure A-3 - Typical Finger Pier in Boathouse Pier A

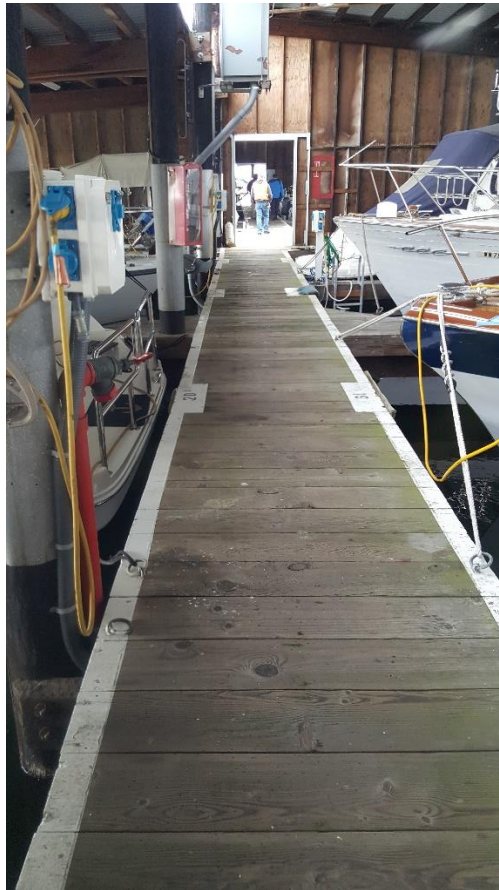
Figure A-4 - Typical Walkway Pier in Boathouse Pier B

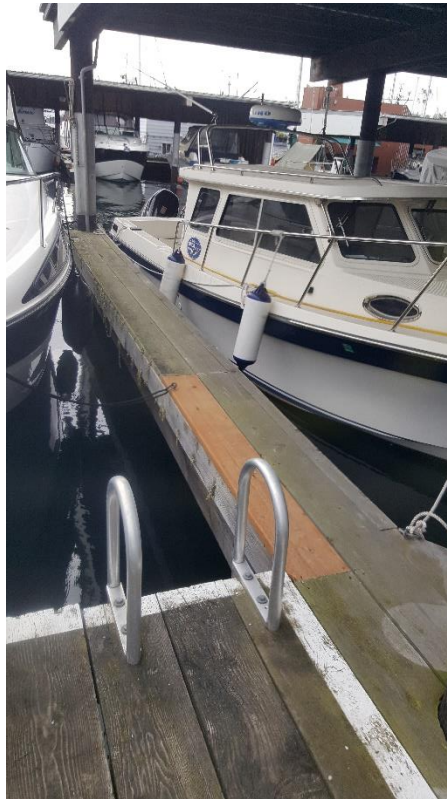
Figure A-5 - Typical Finger Pier Repaired in Boathouse Pier B

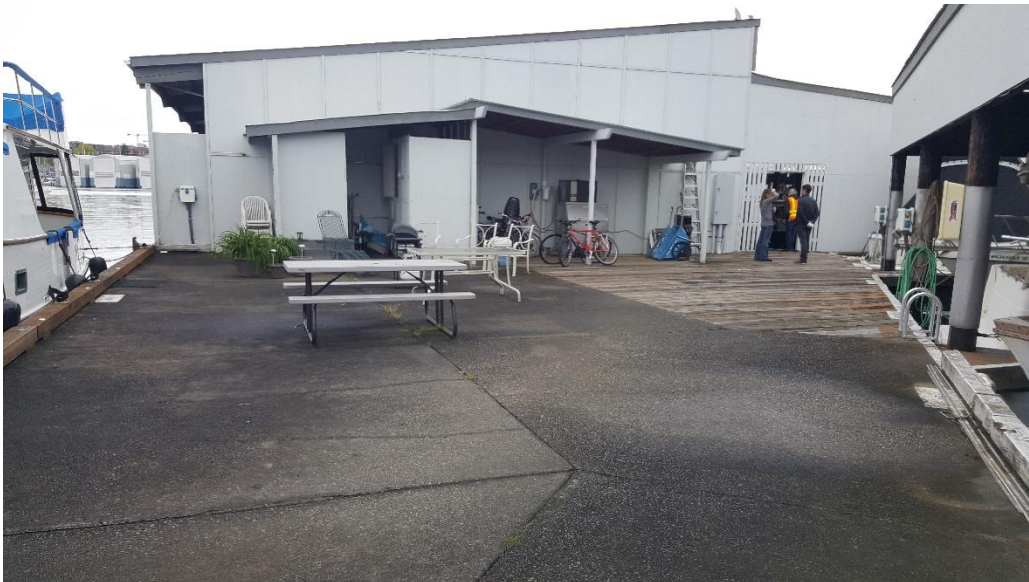
Figure A-6 - Boathouse Pier C Entrance

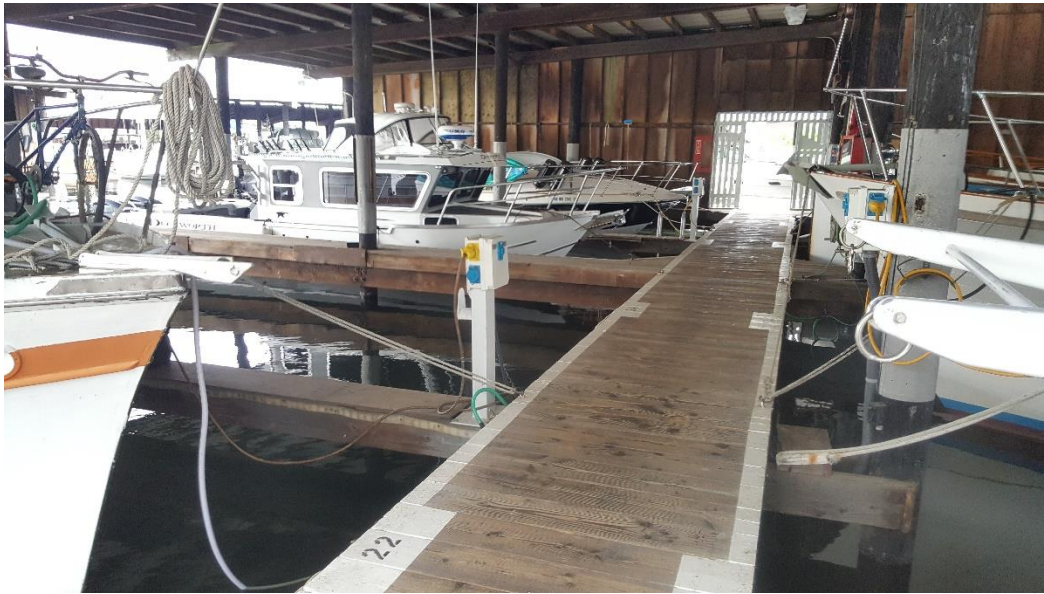
Figure A-7 - Typical Walkway Pier in Boathouse Pier C

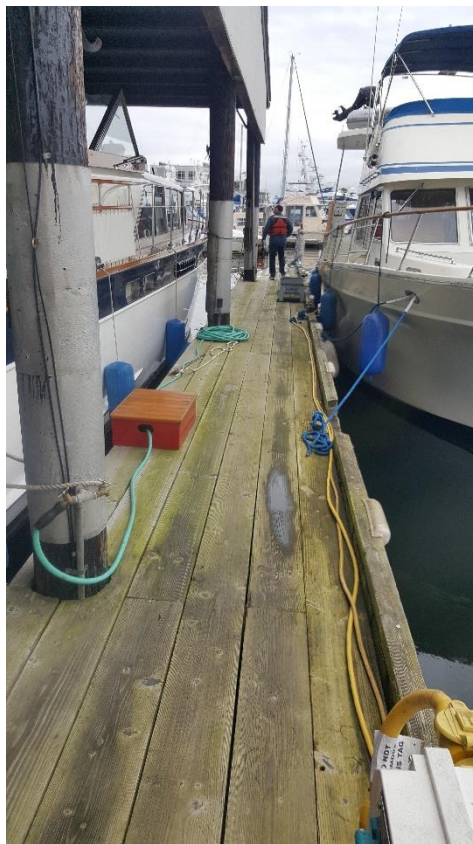
Figure A-8 - Minor Fungal Decay at Boathouse Pier C, North End

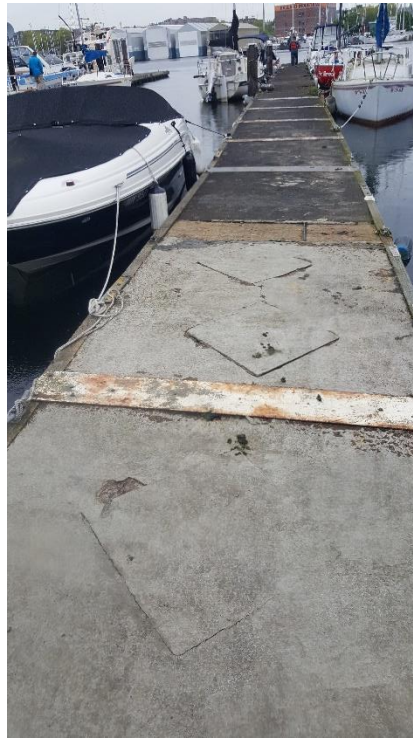
Figure A-9 - Floating Dock D at Entrance

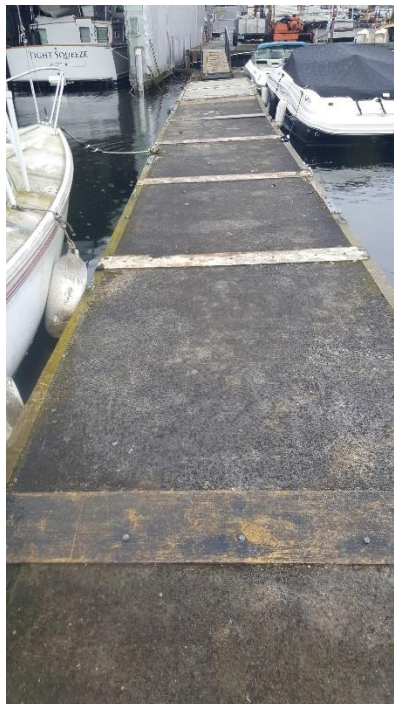
Figure A-10 - Floating Dock D, Looking South

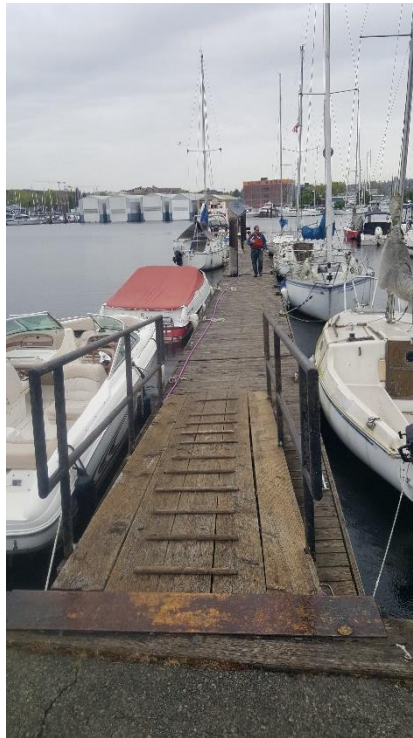
Figure A-11 - Floating Dock E at Entrance

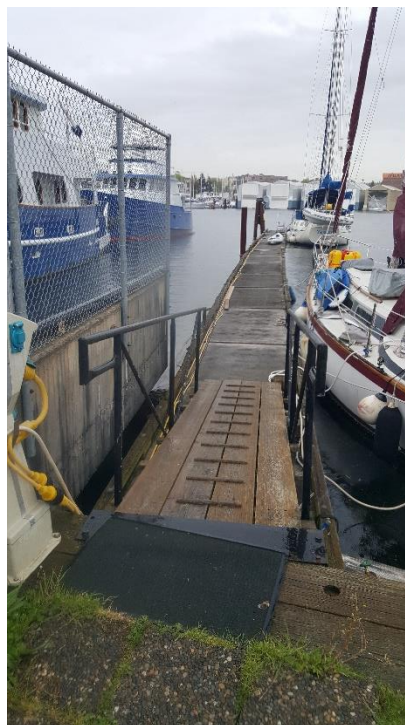
Figure A-12 - Floating Dock F at Entrance

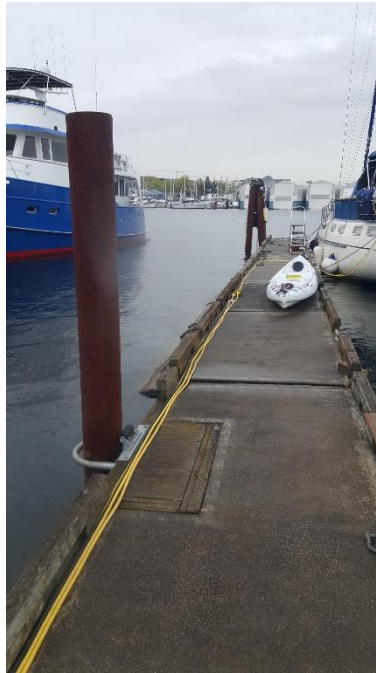
Figure A-13 - Float Guide Piles along Floating Dock F

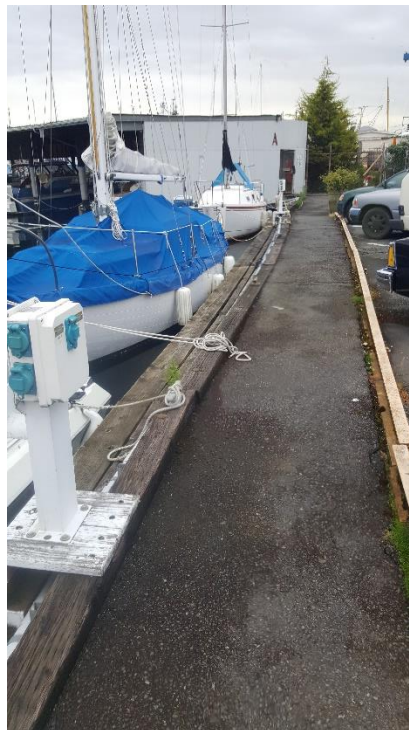
Figure A-14 - Top of Bulkhead, between Docks A and B

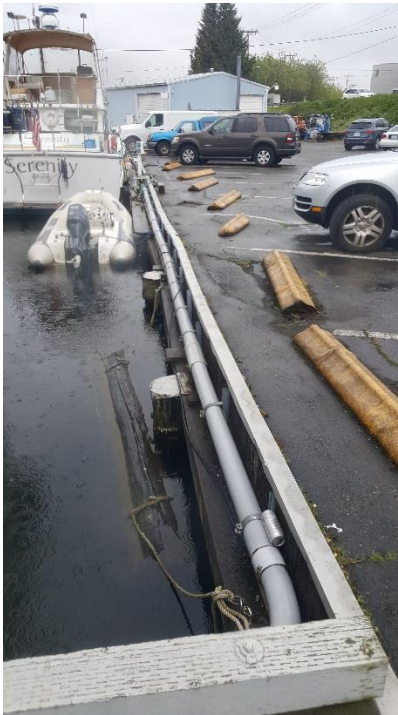
Figure A-15 - Top of Bulkhead, between Docks B and C

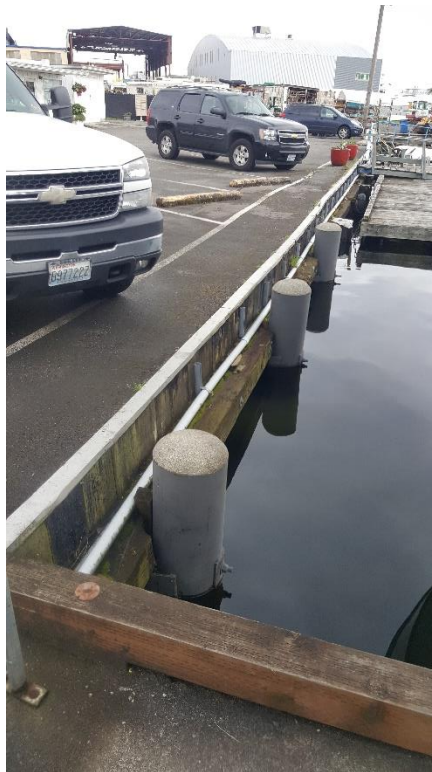
Figure A-16 - Bulkhead with New Steel Piles, adjacent to Dock C Entrance

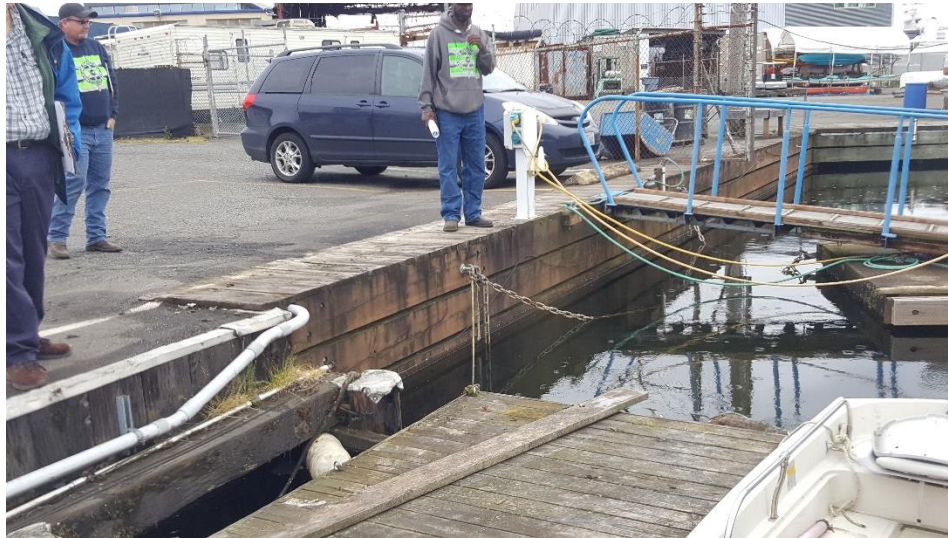
Figure A-17 - Bulkhead adjacent to Dock D

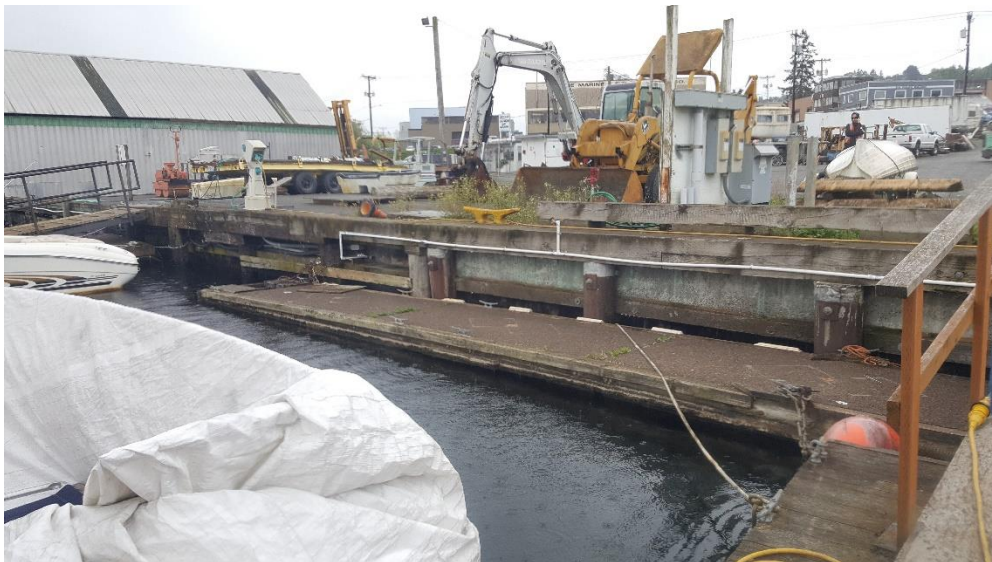
Figure A-18 - Bulkhead between Docks E and F

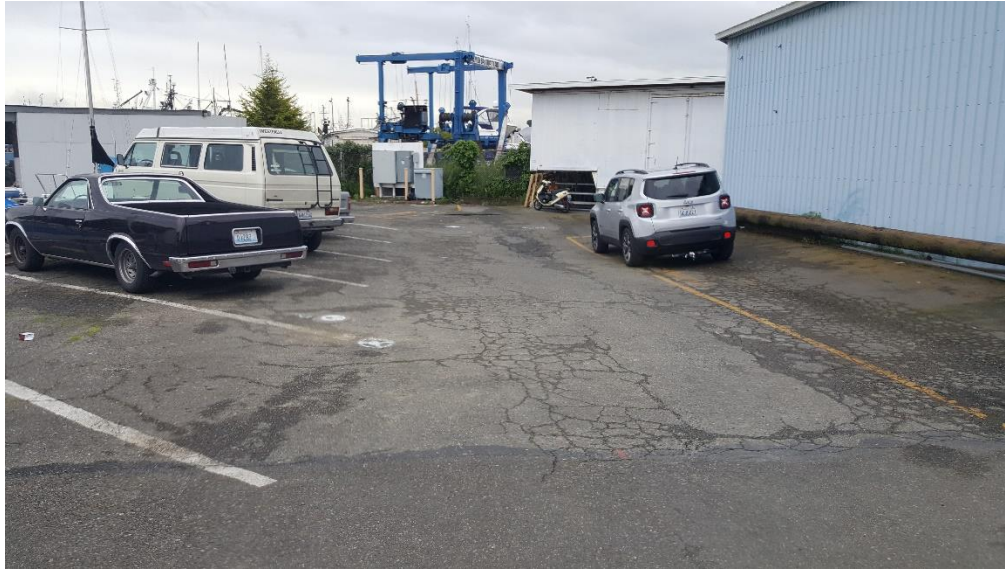
Figure A-19 - Condition of Pavement in front of Warehouse

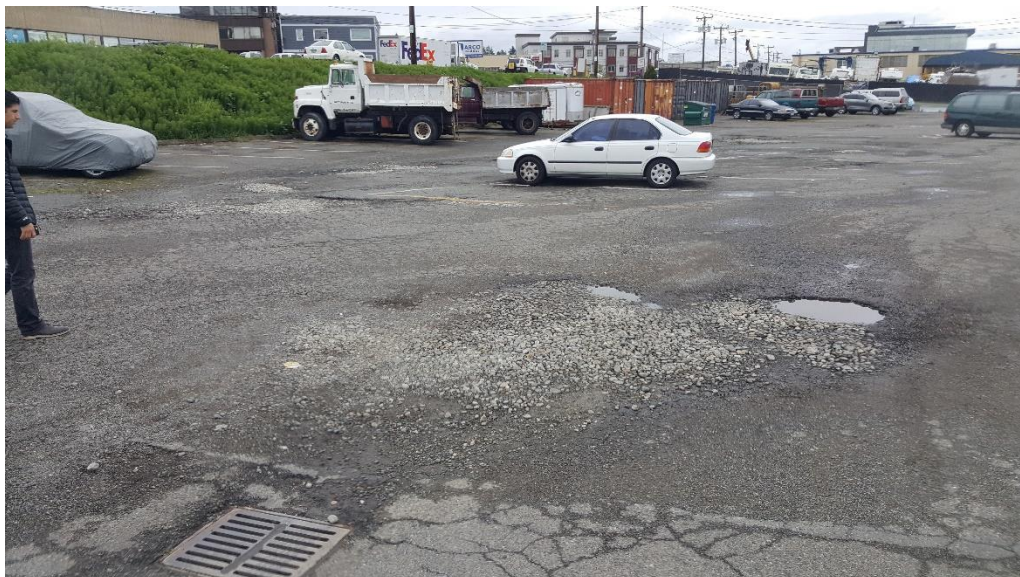
Figure A-20 - Condition of Pavement adjacent to Dock B Entrance

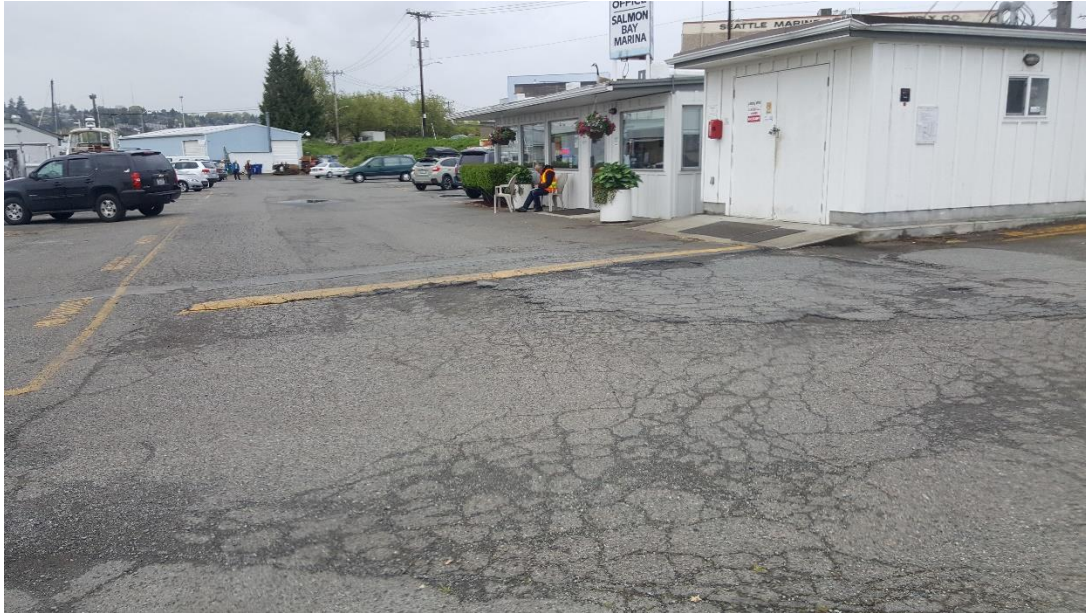
Figure A-21 - Condition of Pavement adjacent to Marina Office Building

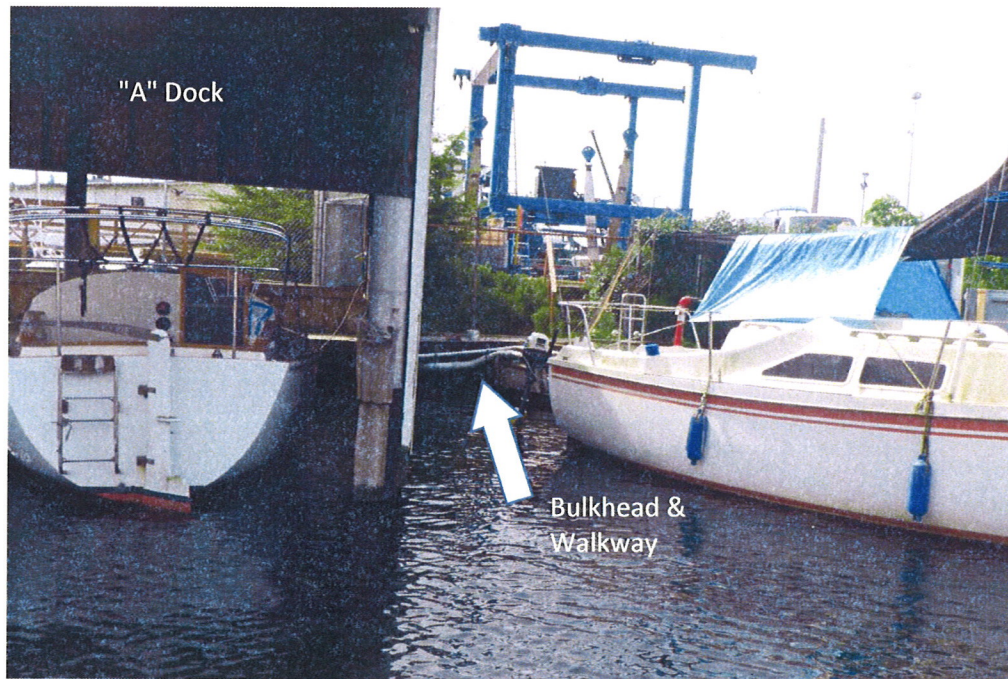
**PHOTO No. 1:** Salmon Bay Marina, East End of Bulkhead, Looking East – Note the walkway for A Dock which spans over the eastern end of the bulkhead.

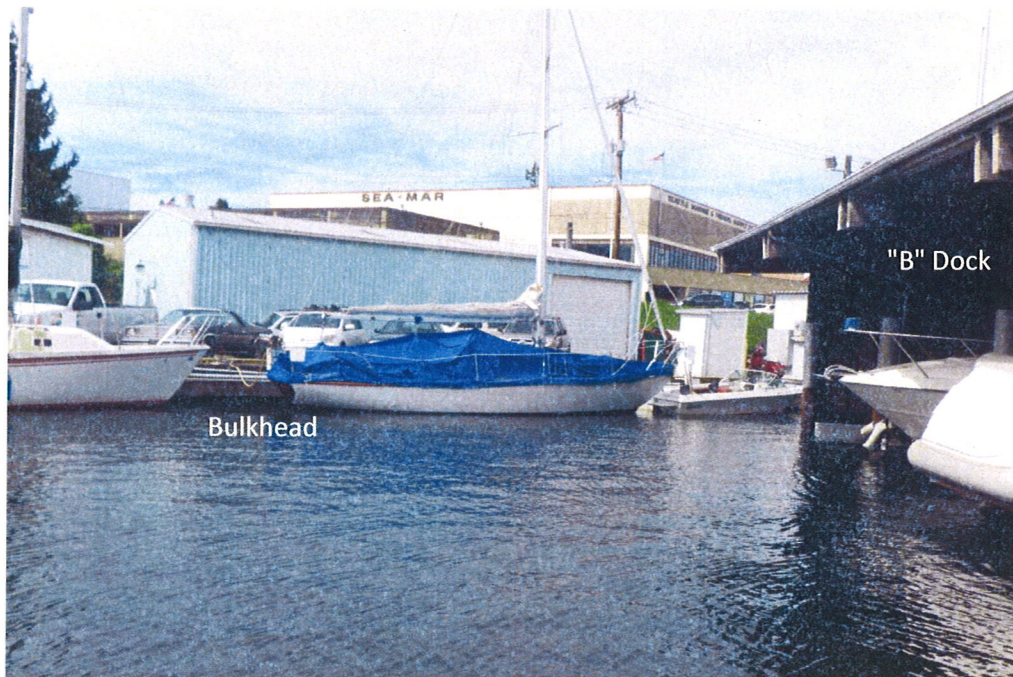
**PHOTO No. 2:** B Dock, Looking South – Note the vessels moored alongside the bulkhead at the south end of B Dock. The piles in this section of Bulkhead between A Dock and B Dock are numbered 1–13 from the east.

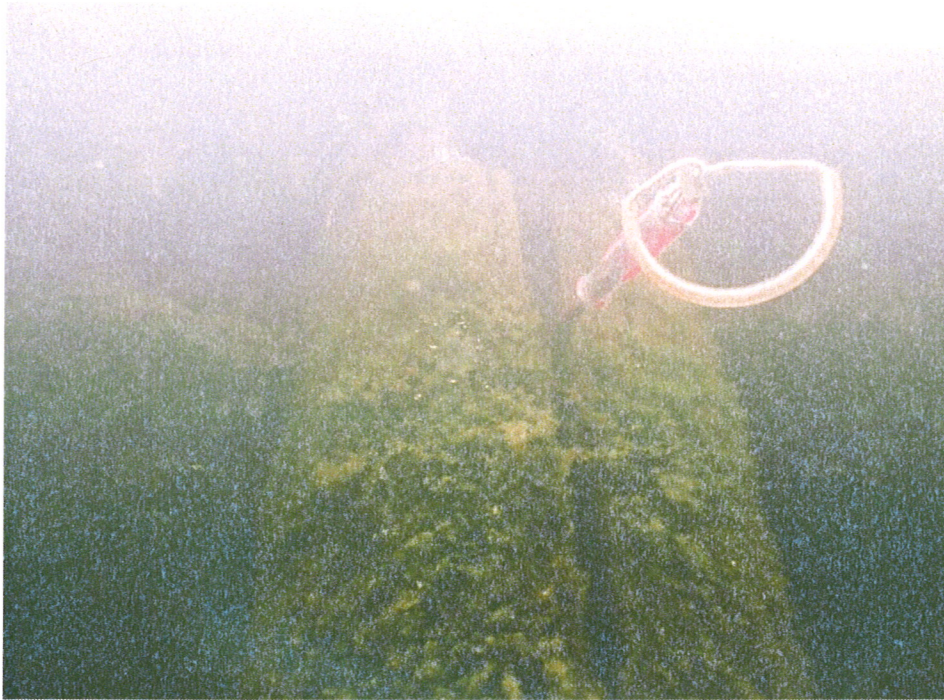
**PHOTO No. 3:**

Bulkhead Pile No. 3 –  
Note the screwdriver  
inserted into a split,  
near the top of the  
pile. Level II  
examination found  
extensive fungal and  
mechanical damage  
in the upper  
approximate 2 feet of  
the pile.

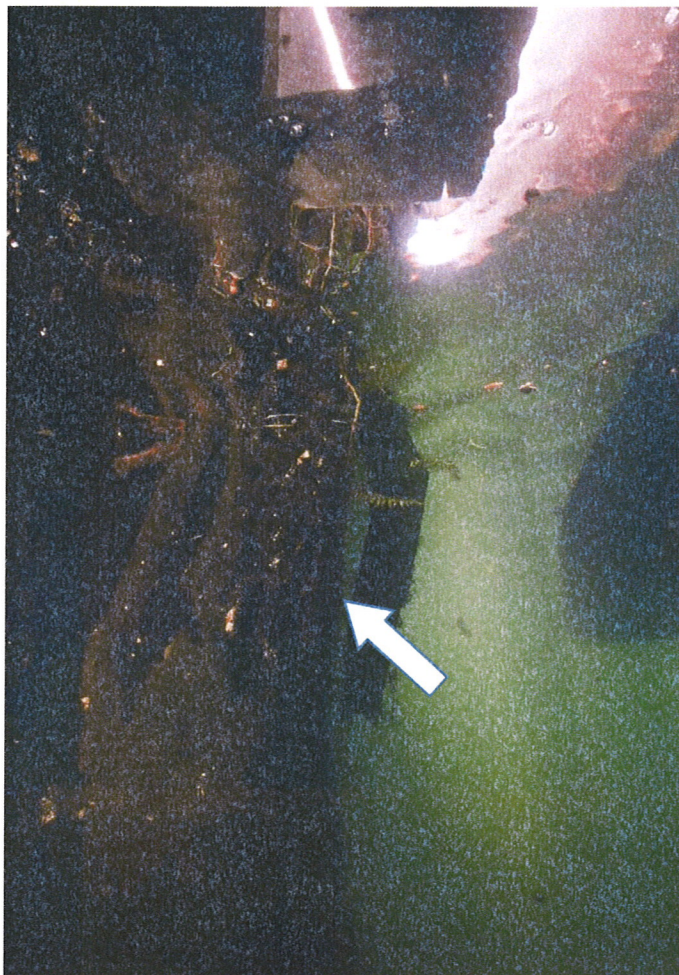
**PHOTO No. 4:**

Bulkhead Pile No. 4,  
Looking West – Note the  
extensive fungal and  
mechanical damage in  
the upper approximate 2  
feet of the pile.

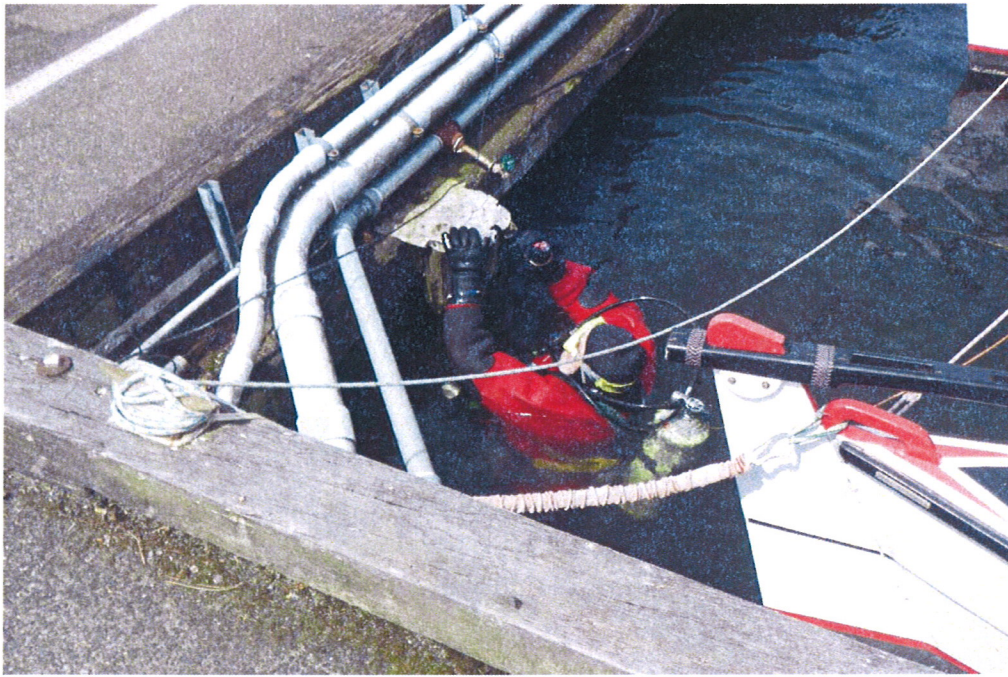
**PHOTO No. 5:** Bulkhead Pile No. 17 – This pile which is located just west of the access walkway to B Dock. Inspection found it to have sustained ~90% loss of section in the upper approximate 2 feet due to fungal decay.

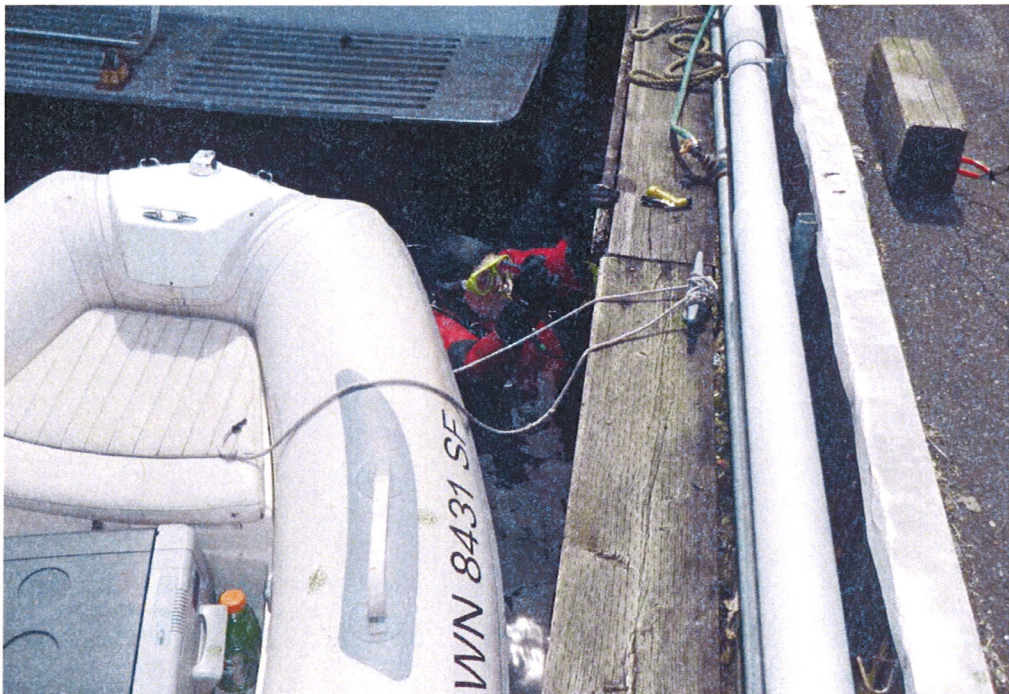
**PHOTO No. 6:** Bulkhead Pile No. 23, Looking East – Note the diver inspecting this pile which is located near the midpoint between B Dock and C Dock. Level II examination found ~50% fungal and mechanical damage and section loss in the upper approximate 2 feet of the pile.

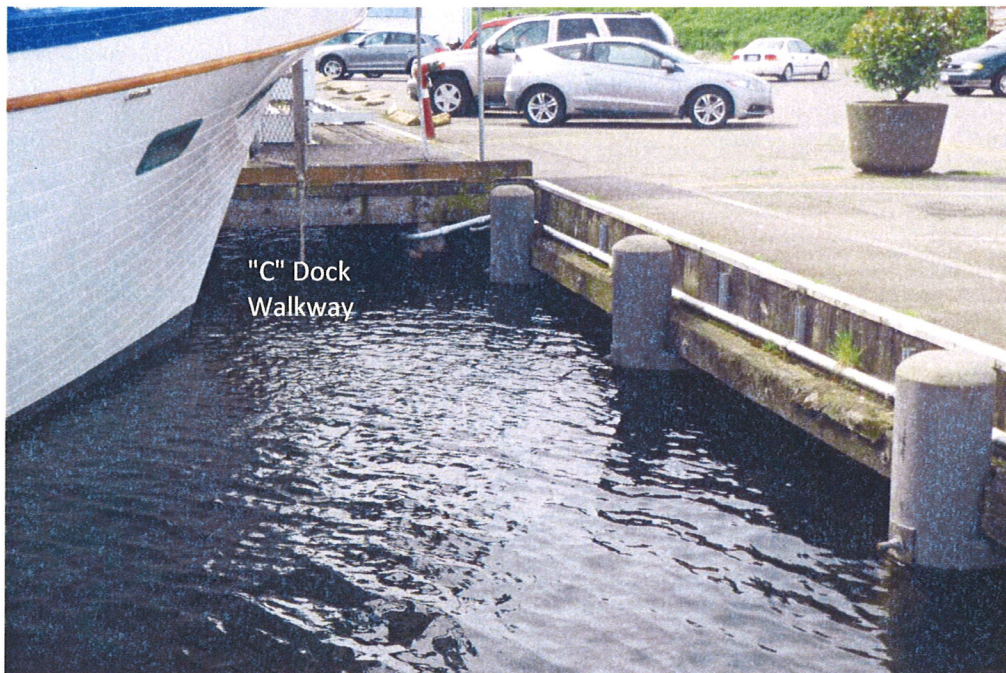
**PHOTO No. 7:** Bulkhead Piles No. 30–32, Looking East – Note the newer concrete filled steel pipe piles installed to replace older, apparently damage timber piles. The access walkway for C Dock is visible in the background.

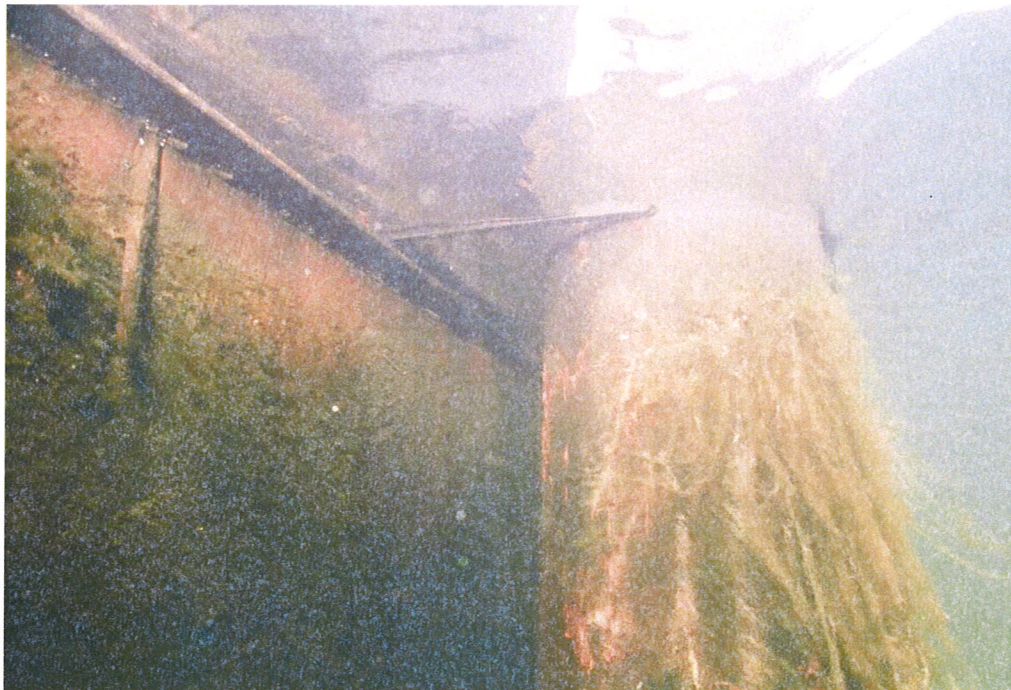
**PHOTO No. 8:** Bulkhead Pile No. 31, Looking West – Note the good condition of the painted steel coating on this steel pile, which was found to be intact with areas of minor surface corrosion. Also note the typical good condition of the creosote treated vertical timber lagging behind the pile.

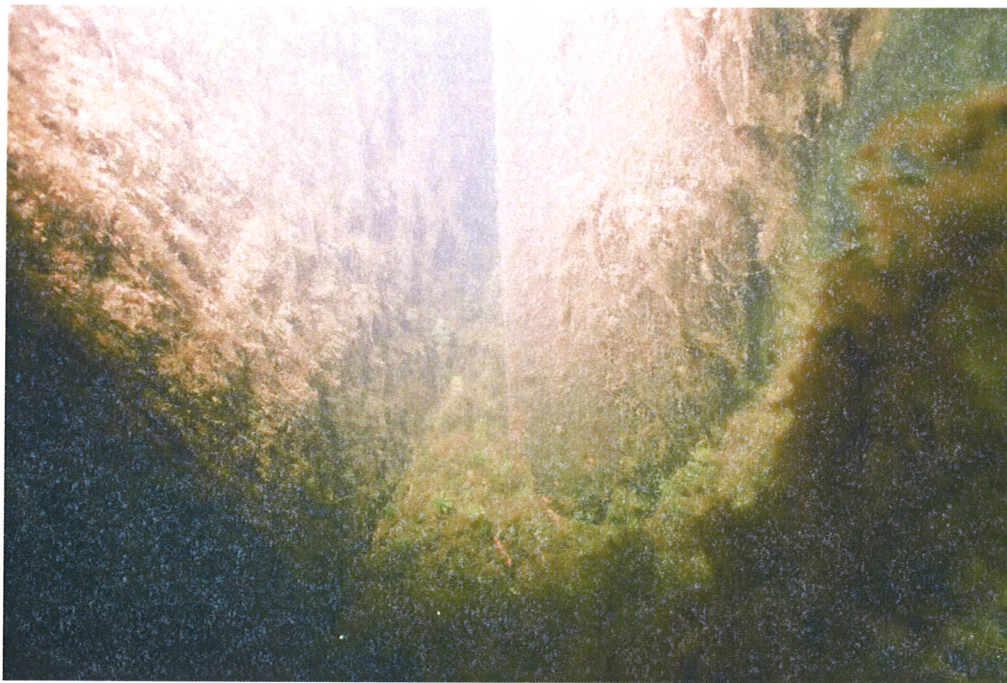
**PHOTO No. 9:** Bulkhead Pile No. 31, Looking West – Note the good condition of the painted steel coating on this steel pile at the mudline. Also note the typical good condition of the creosote treated vertical timber lagging.

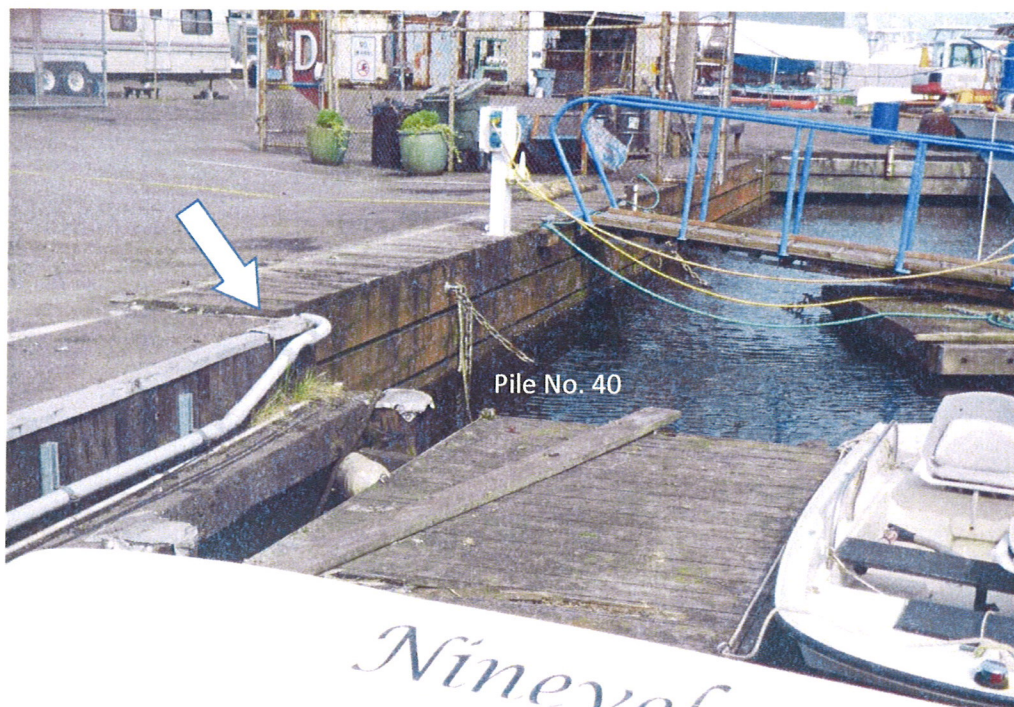
**PHOTO No. 10:** Bulkhead Pile No. 40 – Note the construction detail change at Pile No. 40 (arrow) with horizontal wales installed offshore of the original vertical timber lagging (foreground). Access to the inspection of Pile 41–45 was restricted due to the horizontal timbers at this location west of C Dock.

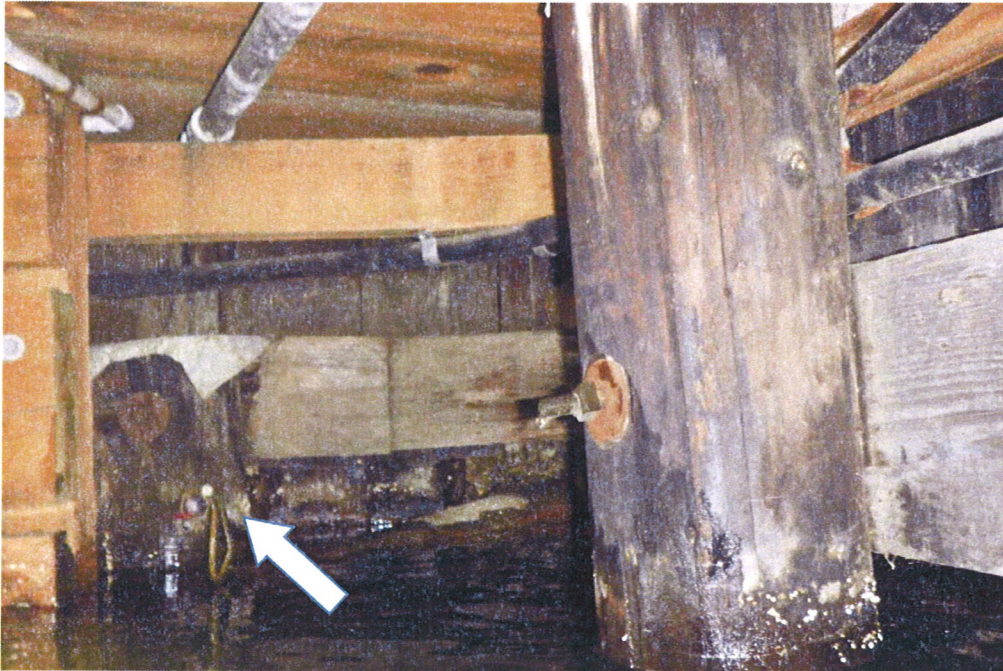
**PHOTO No. 11:** Bulkhead Piles No. 46-47, Looking South – Note the screwdriver inserted into an area of heavy fungal deterioration (~90% loss) at the top of Pile No. 46. Also note the good condition of Pile No. 47.

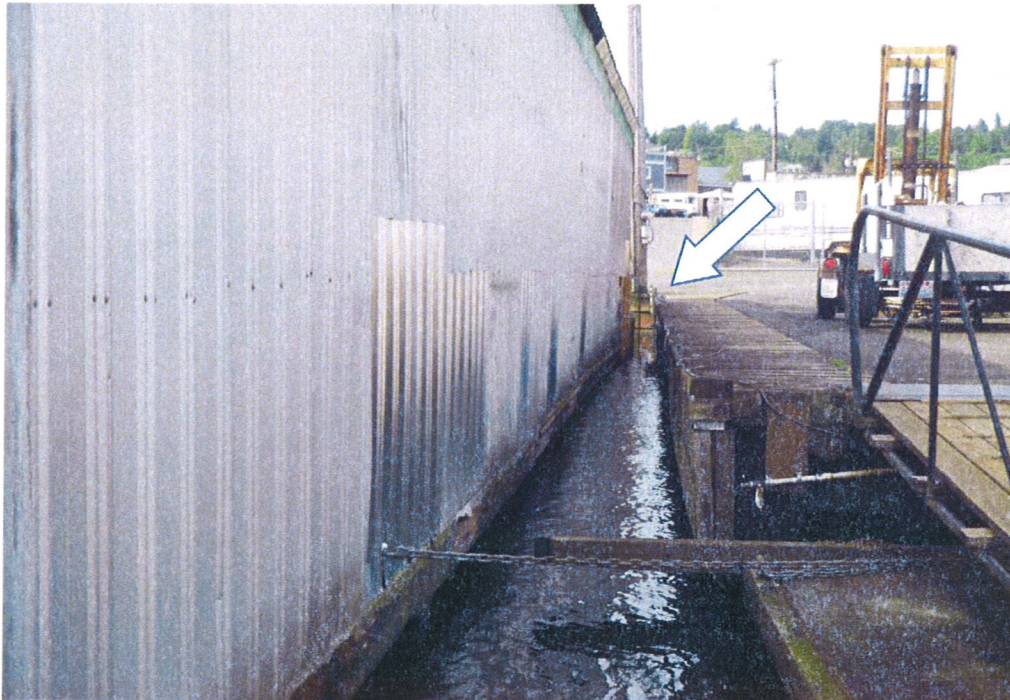
**PHOTO No. 12:** Bulkhead Piles No. 47-56, Looking South – Note the corner at the south end of the bulkhead shown in Photo No. 11, indicated by the arrow. cursory observation of the floatation beneath the adjacent boathouse (NIS) found that it is supported by unencapsulated Styrofoam that is heavily deteriorated.

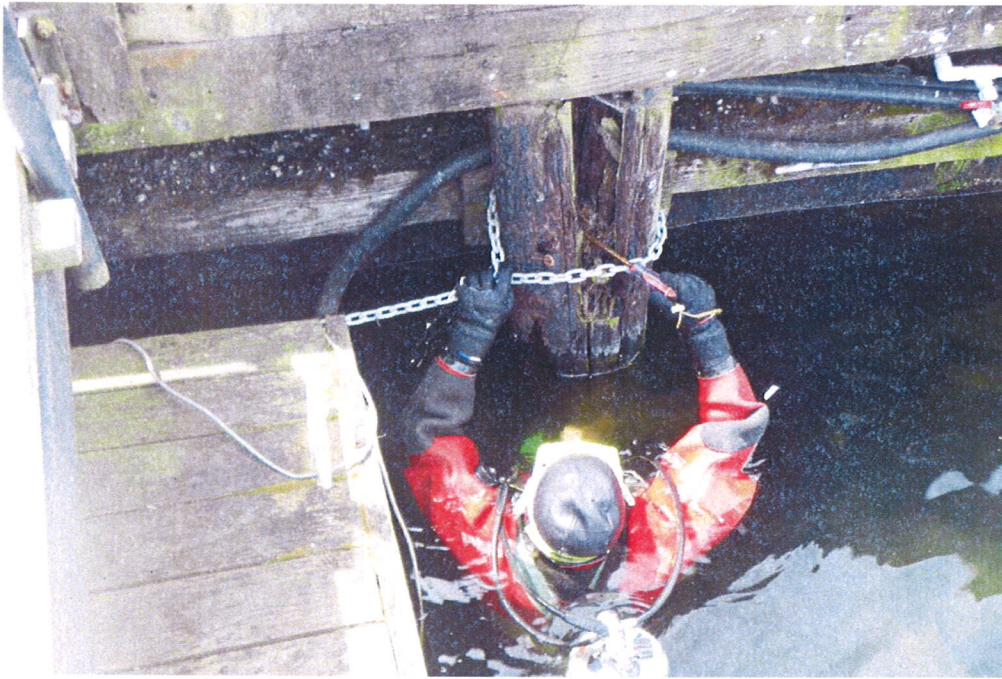
**PHOTO No. 13:** Bulkhead Pile No. 62, Looking South – Note the inspector examining this pile which has sustained ~90% section loss at its top due to fungal decay. Also note the chain around the pile that secures the southern end of Float E.

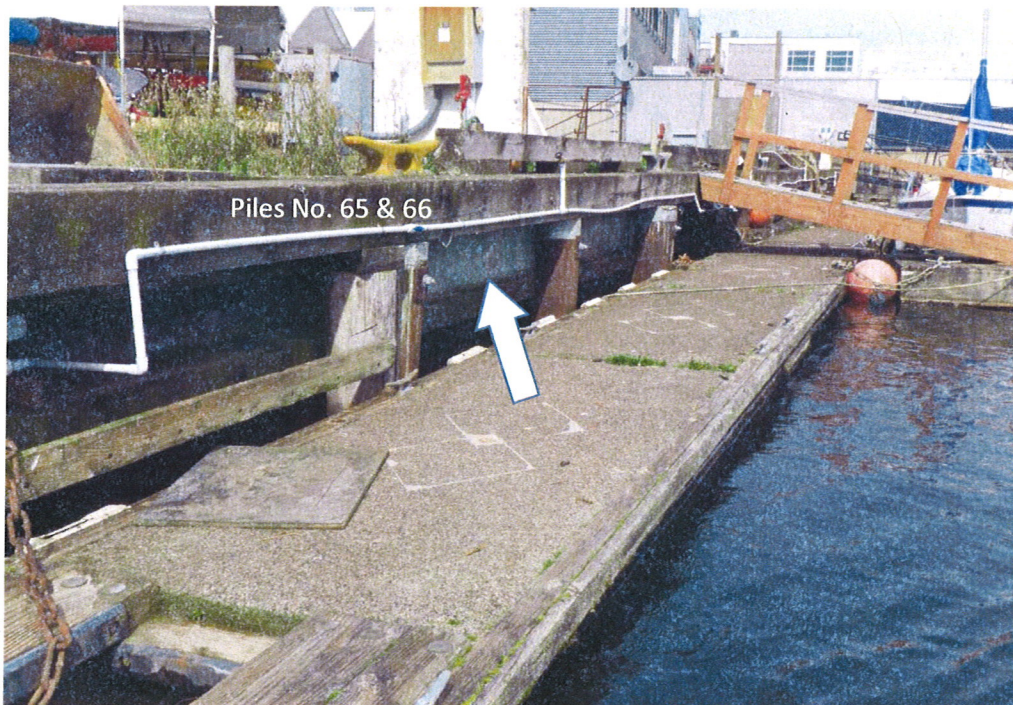
5. The overall condition of the large dimension timber wale near the top of the bulkhead was also observed to be fair to good. No evidence of gross damage or deterioration was noted. In the most recently repaired section of the bulkhead (i.e. the western end between Piles No. 66 – 75) a partial concrete beam has been poured to replace an apparently damaged section of this large dimension timber wale. The concrete beam appears to be in good condition. Refer to Photo No. 14.

**PHOTO No. 14:** Bulkhead Piles No. 65–68, Looking West – Note Piles No. 65 (timber) and 66 (steel). Pile No. 66 is the eastern most of 10 recently installed steel pipe piles. Also note arrow indicating the poured in place concrete cap above the vertical timber lagging in this area.

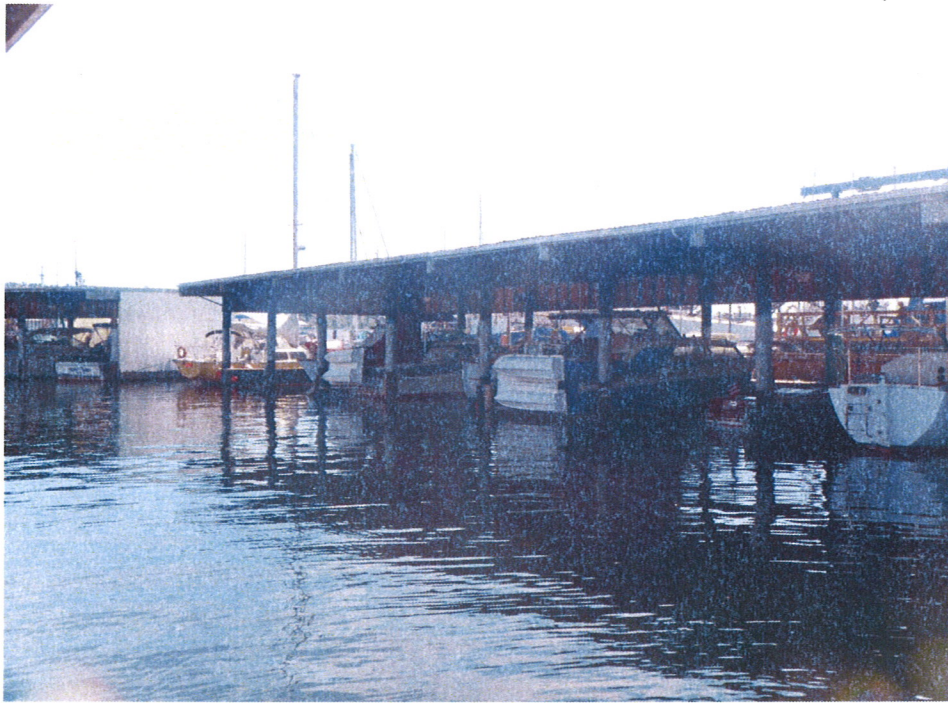
**PHOTO No. 15:**

A Dock, Looking Northeast – Note the typical boathouse construction of the structure using creosote treated piles supporting the roof and the walkways.

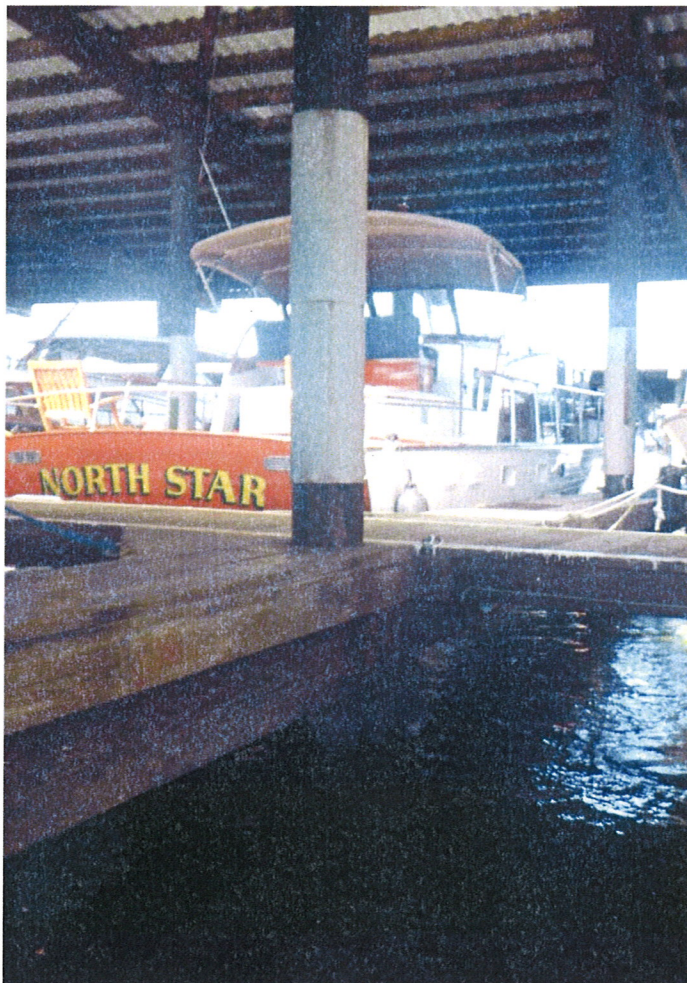
**PHOTO No. 16:** B Dock, Bent 20, Row 3 Vertical and Batter Piles, Looking West – Note the pile supports both the roof and the walkway system. Also note the arrow showing the top of the batter pile secured to the vertical pile with a Seaform concrete encasement.

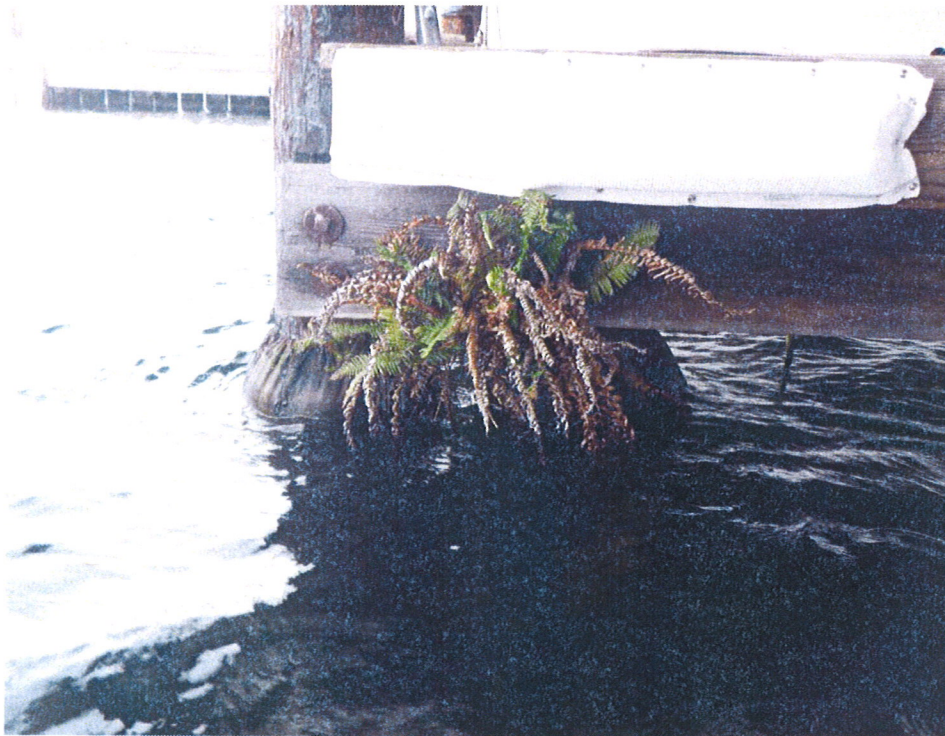
**PHOTO No. 17:**

C Dock, Bent 20 Row 1 Vertical and Batter Piles, Looking North – Note that both piles have had Seaform concrete encasements installed on their upper approximate four feet. Also note the vegetation growing out of accumulated sediments located on top of the concrete jackets.

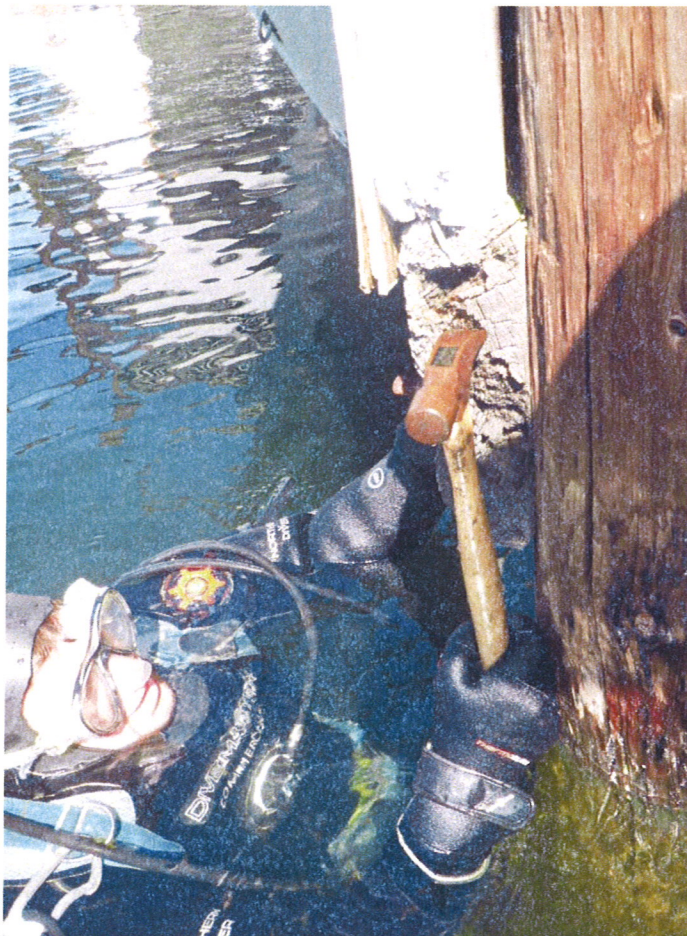
4. Inspection of the timber walkway pile caps associated with the inspected piling found them to also be in generally good condition. However, several timbers were noted to have sustained minor mechanical and/or fungal damage at their ends. Typically this damage was restricted to less than 5% of the members section at the bolted connection to the support piles. Refer to Photo No. 18. Minor defects were noted on the following members:

**PHOTO No. 18:** B Dock, Bent 3, South Cap Timber At Row 4, Looking West – Note the minor (~5%) mechanical and fungal section loss identified at the end of this cap timber. The majority of the examined cap timbers were found to be in good condition and undamaged.
