# Salmon Bay Marina Docks A, B, C Closure

## Supporting Documentation

# **SALMON BAY MARINA: SITE OBSERVATIONS**

## **SITE OBSERVATIONS, LITERATURE REVIEW, AND DISCUSSION**

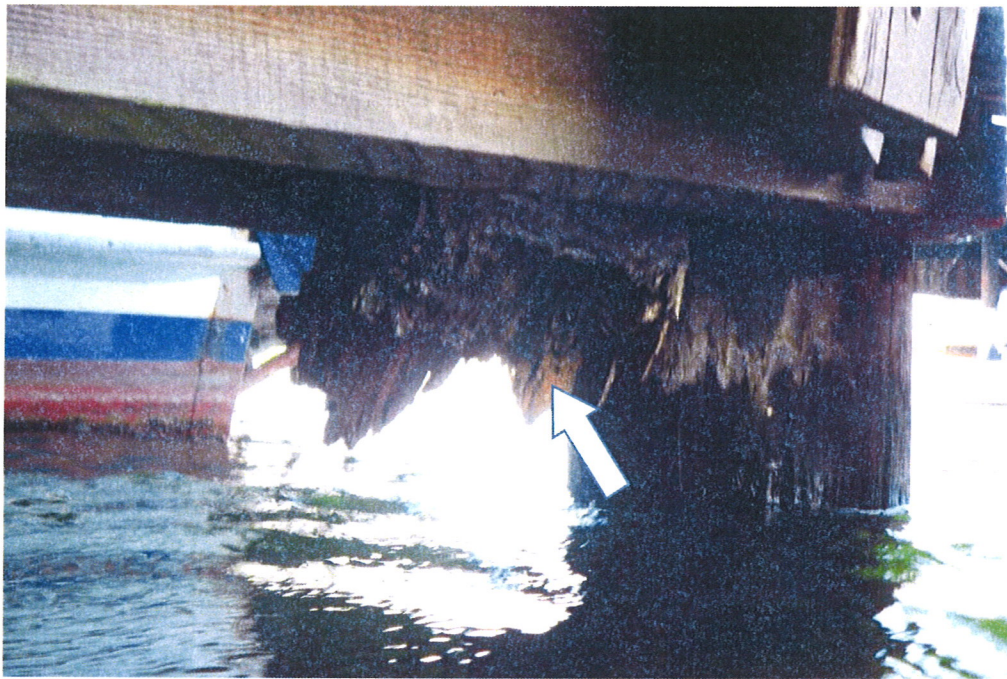
**PHOTO No. 19:** C Dock, Bent 18, Row 5 Vertical Pile, Looking North – Note the severe fungal damage to the top of the original untreated batter pile. Underwater inspection found that this pile which sustained heavy damage above water has been pulled over to the vertical pile underwater and secured using a Seaform concrete encasement.

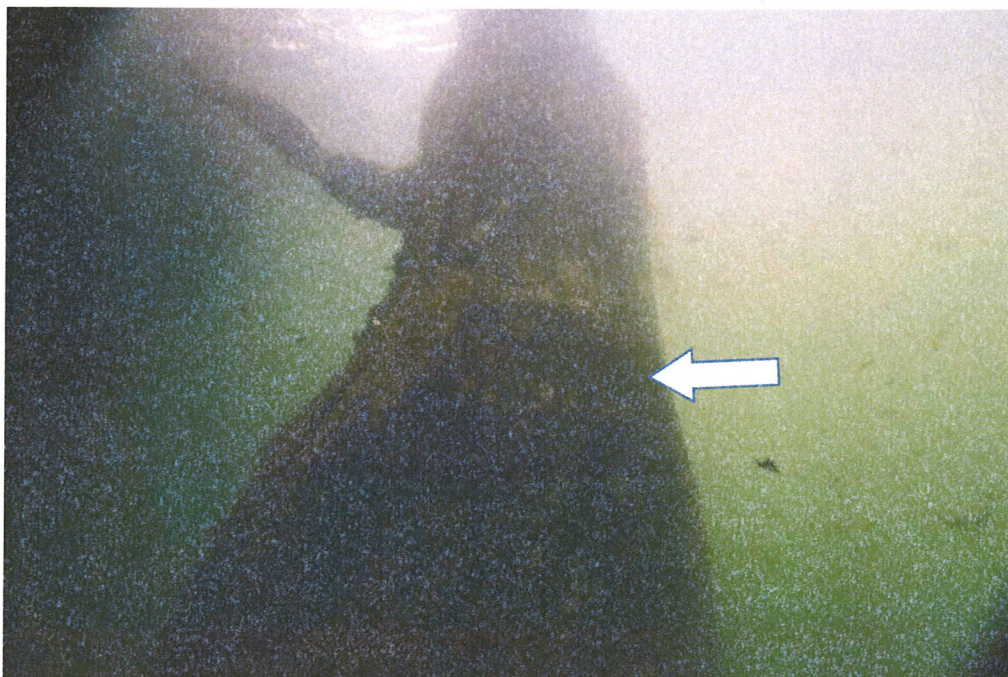
3. The overall condition of the batter piles was also found to be good. These piles are connected to the vertical piles near the high lake level. The connection is covered with a *Seaform* concrete encasement which encompasses the top of the batter pile and encircles the vertical pile to which it is attached. The concrete at these connections were all found to be intact, and no evidence of deterioration or damage was found in the piles beneath the concrete encasement. One batter pile located on Dock C, Bent 18, Row 5 Batter appears to have been originally secured to the Row 5 vertical pile above the current full pool elevation. As shown in Photo No. 19, the batter pile sustained severe fungal section loss at its top. This seems to indicate that at some point in the Marina's history, all of the original timber batter piling were connected above water to the vertical piling and that due to significant fungal decay at the top connection, the upper damaged portion was removed and the connection was made lower on the vertical pile using the Seaform Jackets. Refer to Photo No. 20.

**PHOTO No. 20:** C Dock, Bent 18, Row 5 Vertical and Batter Piles, Looking Northeast – Note the undamaged lower portion of the original timber batter pile has been secured to the vertical pile using a Seaform concrete encasement. This type of connection was found to be typical throughout the Docks.

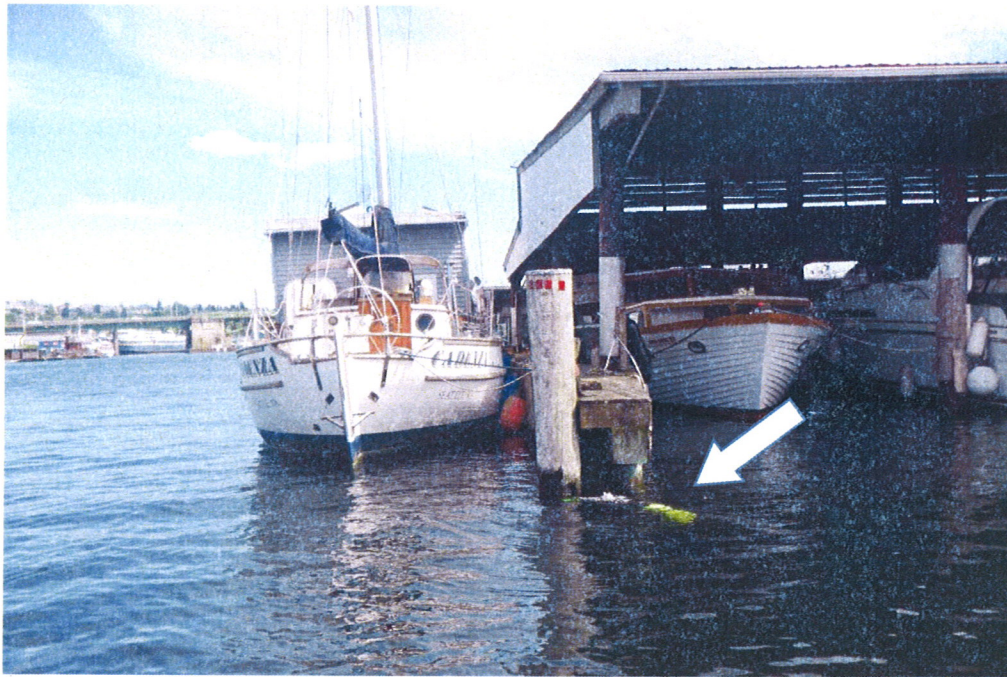
2. It is estimated that approximately 25% of the piles within the Boathouse Docks A, B and C were included in the investigation. In total 115 piles located within the three structures were inspected. The overall condition of the structural piles inspected was found to be good. Of the 115 piles inspected 112 piles (97.3%) are rated in the undamaged classification; One pile (0.9%) has been rated in the 90% classification; One pile (0.9%) has been rated in the 75% classification; and one pile (0.9%) has been rated in the 50% classification. The pile rated in the lower 50% classification was found to have sustained significant biological damage (i.e. ~30% loss of section) in the wet dry zone, (refer to Photo No. 21).

**PHOTO No. 21:** B Dock, West End of North Apron, Looking East – Note the diver inspecting the tall fender pile which protects the corner of the structure. The pile was found to be untreated and to have sustained heavy fungal damage in the wet/dry zone.

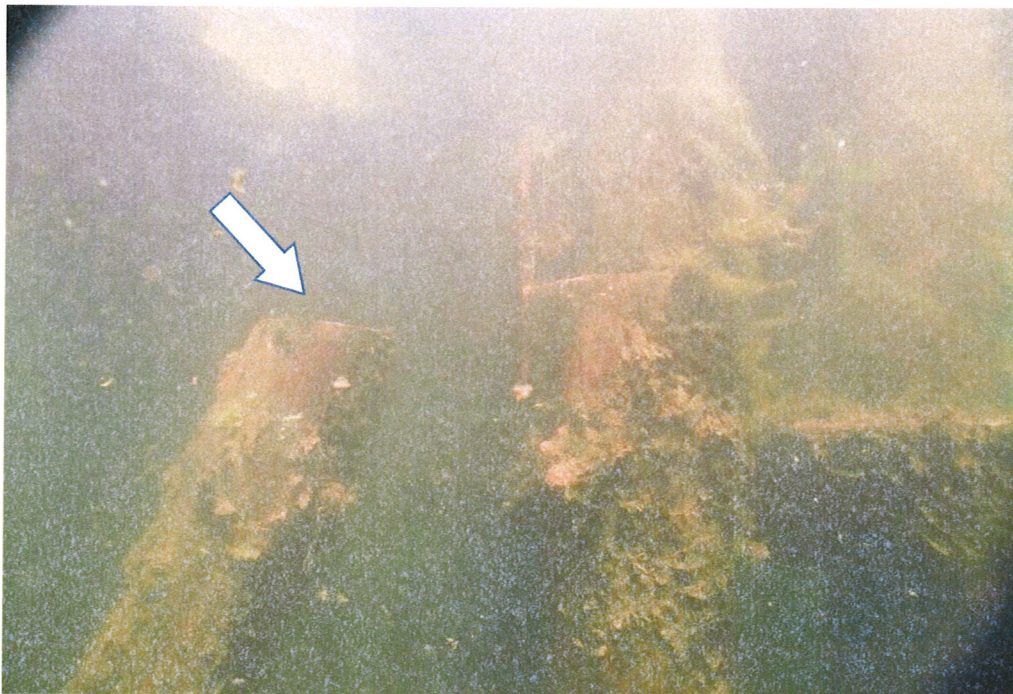
**PHOTO No. 22:** B Dock, East End of North Apron, Looking West – Note the batter pile is not secured to the newer Chemonite treated vertical pile that has been installed as a replacement structural pile in this area.

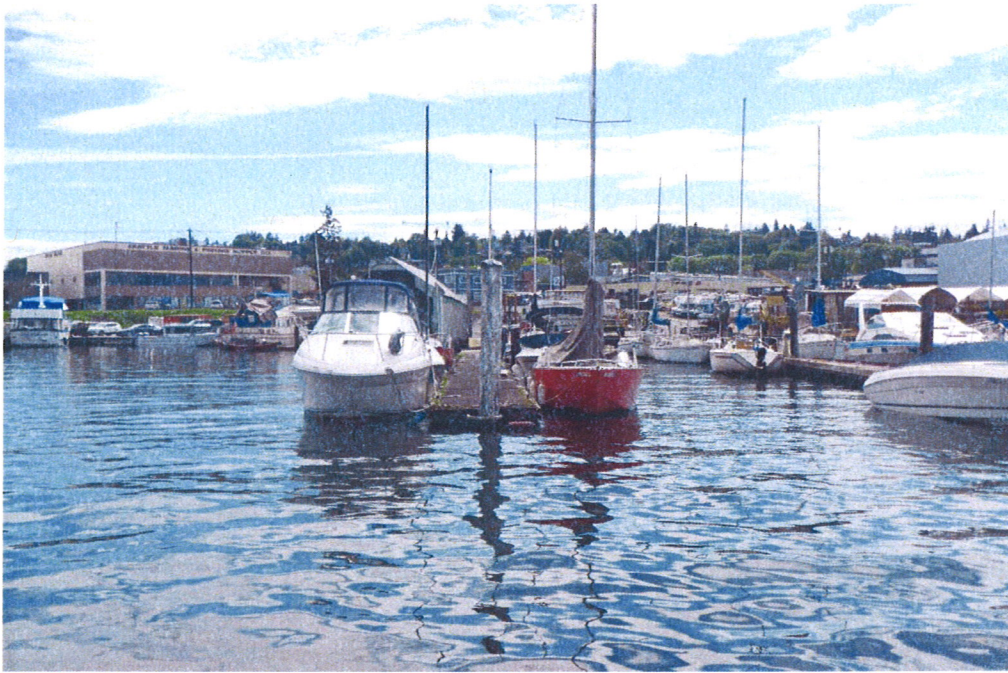
**PHOTO No. 23:** Float D, Looking South – Note the float is constructed using concrete pontoons with timber wales and is secured by creosote treated float anchor piles.

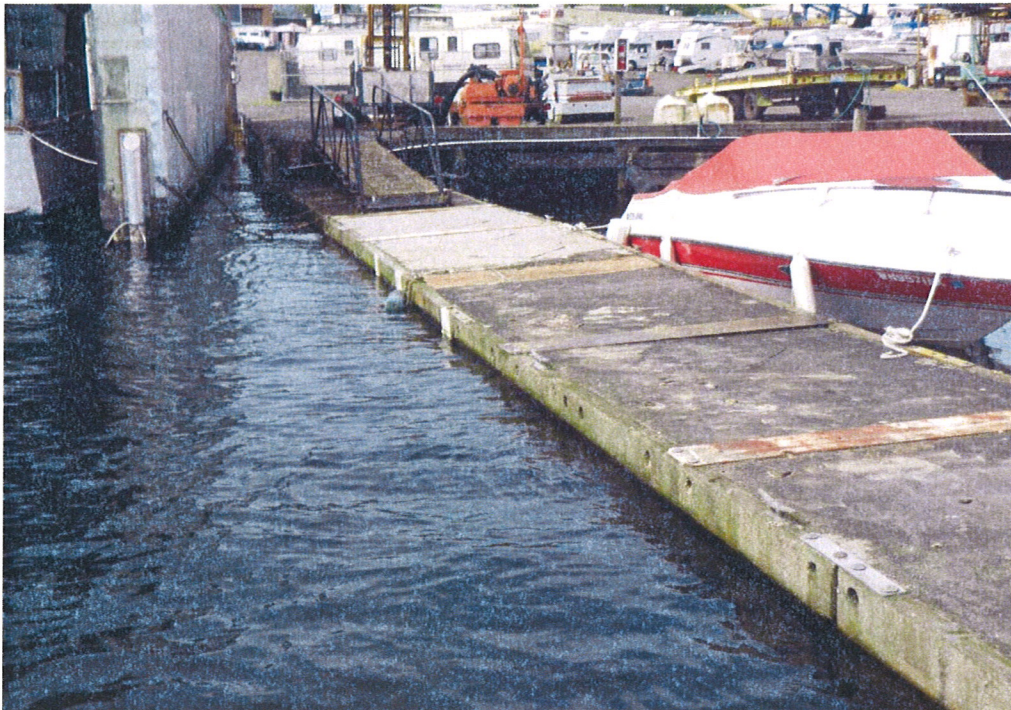
**PHOTO No. 24:** Float D, South End – Note the access ramp that is hinged off of the bulkhead. Also note that the left (east) side of the float has reduced free board when compared to the right (west) side of the float in the area where the ramp lands.

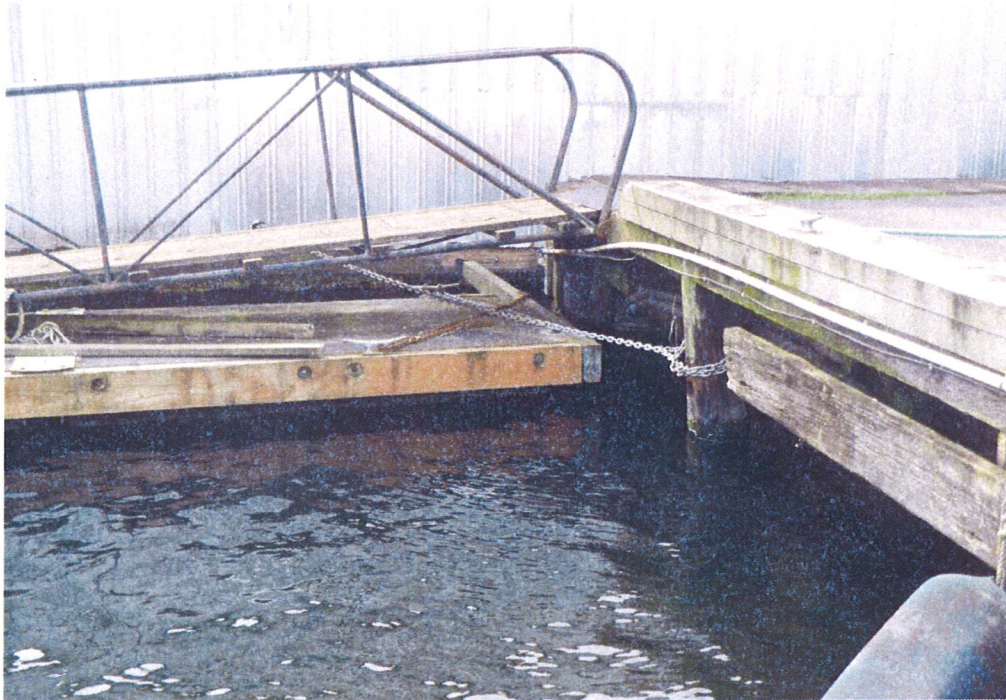
**PHOTO No. 25:** Float D, South End – Note the south end of the float is secured to Bulkhead Piles No. 56 and 57 with galvanized chain.

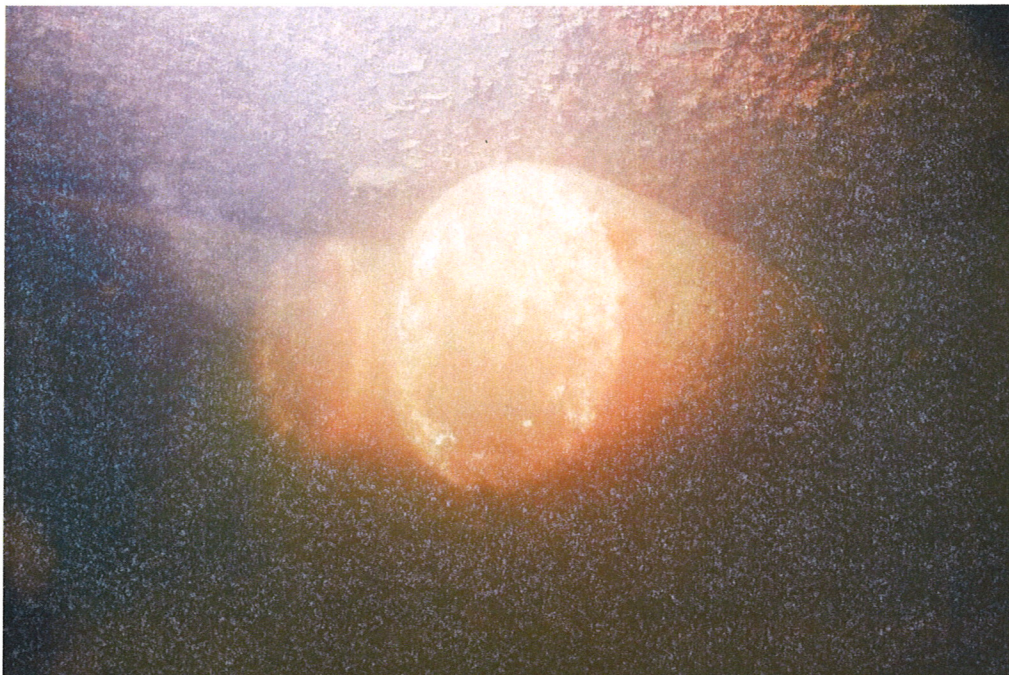
**PHOTO No. 26:** Float D, Supplemental Floatation Barrels – Several plastic barrels were found beneath the shoreward ~1/3 length of the Float. No strapping or other means of securing the barrels was noted and their buoyancy apparently keeps them in-place.

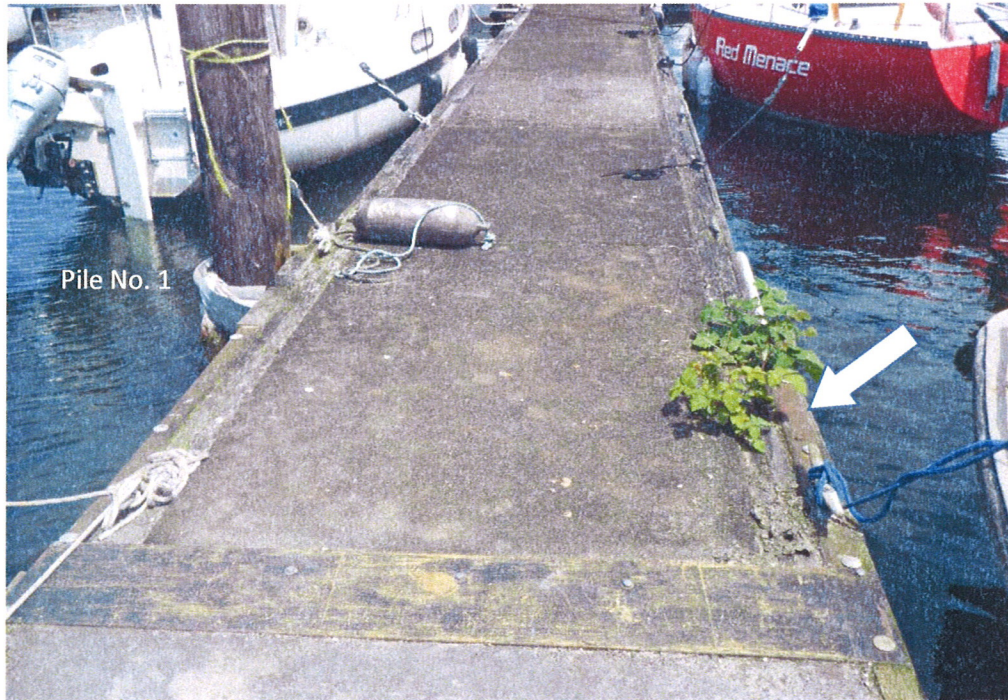
**PHOTO No. 27:** Float D, Near Float Anchor Pile No. 1, Looking North – Note the localized areas of deteriorated concrete and the vegetation growing out of sediments trapped between the timber wales (framing members).

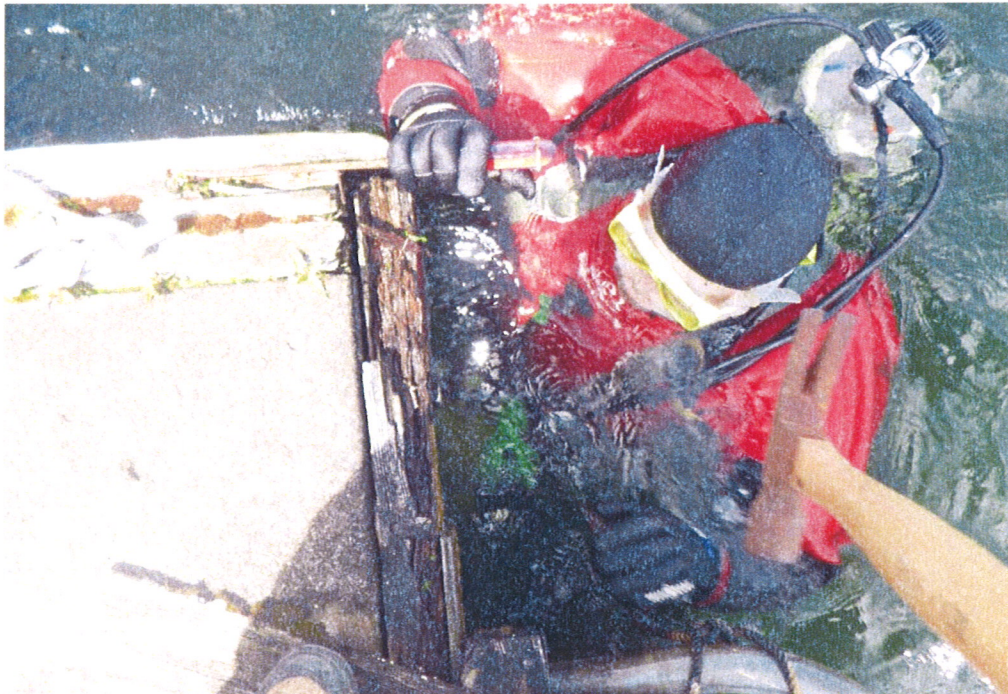
**PHOTO No. 28:** Float D, Northwest Corner - Inspection of the timber wale system noted this area of fungal damage in the timber wale system.

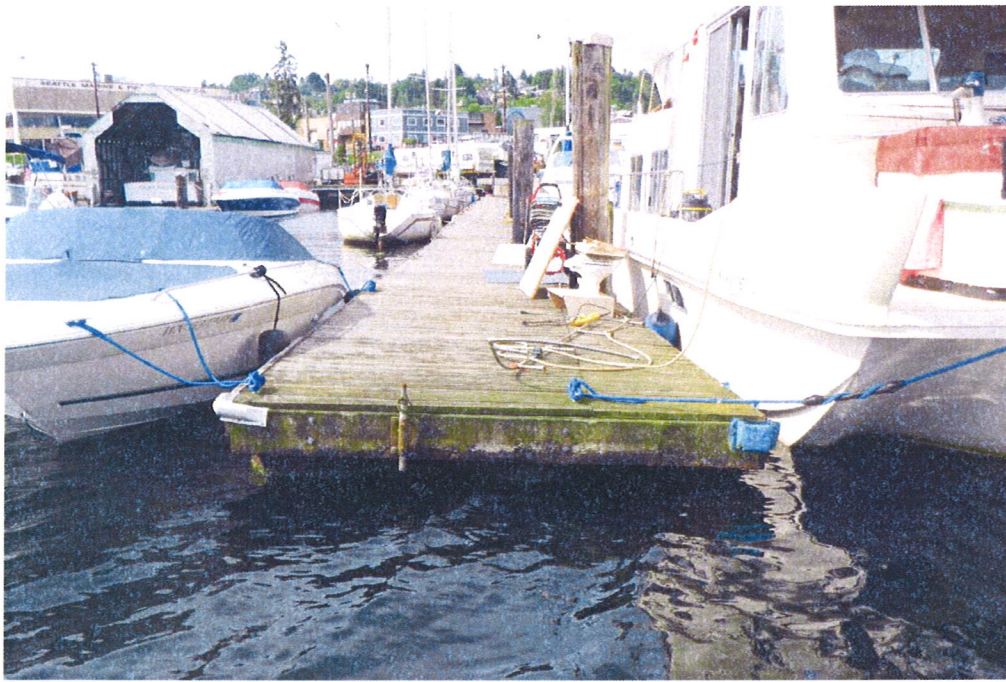
**PHOTO No. 29:** Float E, North End, Looking South –This float is made up of treated timber framing and Styrofoam-filled tire floatation. The float is secured in-place by creosote treated float anchor piles.

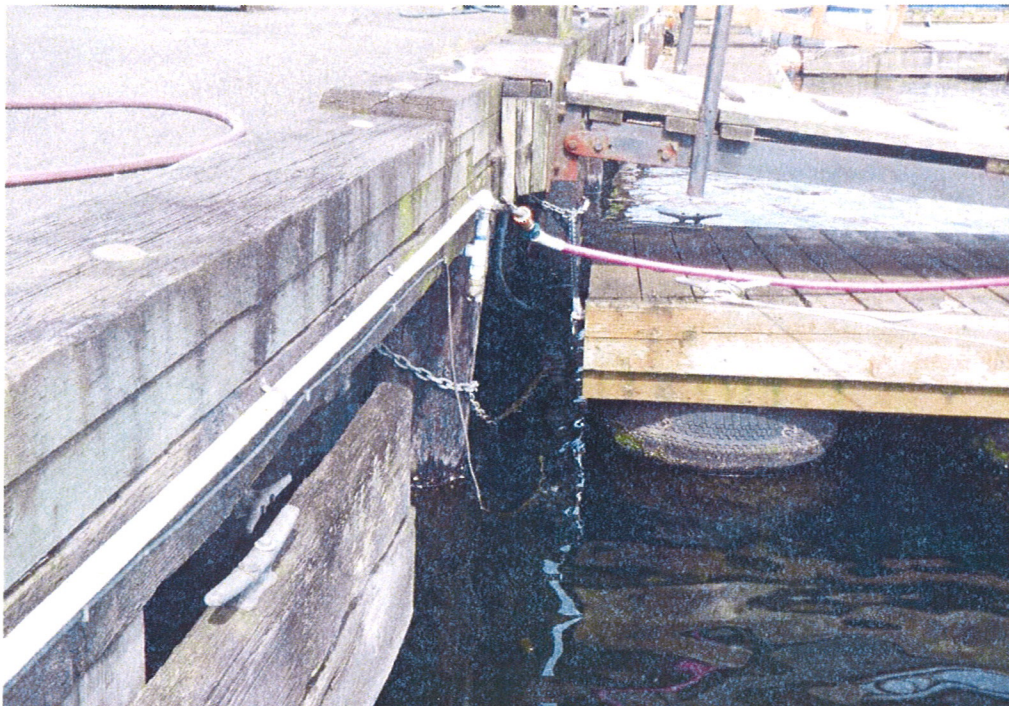
**PHOTO No. 30:** Float E, South End, Looking West – Note the typical construction using treated timber framing and double stacked Styrofoam filled tires. Also note the float is secured to Bulkhead Piles No. 61 and 62 with galvanized chain.

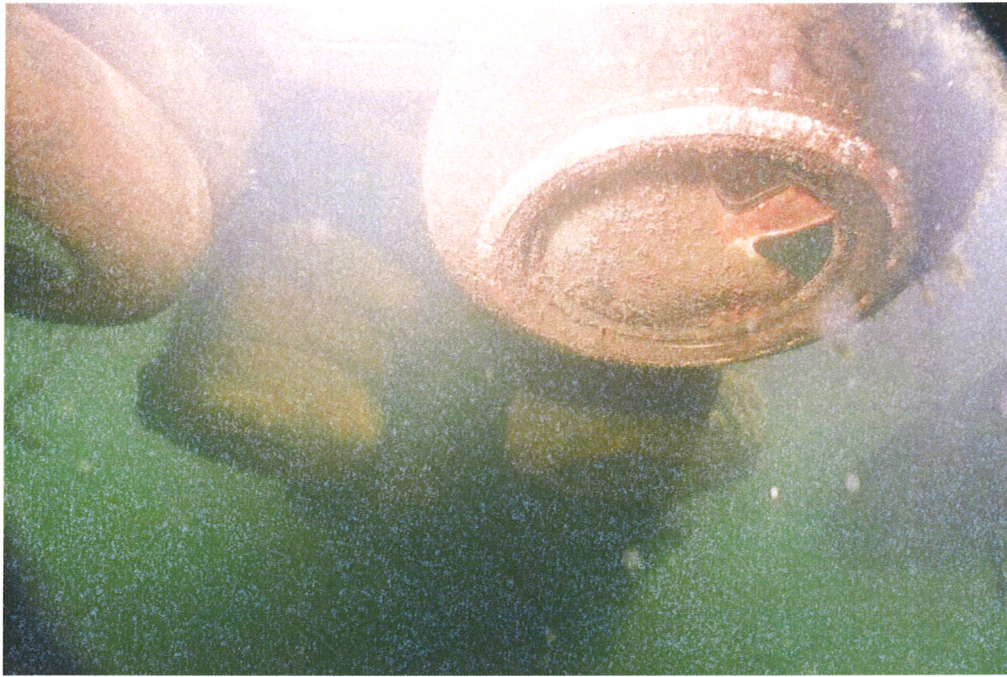
**PHOTO No. 31:** Float E, Typical Floatation – Note the floatation provided by Styrofoam filled vehicle tires.

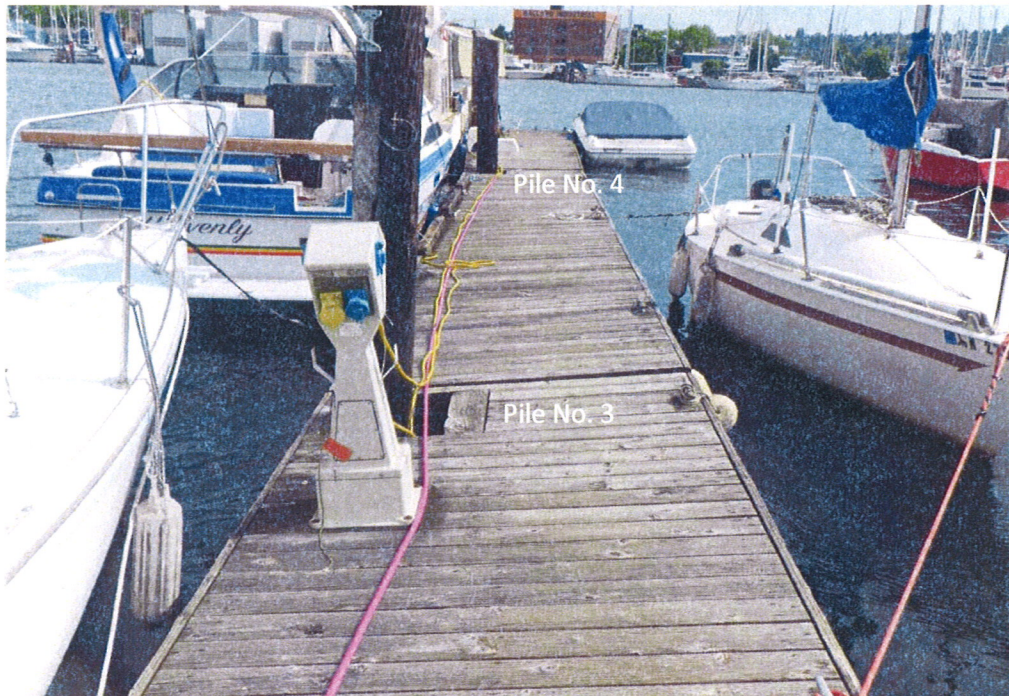
**PHOTO No. 32:** Float E, Looking North – Note the pronounced list of the float, with the east side of the visibly higher than the west side. Refer to Photo No. 33.

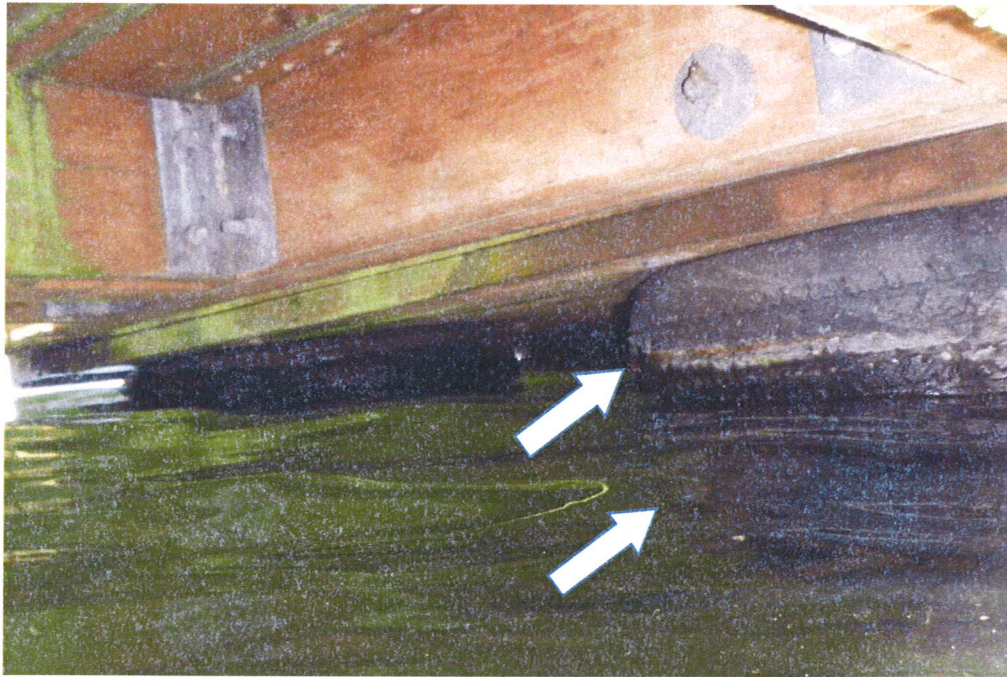
**PHOTO No. 33:** Float E, Near Float Anchor Pile No. 3, Looking Northwest – Note the pronounced list of the float in this area with the east side sitting higher out of the water than the west side. Also note the arrow indicating two, double stacked floatation tires on the east side.

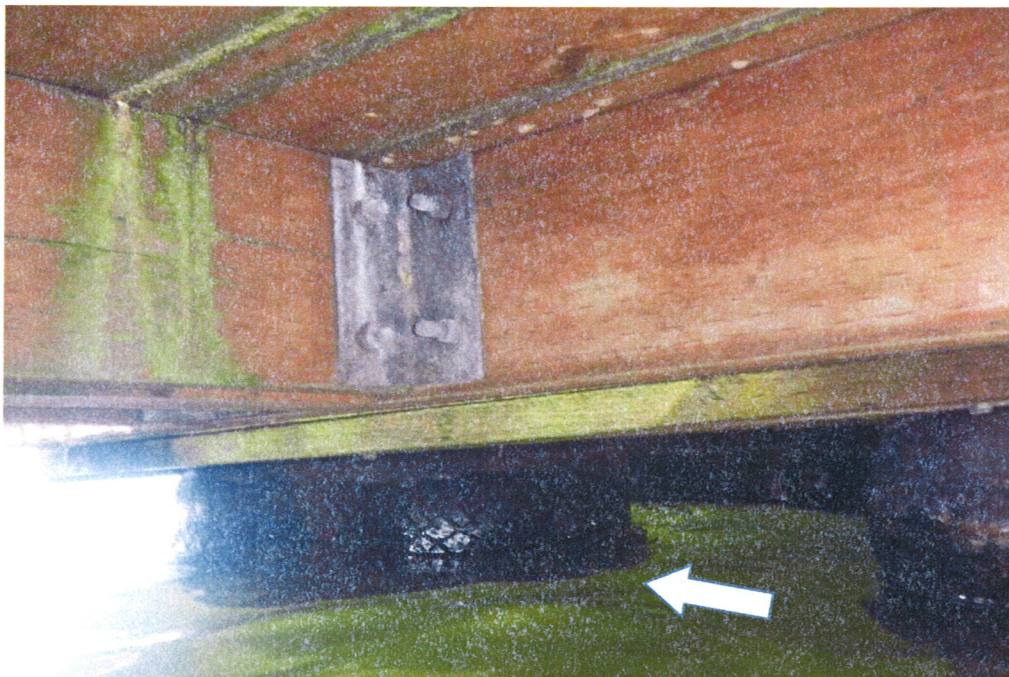
**PHOTO No. 34:** Float E, Close-up of Photo No. 33 Above – Note there is only one elevation of floatation tires at this low point on the float. The addition of supplemental floatation may correct the differential freeboard, leveling the float in this area.

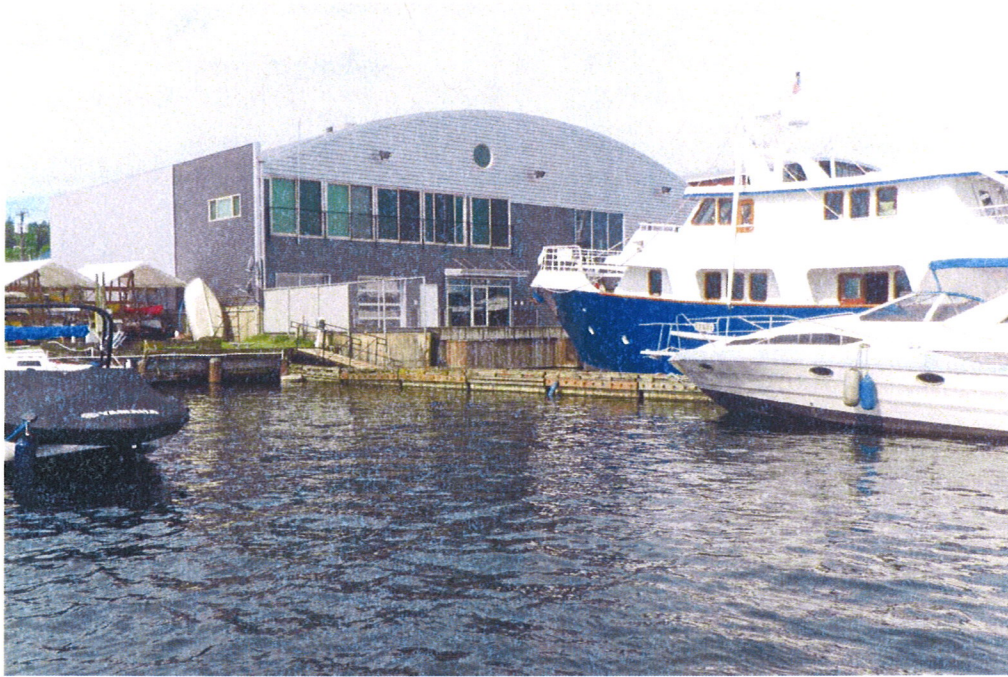
**PHOTO No. 35:** Float F, South End, Looking Southwest – Note the float is constructed with concrete pontoons secured together with timber wales. The southern portion of the float was found to be floating level with good freeboard.

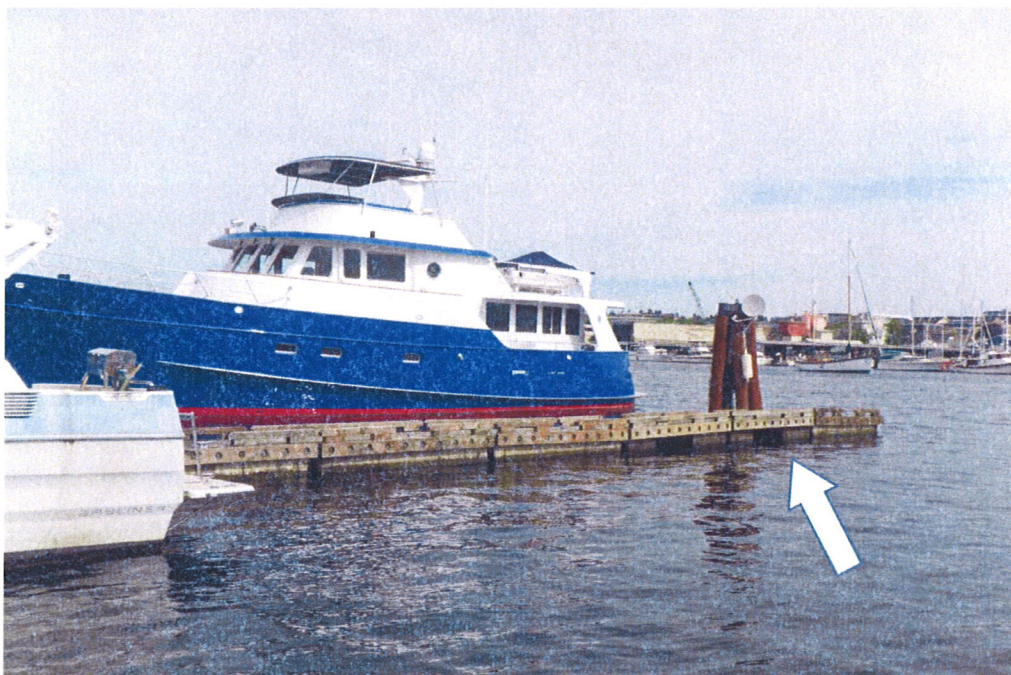
**PHOTO No. 36:** Float F, North End, Looking Northwest – Note the five pile dolphin constructed with steel pipe piles that secures the offshore end of the float. Also note the differential freeboard in the northern-most floatation pontoons.

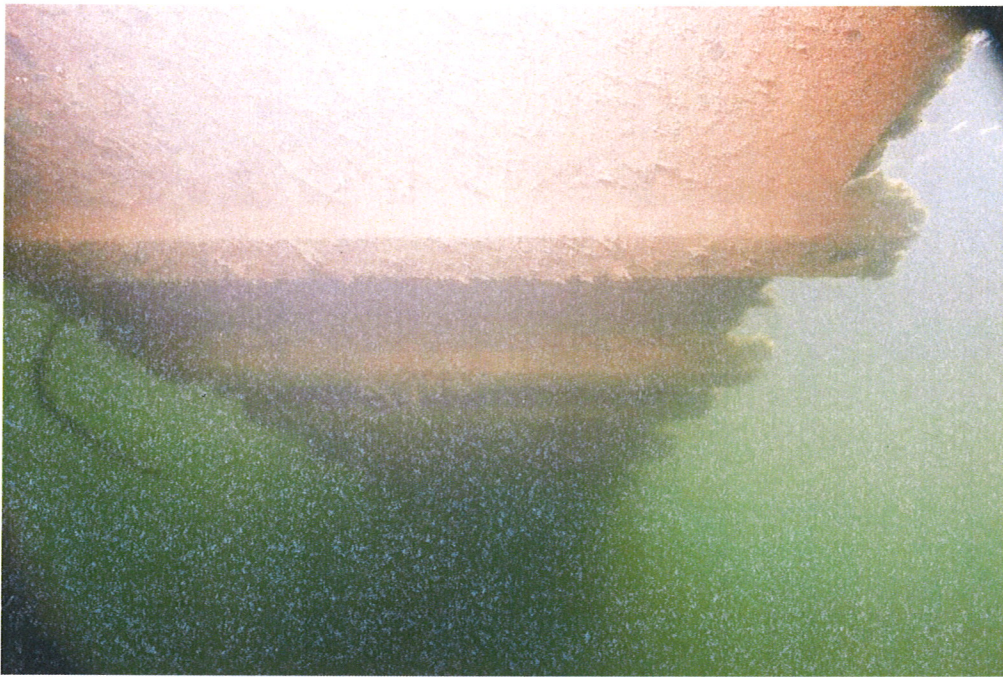
**PHOTO No. 37:** Float F, Underside of Pontoon, Looking North – Note the good condition of the concrete and the horizontal timbers secured across the bottom of the pontoons.

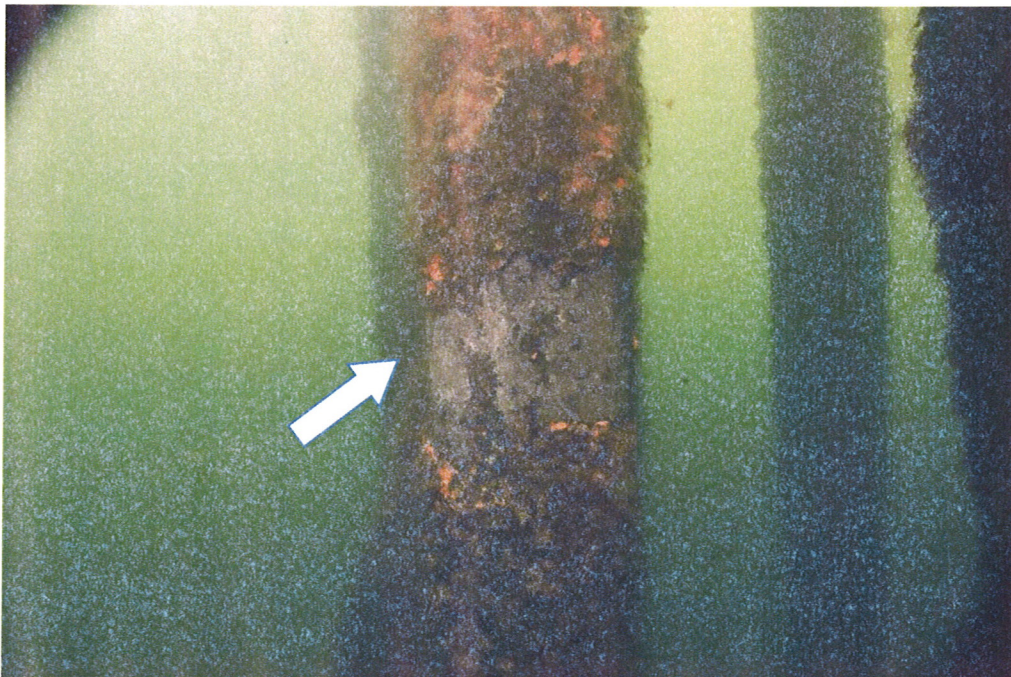
**PHOTO No. 38:** Float F, Dolphin Pile E Pile – Note the band of Level II cleaning conducted in the submerged zone which removed the corrosion/algae matrix and exposed the underlying steel base metal. Close examination found the steel surface to be smooth and in visibly good condition.

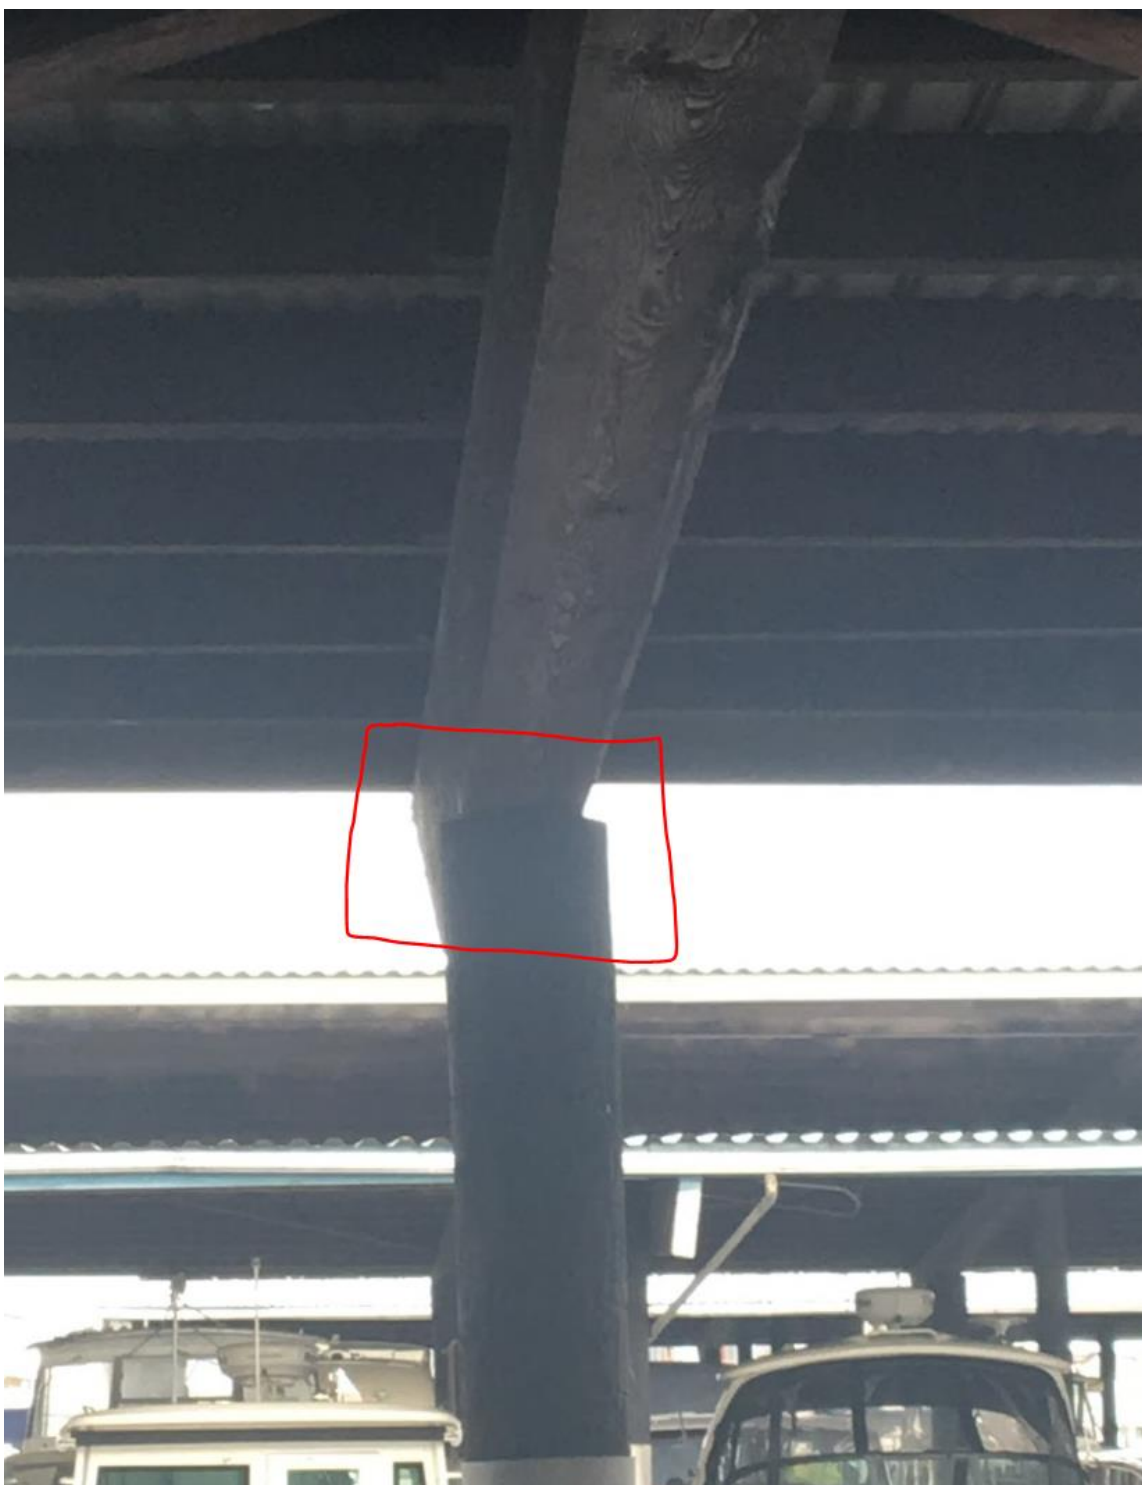
Figure B-1 - Pile-to-Roof Connection. Note: no vertical tie-downs exist at the roof level.

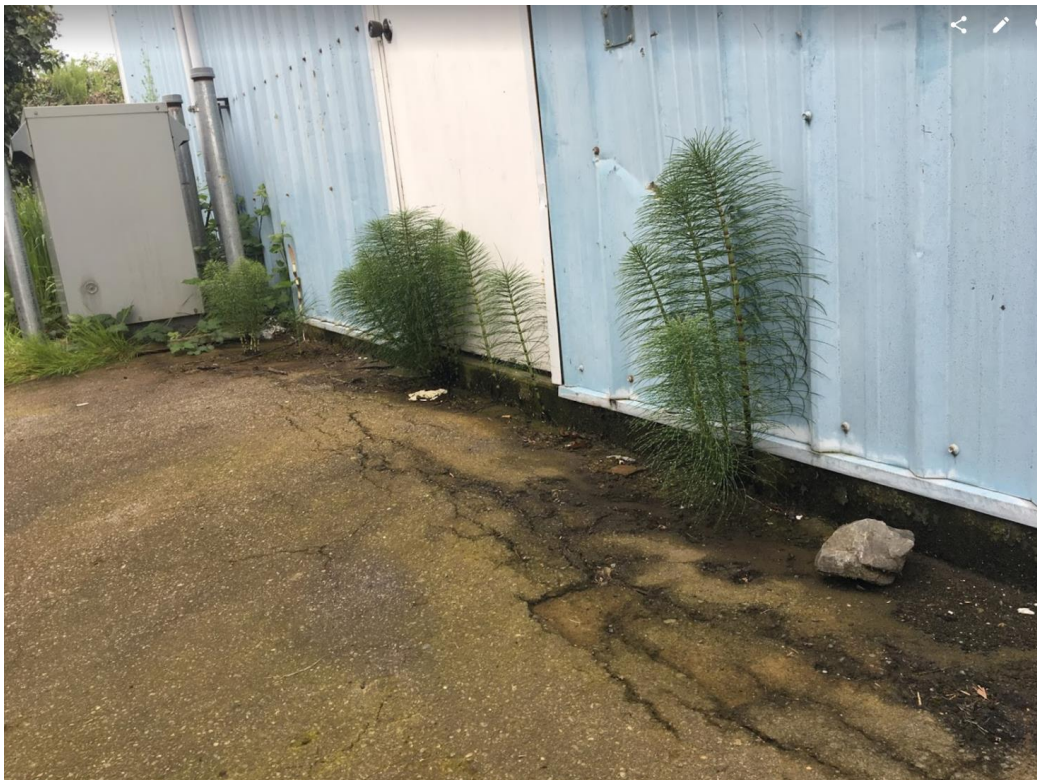
Figure B-5 - Settlement at Warehouse

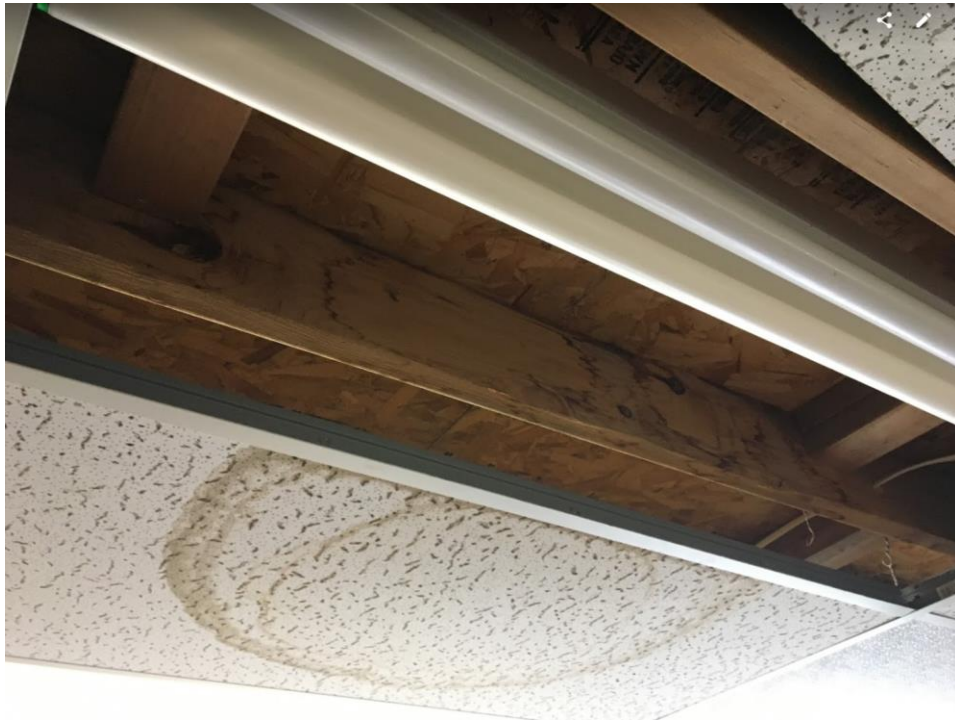
Figure B-6 - Localized Water Spot beneath Mezzanine in Warehouse

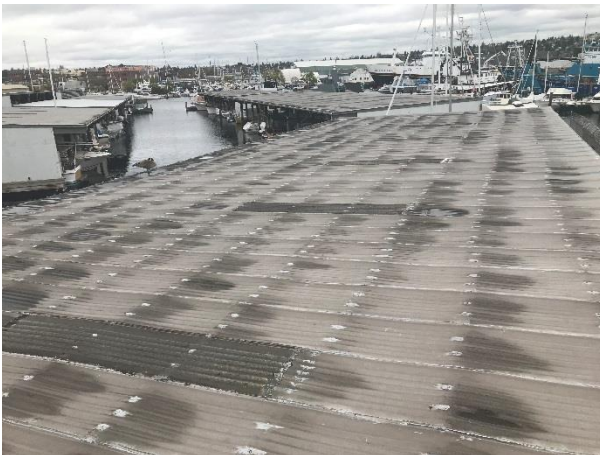
1. Fastener connection failure
2. Failed attempted sealant repair at EACH fastener
3. Severe roof deflection which leads to ponding water between each purlin
4. Light gauge metal panels
5. 36-inch spaced purlins (insufficient for metal roof of this type)
6. Attempted misguided repairs (sealant of various types. Should be tested for asbestos)
7. Possible water damage at failed fasteners

Photo 1: Sealant at EVERY fastener

Our team recommends option 1 due to the following factors -

- 1. Potential life safety concerns with lack of positive connect between metal roofing and support structure. Basically, the roofs could blow-off and cause harm to the public due to the fastener issues outlined above.
- 2. Removal of the existing metal roof will provide the opportunity to repair/replace deteriorated framing

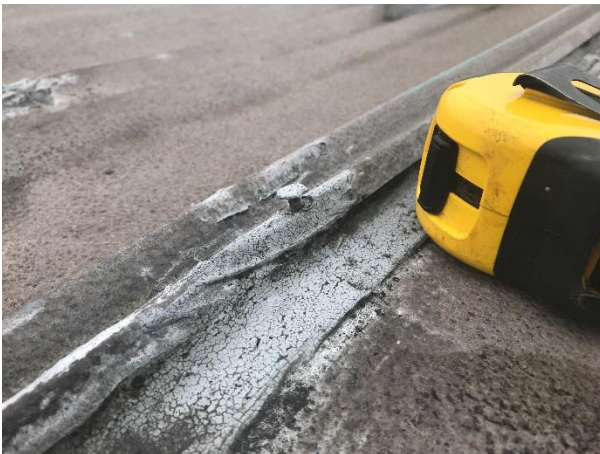
Photo 3: Fastener backout/Split

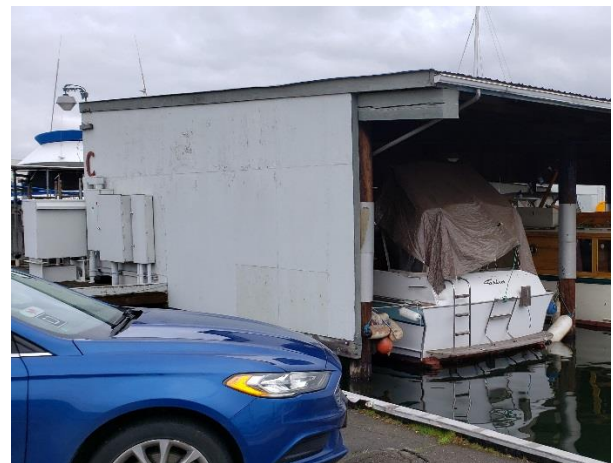
1. Twisted beams (load transfer inadequate)
2. Long horizontal cracks in beams
3. No visible connection between column and purlins (need to verify if tenon exist)
4. Metal roof is not structural

*Photo 7: Split beam*

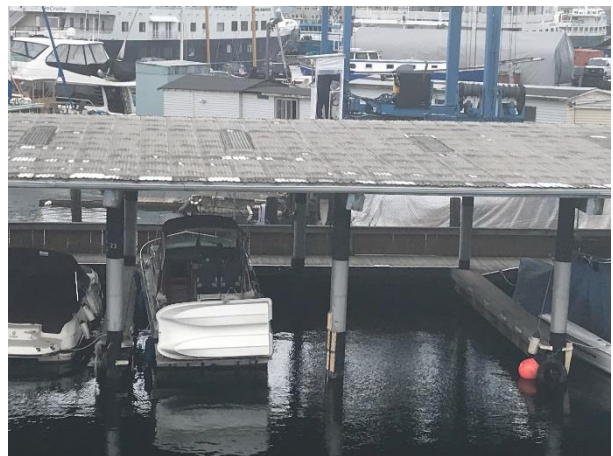
The roof system at the three roofs has failed due to outdated design, lack of maintenance and damage from over loading of snow or persons walking on the roof.

*Photo 9: Partial view of Roof A*

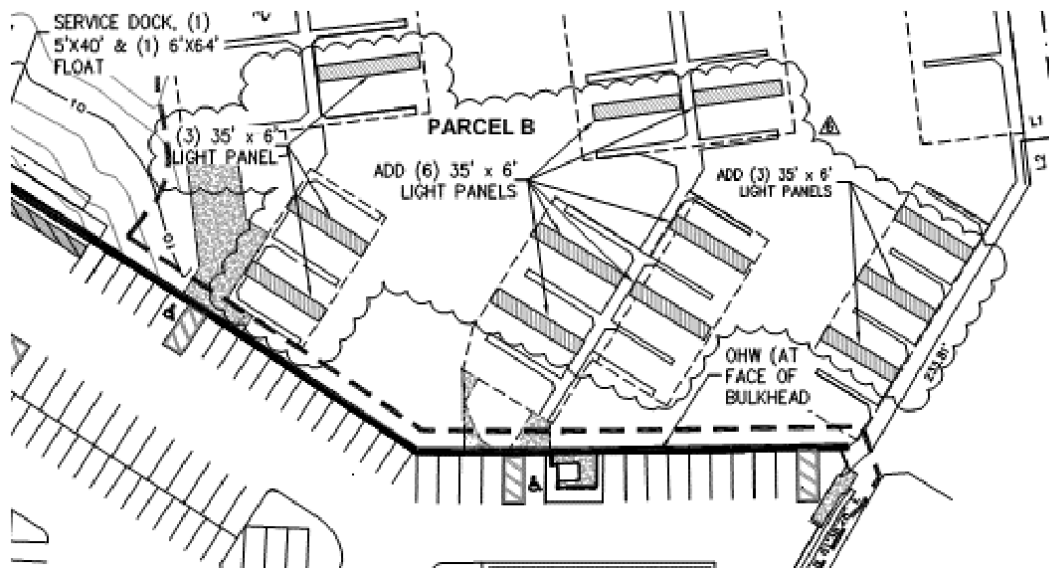
In 2019, Cornerstone Architectural Group, in partnership with PSM Consulting Engineers, provided a limited visual assessment of the existing metal roof system on portions of Docks A, B, and C (see **Figure 2**) for the intention of skylight installations. Cornerstone's assessment determined "the roof system at the three roofs has failed due to outdated design, lack of maintenance, and damage from overloading of snow or persons walking on the roof." Cornerstone ultimately did not recommend installing skylights in the existing roof system "due to the potential for life safety issues during any construction work and general safety for the occupants & general public."

**Figure 2 – Extent of Cornerstone's Visual Assessment at Docks A, B, & C (clouded area)**

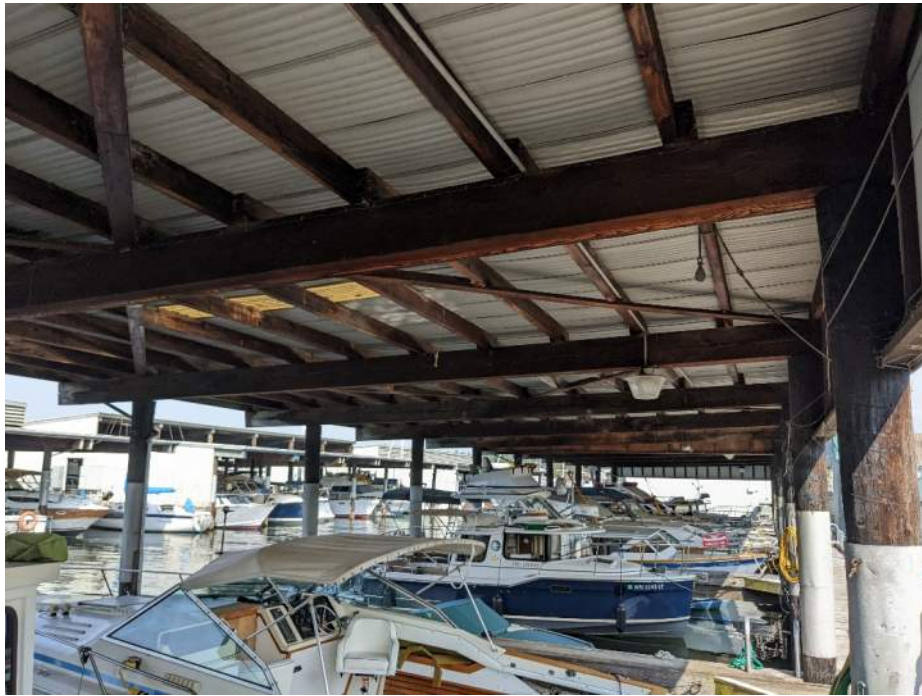
In general, the roof girders and joists are in **Good condition**. Occasional signs of splitting and warping were observed in the girder members (see **Figures 9 and 10**). Moderate weathering can also be seen at the ends of the girders where they are more exposed to rain and sun but does not appear to affect the primary spans of the girders.

**Fig 3 – General Roof Framing at Dock A**

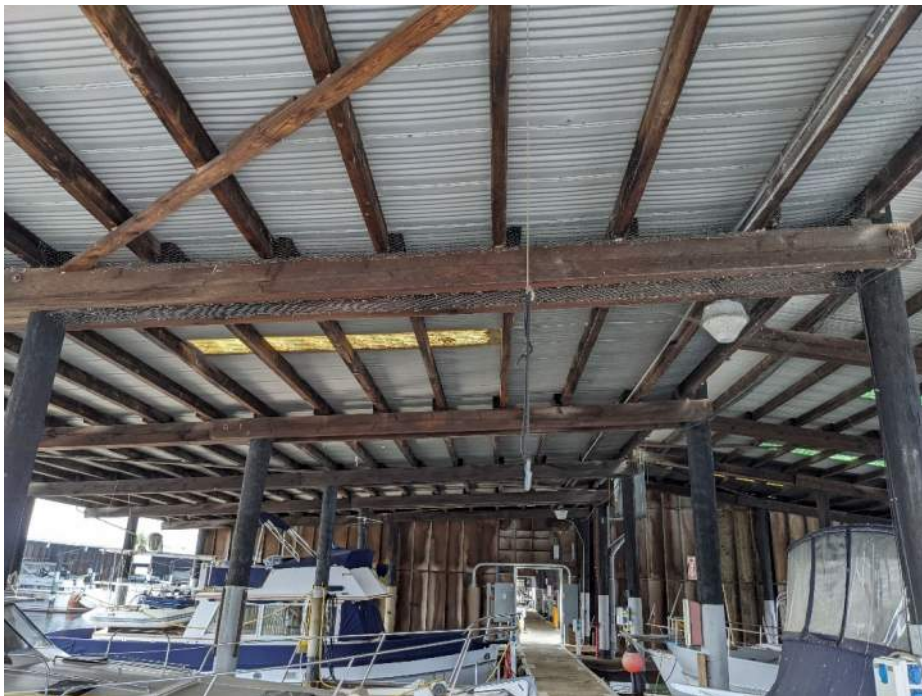
**Fig 4 – General Roof Framing at Dock B (Dock C Similar)**

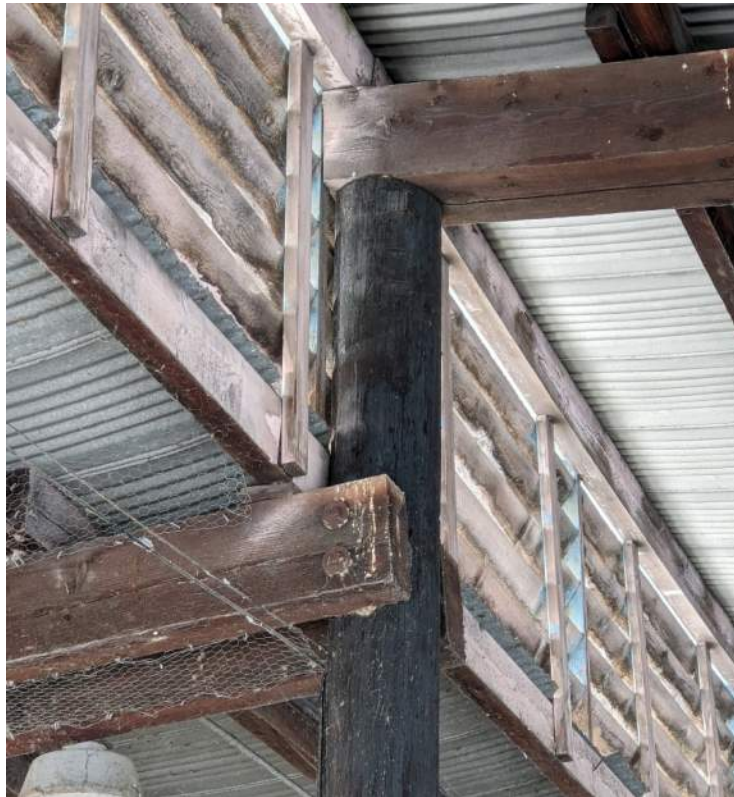
**Fig 5 – Typical Girder Connections at Dock C Roof Ridge (Dock B Similar)**
