# Salmon Bay Marina Docks A, B, C Closure

## Supporting Documentation

# **SALMON BAY MARINA: SITE OBSERVATIONS**

## **SITE OBSERVATIONS, LITERATURE REVIEW, AND DISCUSSION**

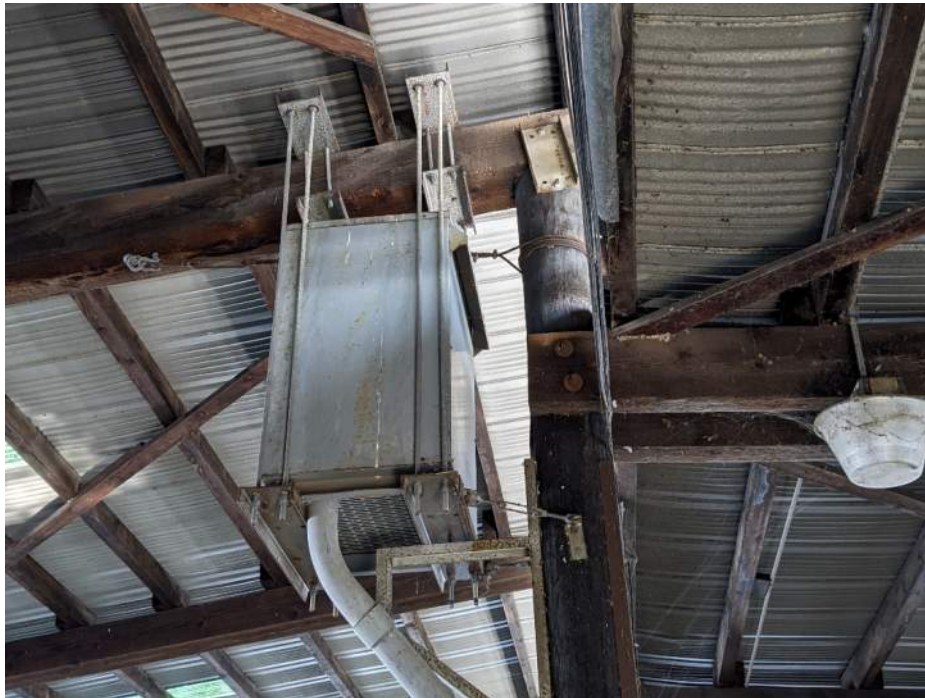
**Fig 7 – Mechanical Equipment and Girder Connection Retrofit**

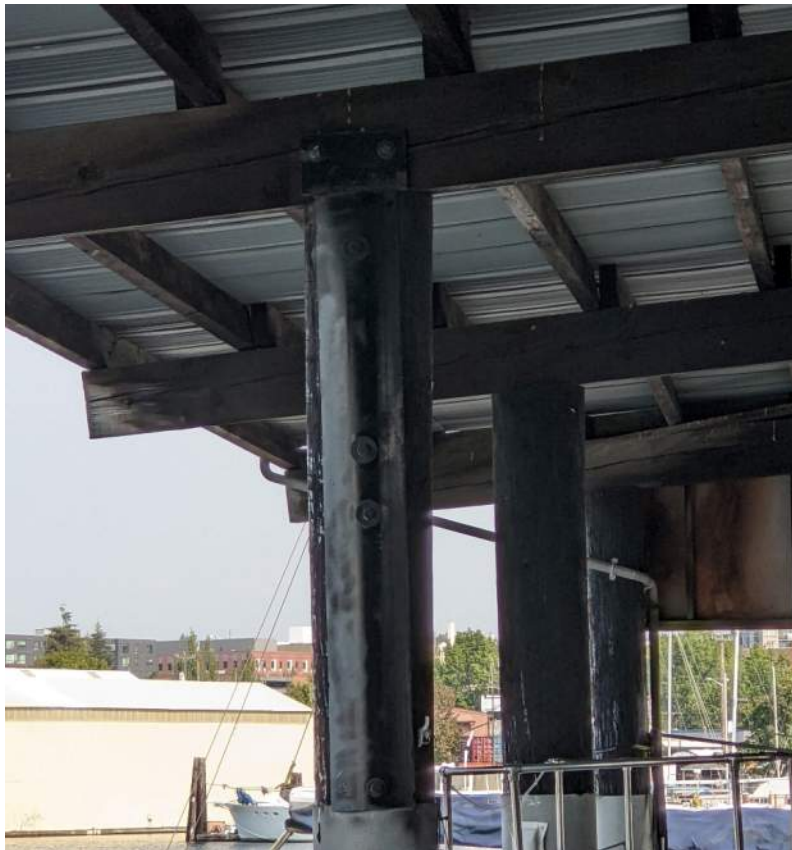
**Fig 8 – Girder to Pile Retrofit**

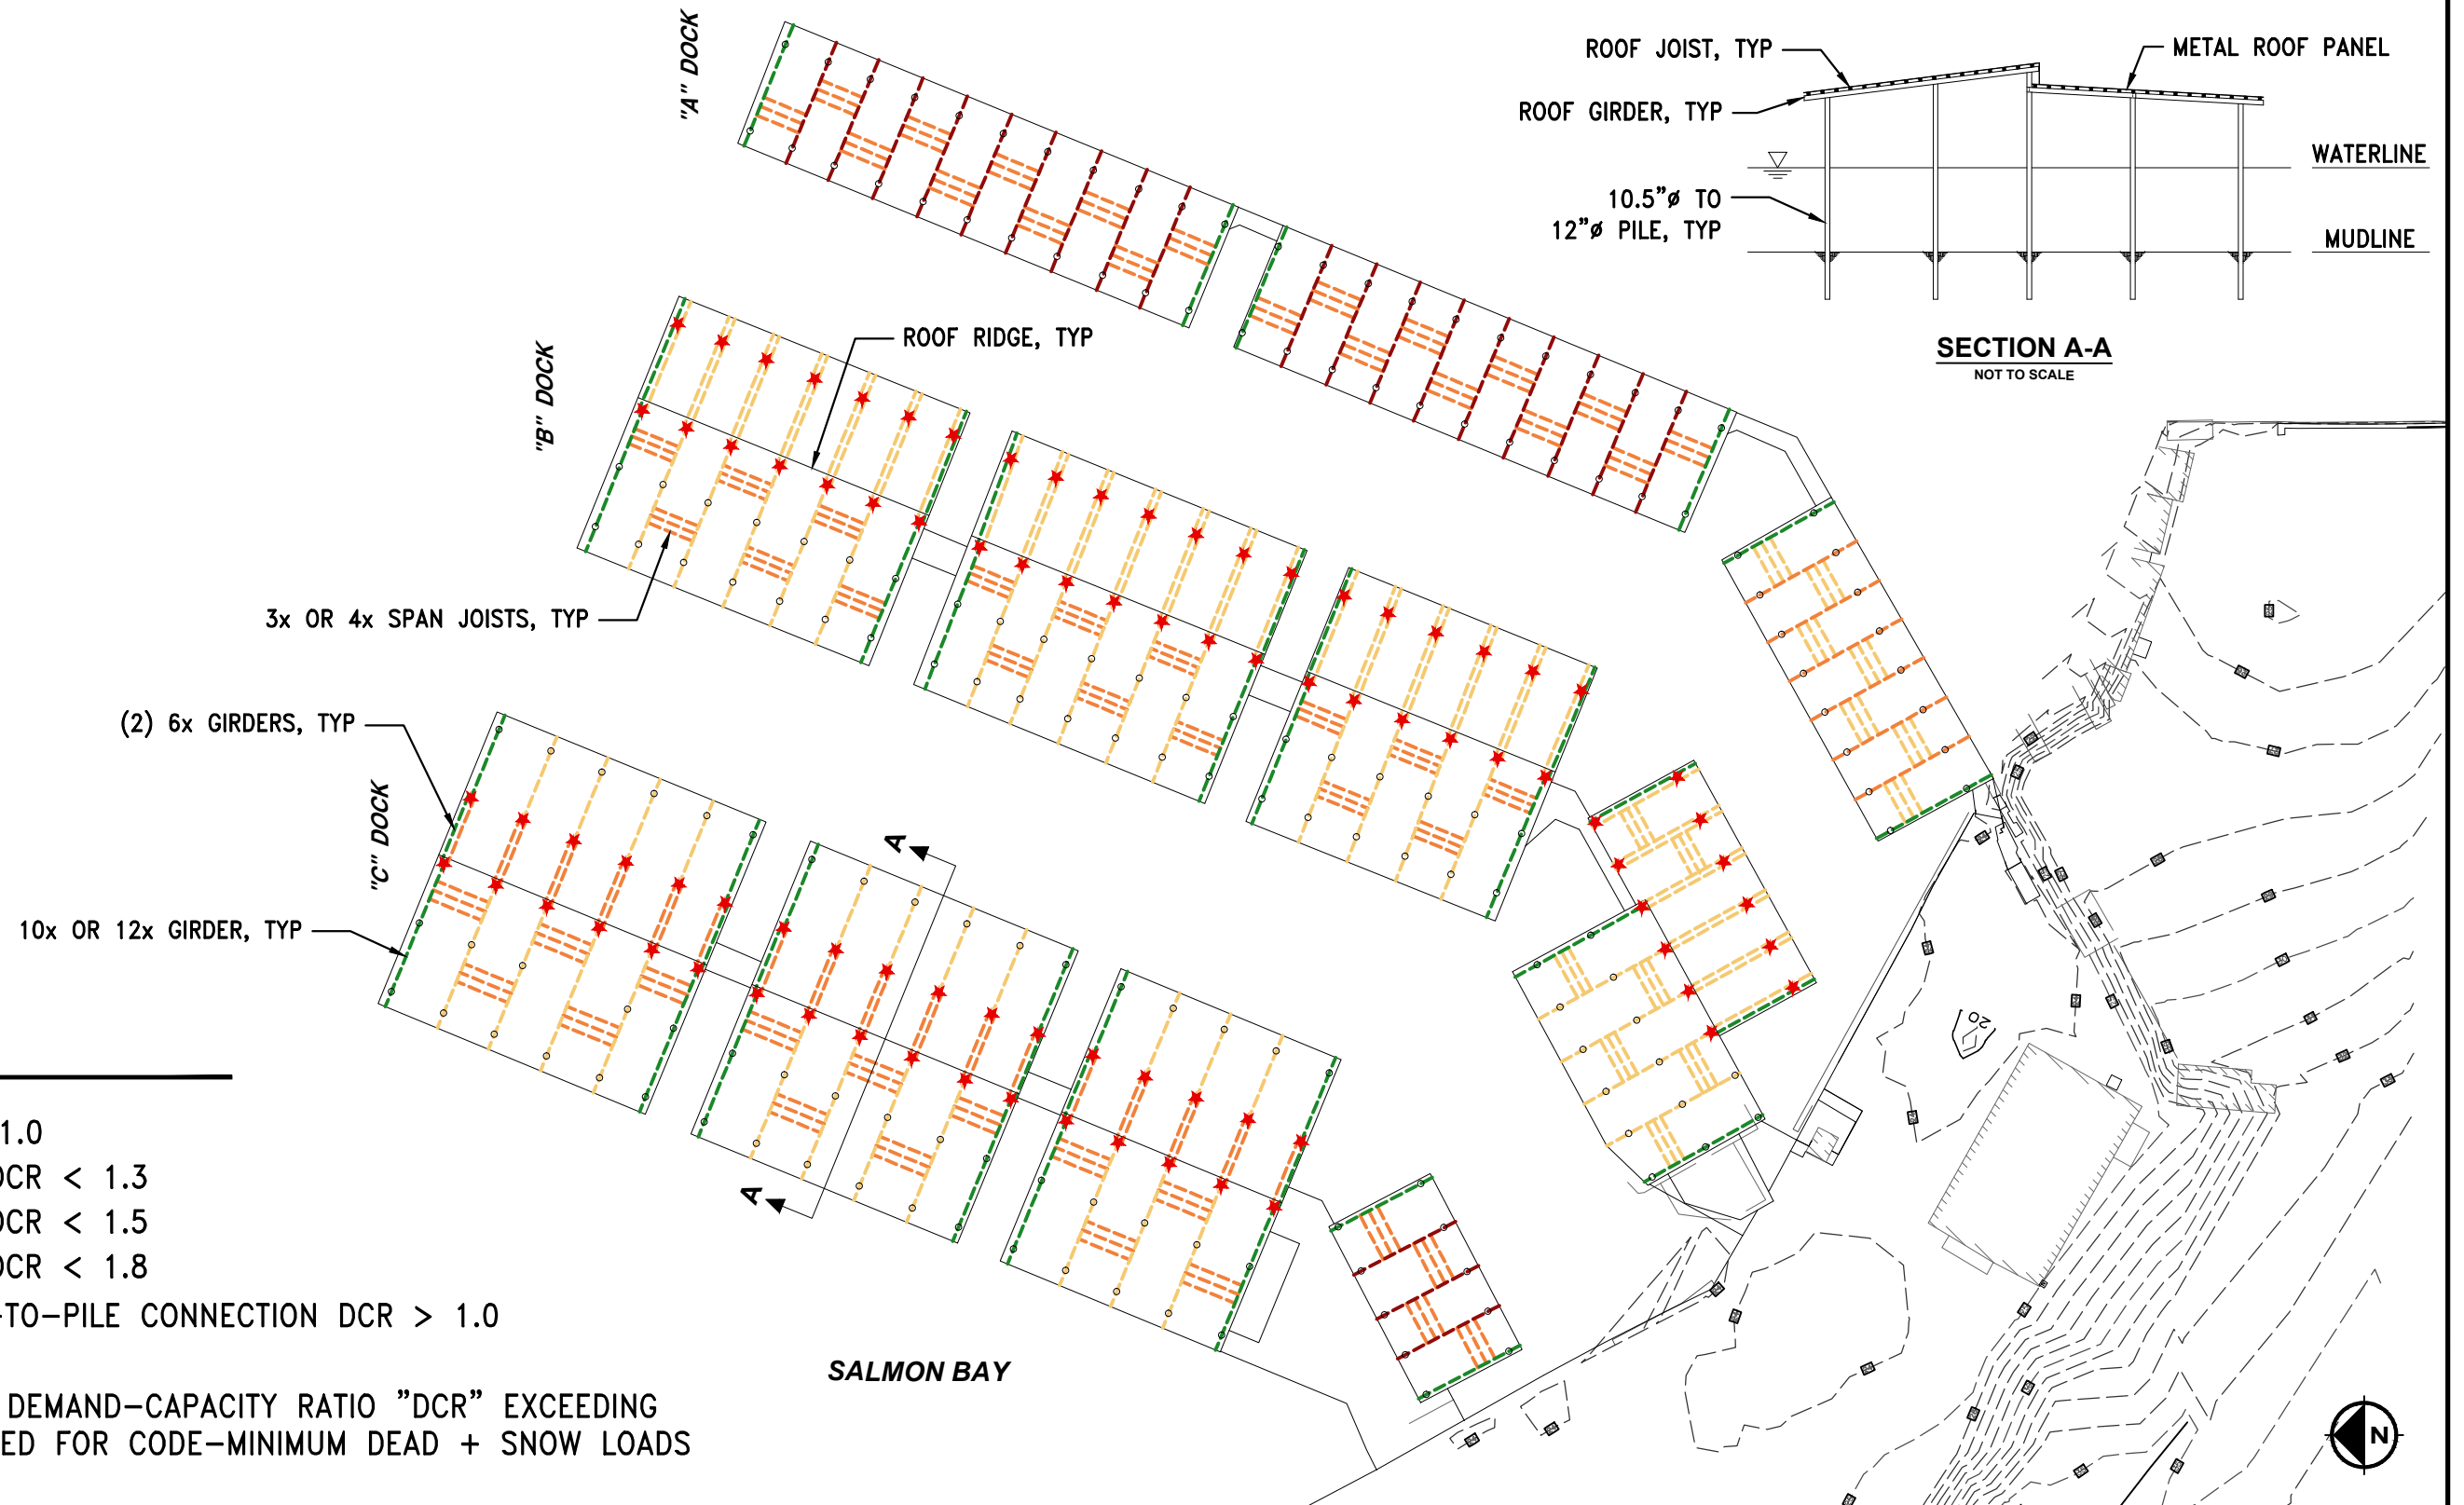
HEAT MAP

- DCR < 1.0
- 1.0 ≤ DCR < 1.3
- 1.3 ≤ DCR < 1.5
- 1.5 ≤ DCR < 1.8
- ★ GIRDER-TO-PILE CONNECTION DCR > 1.0

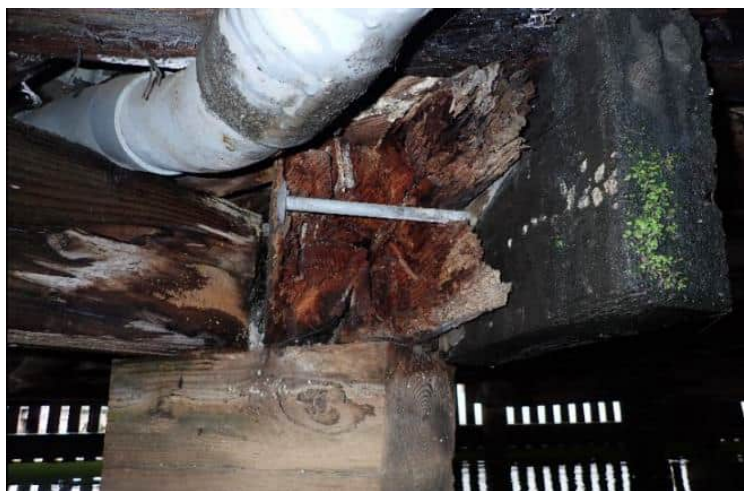
Advanced deterioration was also observed at the 27 timber piles supporting the inshore-most platform at Dock C, primarily due to fungal rot as shown in Figure 4. Section loss up to 35 percent was observed at 15 timber piles, section loss between 35 and 50 percent was observed at two timber piles, and section loss greater than 50 percent was observed at an additional two timber piles. The presence of fungal rot at both the top of pile and bottom of pile cap resulted in reduced bearing at 6 pile locations. The most severe cases of bearing loss were accompanied by crushing and rotation of the lower 12 in. by 12 in. timber cap.

**Figure 4: Dock C, Inshore Platform - Timber Pile Cap with Severe Section Loss at its End Due to Rot**

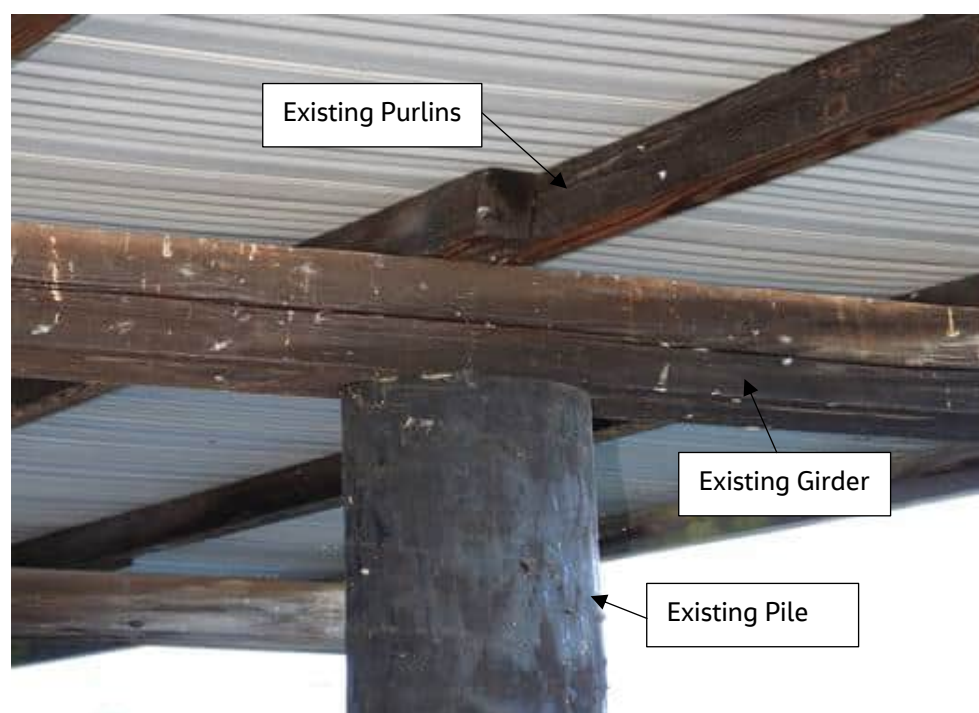
The roof structure consists of metal roofing material sitting on timber purlins that are supported by timber girders which in turn are supported by creosote-treated timber piles. Most of the existing girder-to-pile connections consist of a girder bearing on a pier, with no visible positive hardware-based anchorage. A second typical girder-to-pile connection has parallel timber girders on either side of the pile connected with a thru-bolt. There are no significant lateral bracing elements – lateral forces appear to be resisted by the piles acting as cantilevers extending out of the mud.

Figure 5 – Typical Gravity Connection

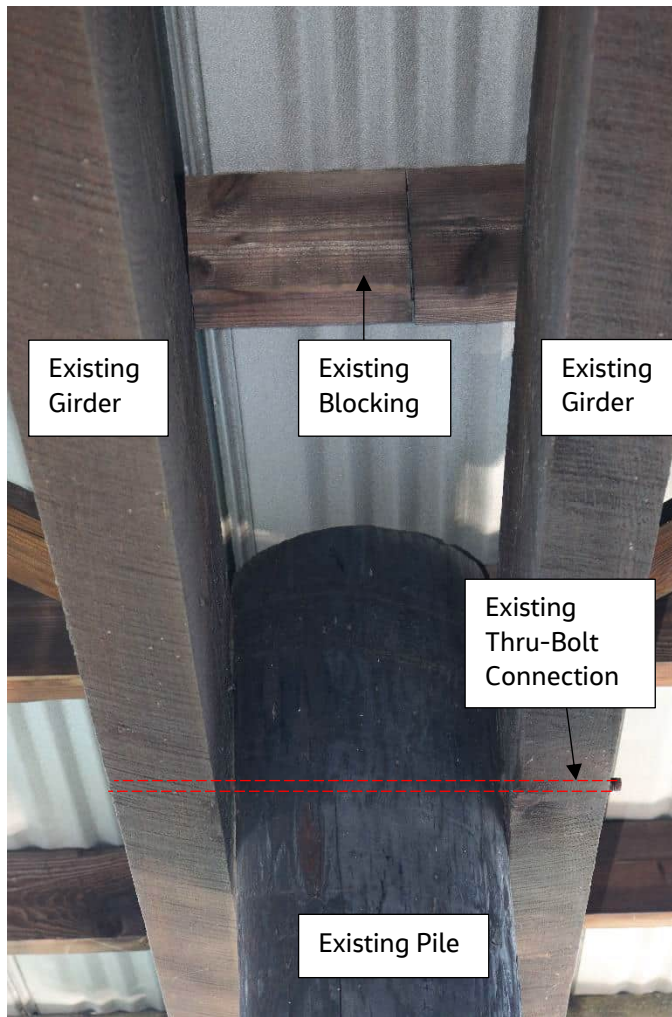
**Figure 6 - Example of the Thru-Bolt Girder-to-Pile Connection.**

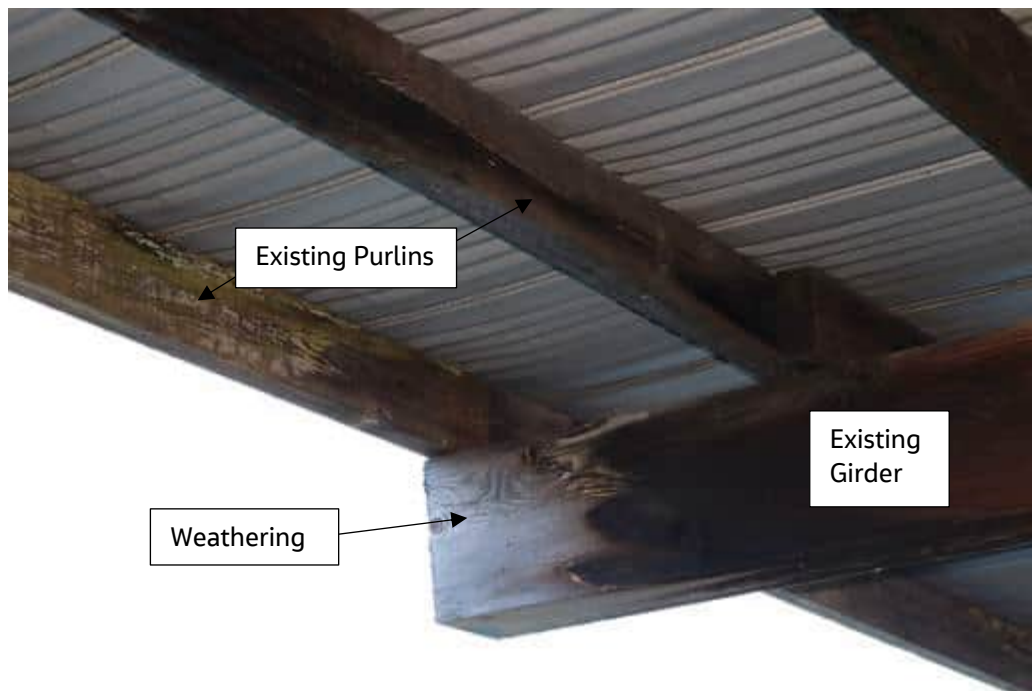
There are locations, especially at the exposed girder ends or at locations of roof leaks where water intrusion is occurring. Some girders have large horizontal splitting and others are twisting intermittently throughout the three docks. Some timber piles exposed to the weather are showing signs of the creosote leaching out of them.

**Figure 7 - Example of Weathering at Exposed Ends of a Girder**

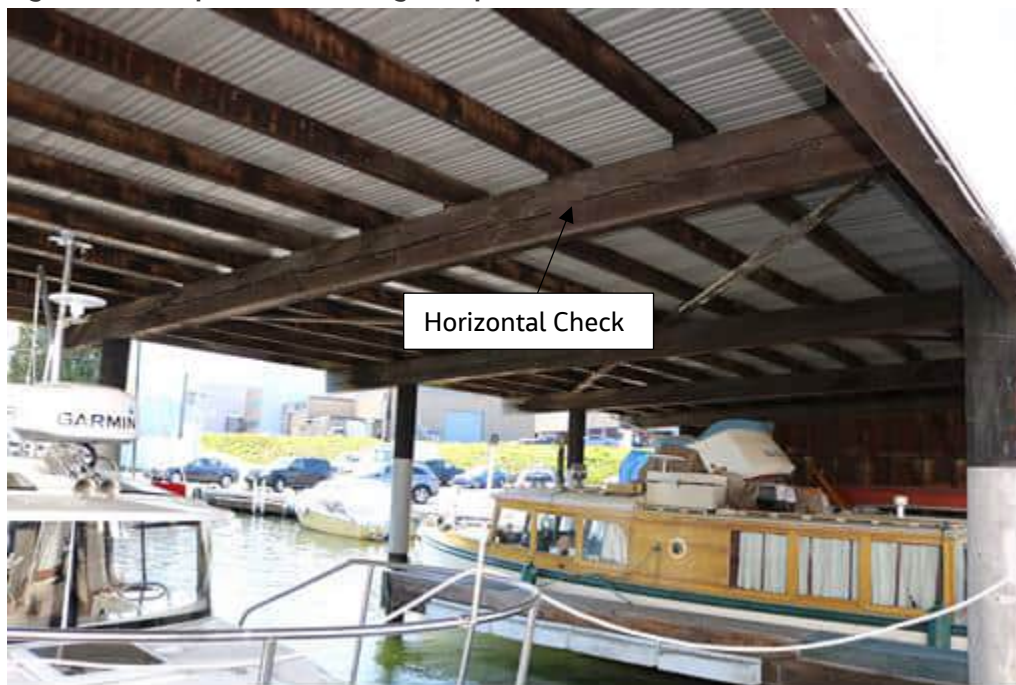
**Figure 8 - Example of Large Horizontal Checks in a Girder**

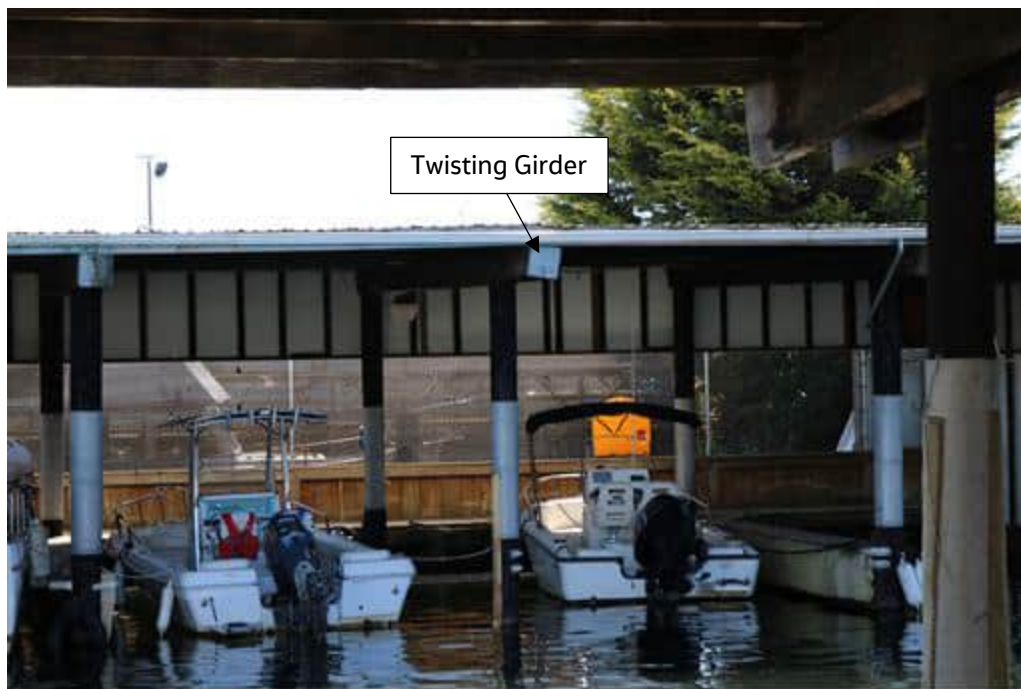
Figure 9 - Example of Twisting Members

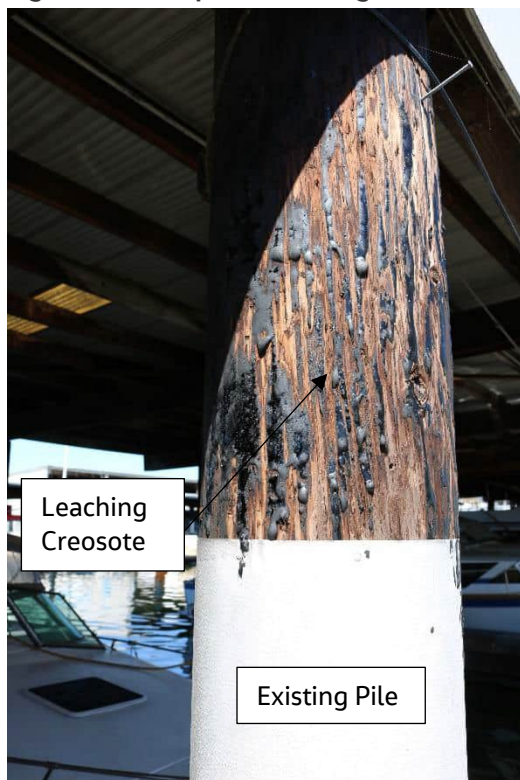
Figure 10 - Example of Creosote Leaching Out of Timber Pile due to Sun Exposure.

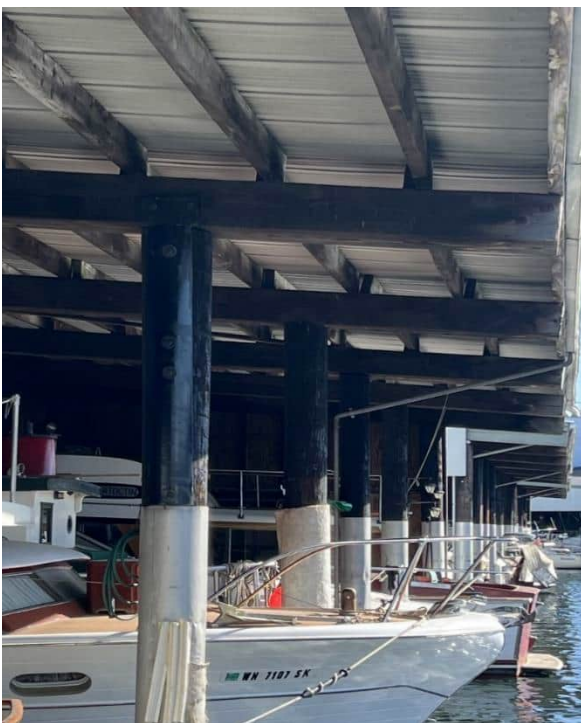
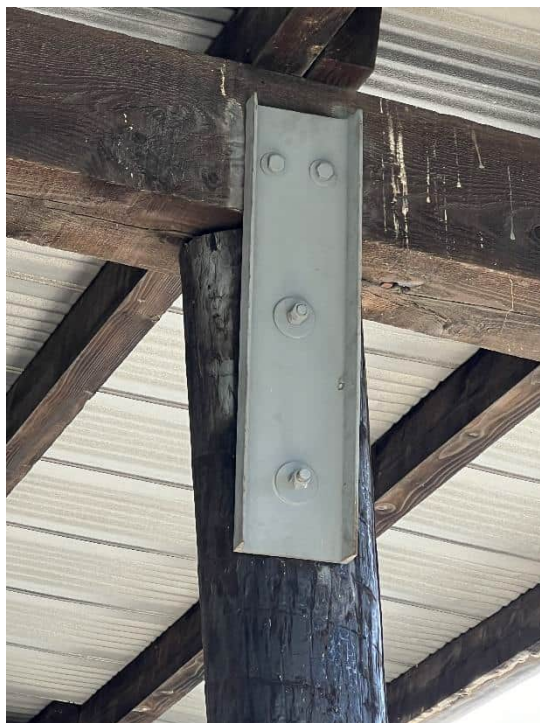
There have been various retrofits performed on some girder-to-pile connections to provide a positive connection.

Figure 11 – Retrofits- Examples of Girder-to-Pile Connections.

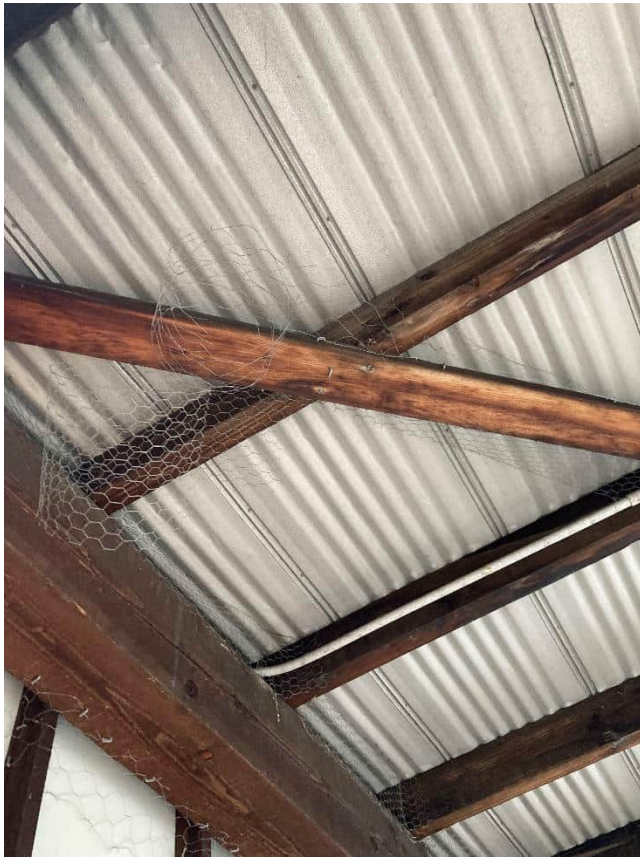
The roof seems to have received sealing treatment to the topside of the roof and appears to have served only to conceal the above issues by covering them.

Recent water damage suggests the roof is not preventing water intrusion to the structural underside as shown in Figure 13

**Figure 14 – Roof Showing Recent Water Damage**

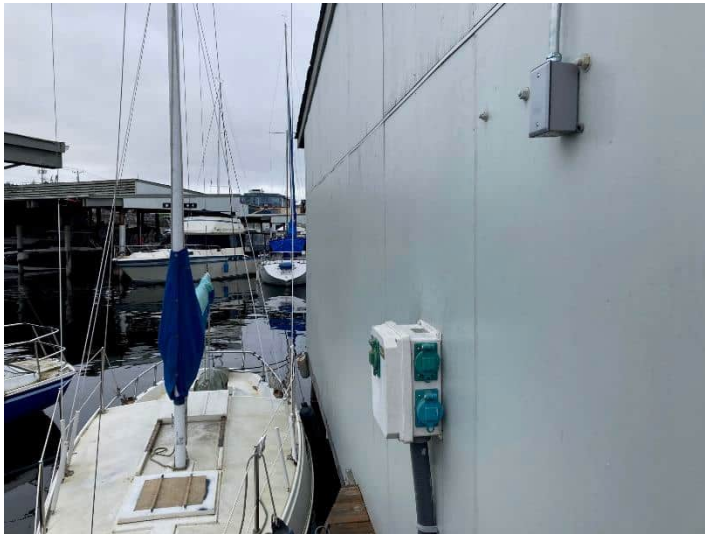
**Figure 15 - Typical Boathouse Side Wall**

Figure 14 depicts the typical boathouse side wall, note the mounting of electrical power outlet and junction box mounted. The plywood and paint appear to be in good condition, well maintained.

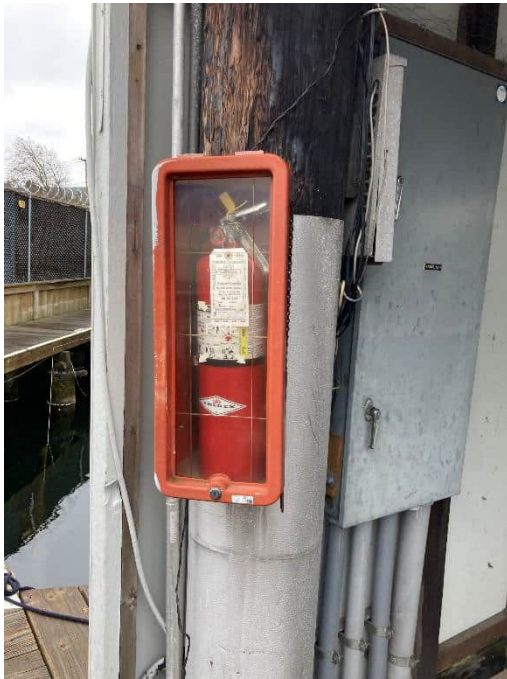
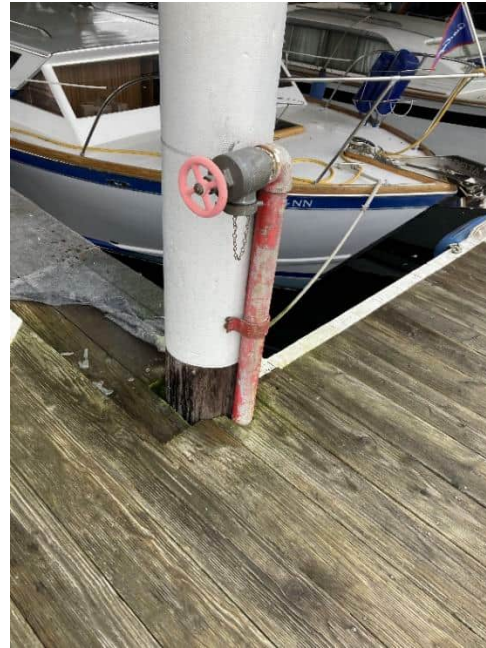
**Figure 16 – General Fire Protection on the Docks**

Fire protection on the docks is limited to hand-held fire extinguishers and dry-pipe hydrants, which would be charged at an upland Siamese connection, which is noted later in this report (see Figure 15 above; and Figure 24 in Section 3.4 - Fire Protection).

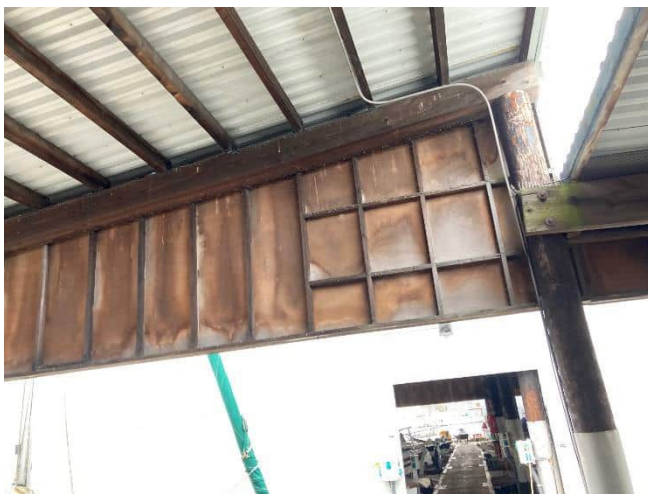
**Figure 17 - Dropped Wind Screens**

The dropped wind screens are lightly constructed, almost temporary in appearance, but holding up moderately well despite some apparent water damage that can be seen here.

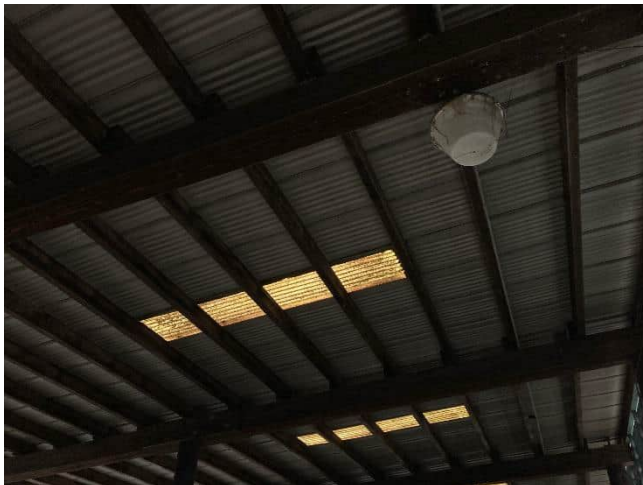
**Figure 19 – Roof Skylights**

The skylights that were installed don't add much usable natural light into the boathouses and have apparently exacerbated the leaking of the roofs. The light penetration will be required if rebuilt.

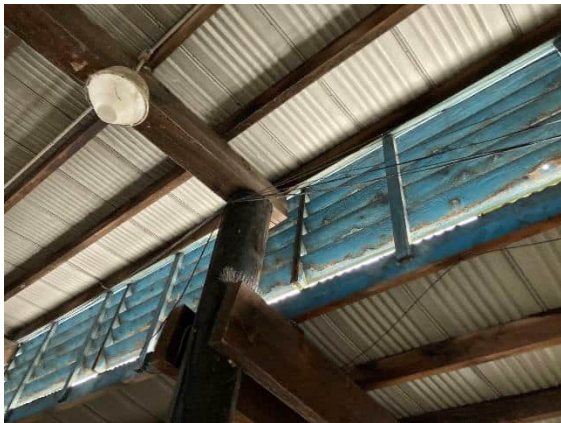
**Figure 22 – An Existing Light Fixture**

The typical condition of the space is exemplified by the existing light fixture and the worn-out wood louver at the roof clerestory, which is likely in poor condition due to the difficulty of safely accessing the roof areas for routine maintenance, hindering regular upkeep and repair.

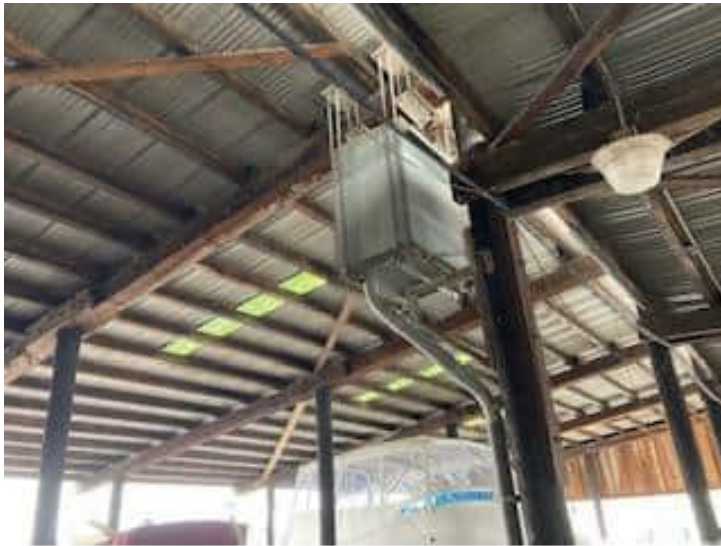
Figure 23 - Typical Hanging Transformer Suspended from Roof Structure (only at Dock B and Dock C)

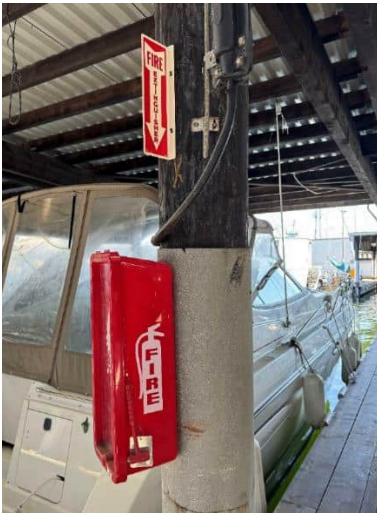
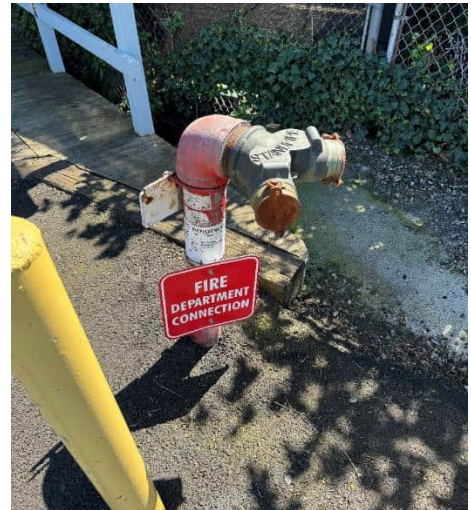
Each pier is provided with fire extinguishers spaced intermittently along the length of each pier, with their locations identified by required signage, mounted above fire extinguisher cabinets.

Figure 25 – Existing Fire Protection System

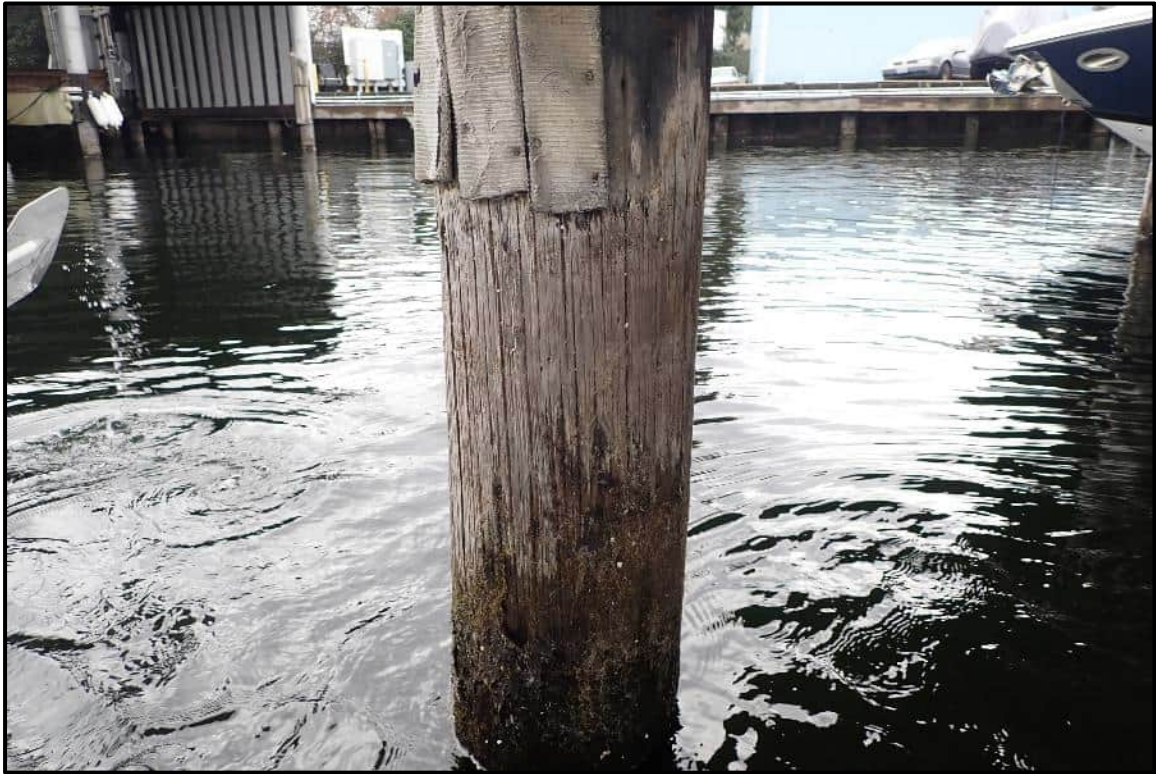
The timber piles measure 9 in. to 12 in. wide, with no discernable pattern to the change in pile diameter across the facility (Photo 2-1). The piles along the three docks extend from the mudline to approximately 12ft to 4ft above MLW (mean low water) and support the roof structure of the protective enclosures. Conversely, the piles beneath the inshore platforms at Dock B and Dock C, as well as the bulkhead and wave screens, extend approximately 3ft above MLW.

Photo 2-1: Typical timber pile ranging between 9 in. and 12 in. wide, along Docks A, B, and C.

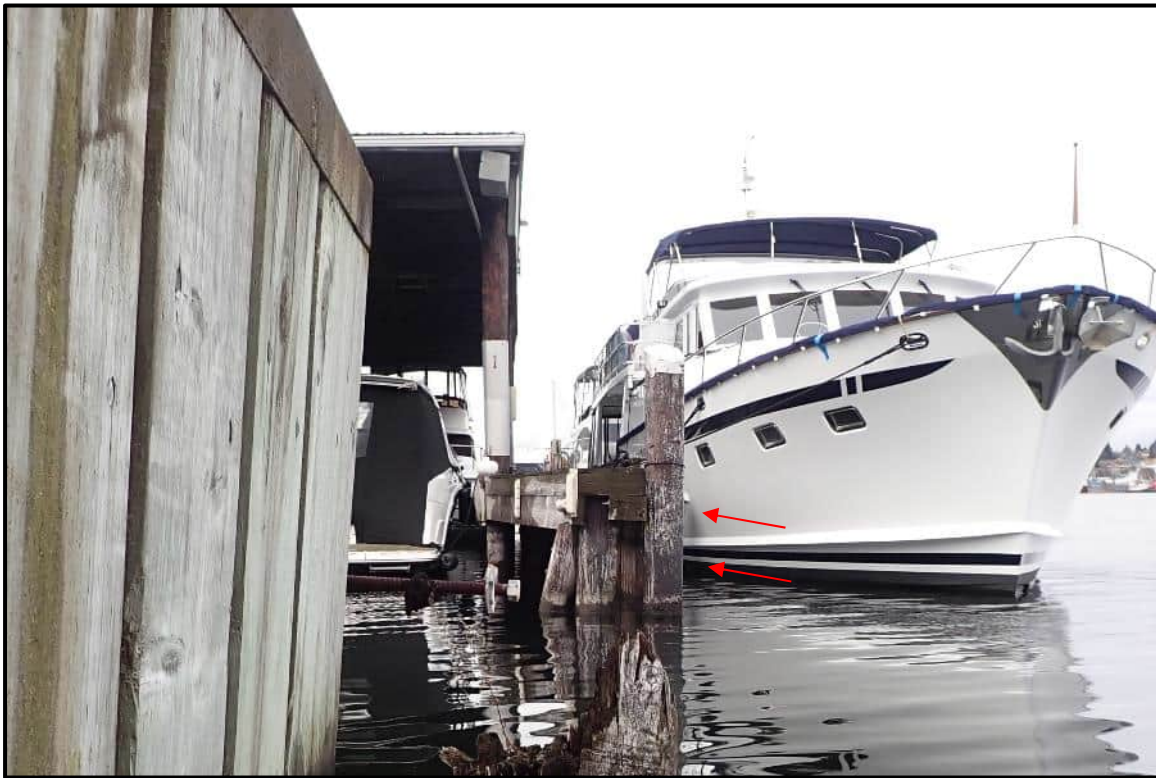
Photo 2-2: Wave screen at the offshore end of the Docks A, B and C.

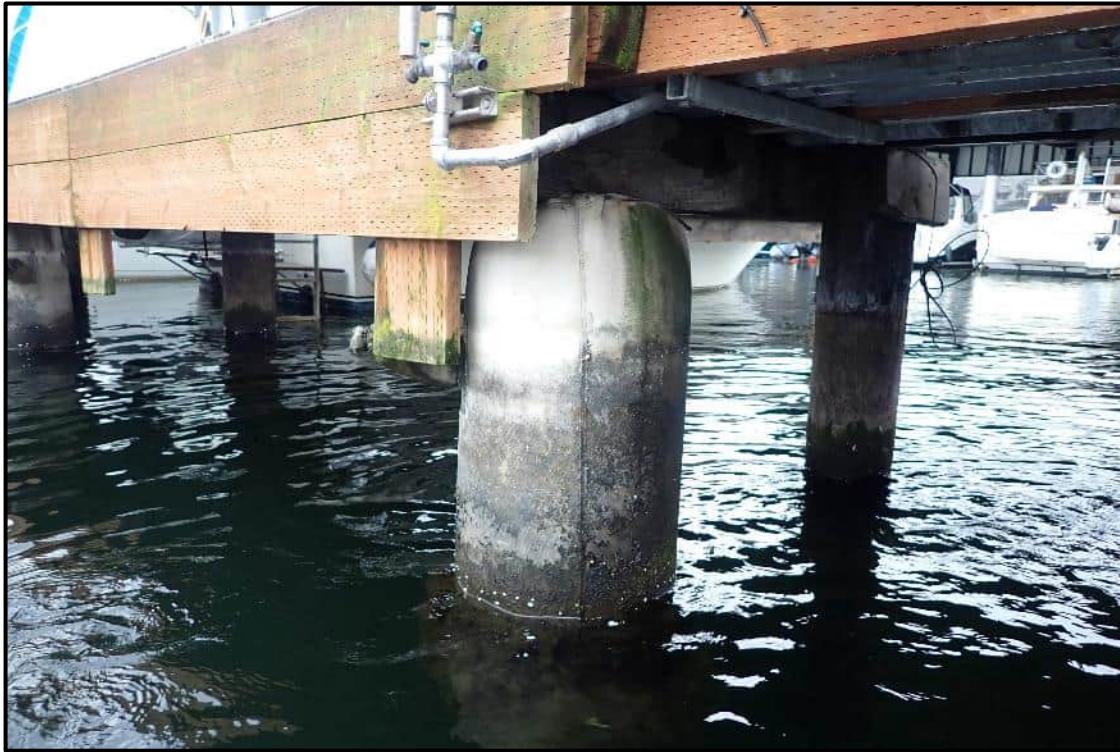
Dock B is composed of 119 timber plumb and batter piles arranged into 29 bents. Each bent typically contains 4 piles. A wave screen supported by an additional 15 piles is positioned at the offshore end of the dock to limit the effects of wake on the berthed vessels (Photo 2-2). A small platform is positioned inshore of dock and affords access to the entrance. The platform is supported by 12 timber piles supporting a latticework of timber pile caps and stringers. Concrete grout repairs are present over the top 4.5 ft of 11 piles (Photo 2-3).

Photo 2-3: Typical concrete bag repair at Docks A, B, and C.

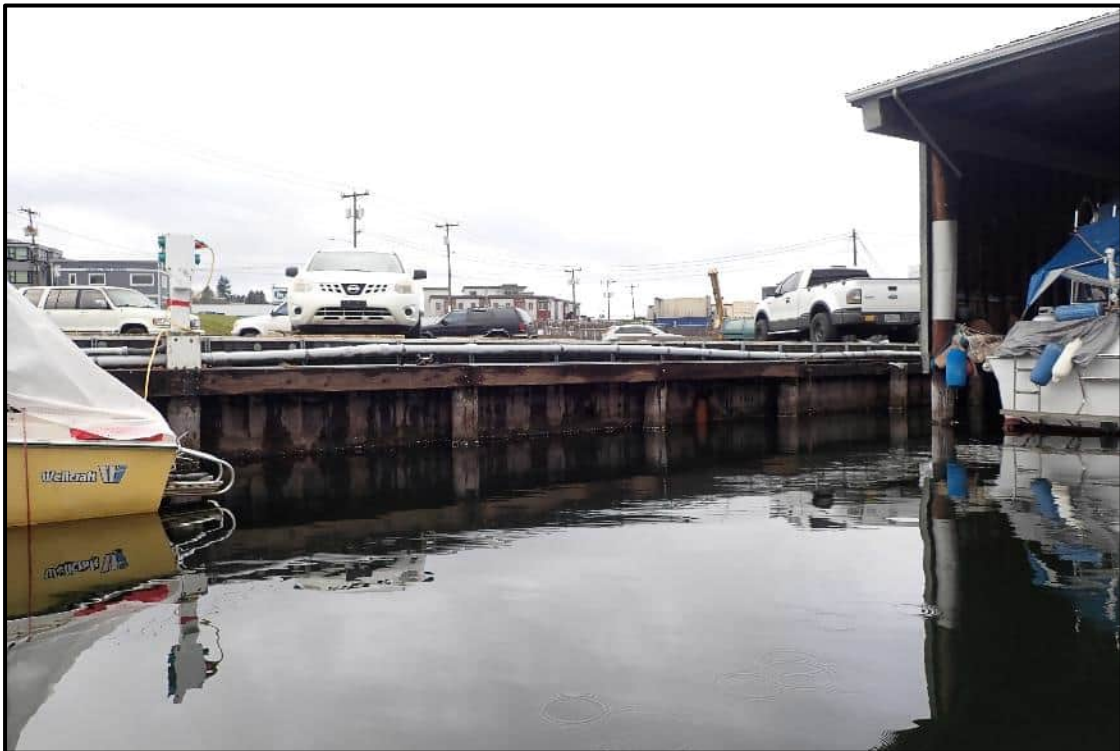
A timber sheet pile bulkhead retains fill along the parking lot that runs the length of the property. Intermittent timber piles at the face of the bulkhead support a narrow walkway that carries marina utilities to the three docks and acts as the emergency egress point from the water via retractable in-water safety ladders (Photo 2-4).

Photo 2-4: Intermittent timber piles at the face of the timber sheet pile bulkhead.

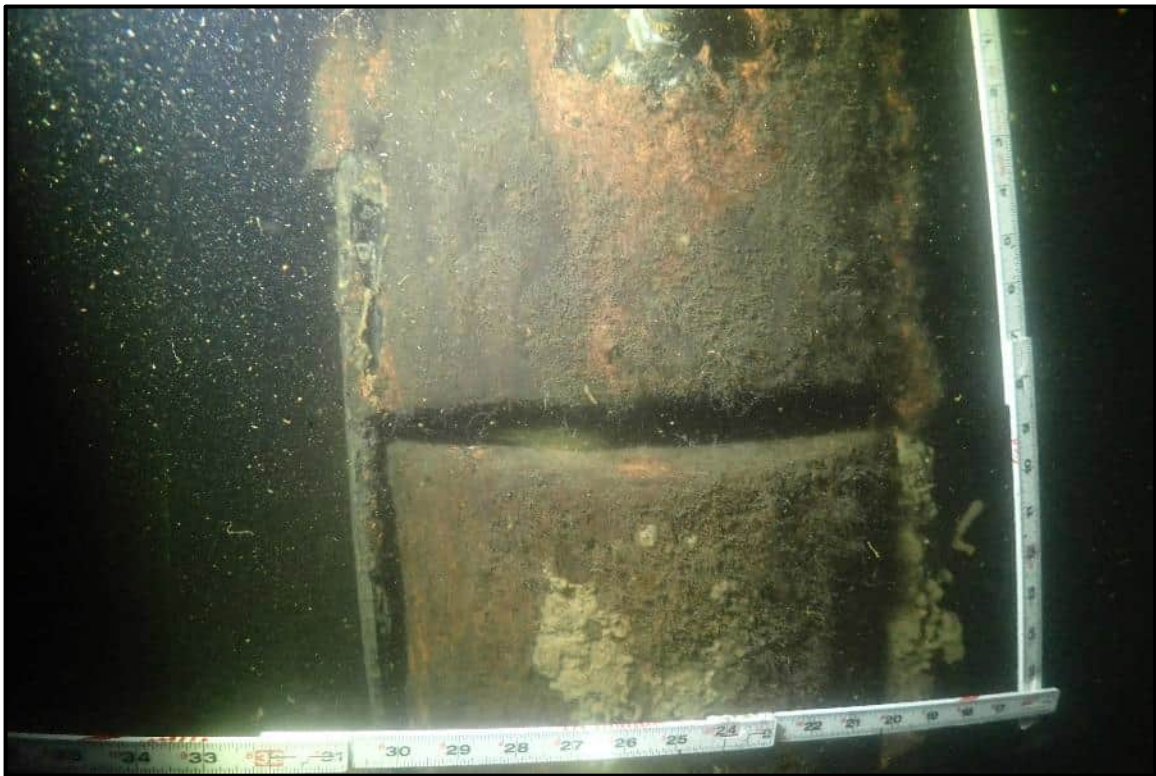
A total of 43 timber plumb and batter piles support the offshore wave screens located at the north end of each dock. Moderate to advanced deterioration was observed at 21 timber piles: including reduced bearing at the pile/post interface and corrosion of the steel fishplate and/or connection hardware. Severe deterioration was also observed at an additional 8 piles: including loss of bearing at the pile/post interface (Photo 3-1), severe corrosion of the fishplates and connection hardware (Photo 3-2), and failure of the bolted timber batter pile connection (Photo 3-3).

Photo 3-1: Loss of bearing at pile/post interface along the offshore wave screen.

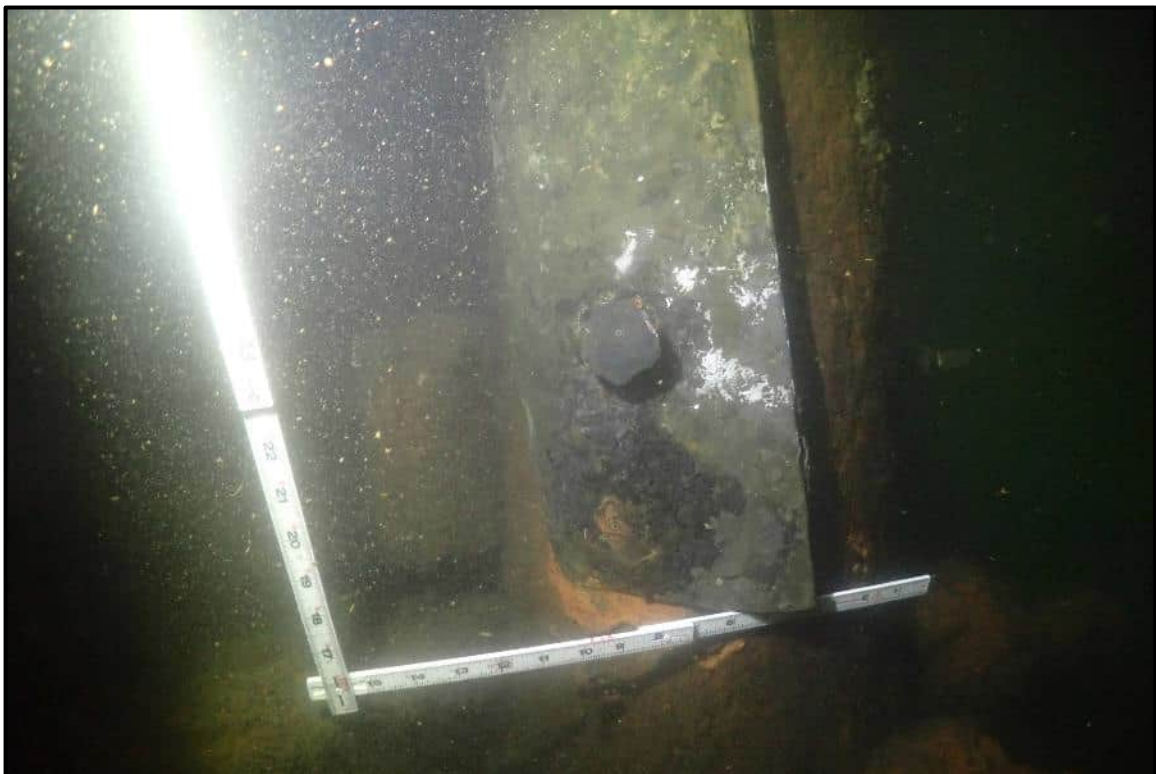
Photo 3-2: Corrosion through full thickness of steel fish plate at pile/post connection of timber pile at offshore wave screen.

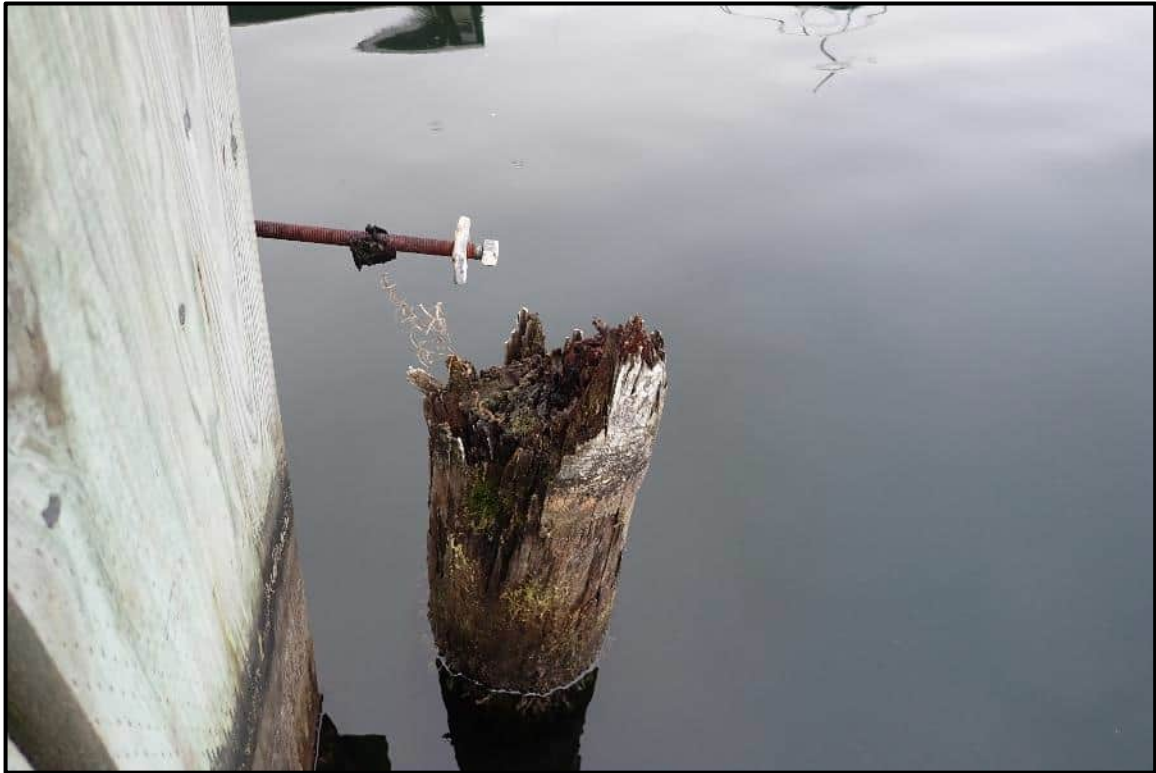
Photo 3-3: Failed connection at top of pile due to fungal rot at offshore wave screen.

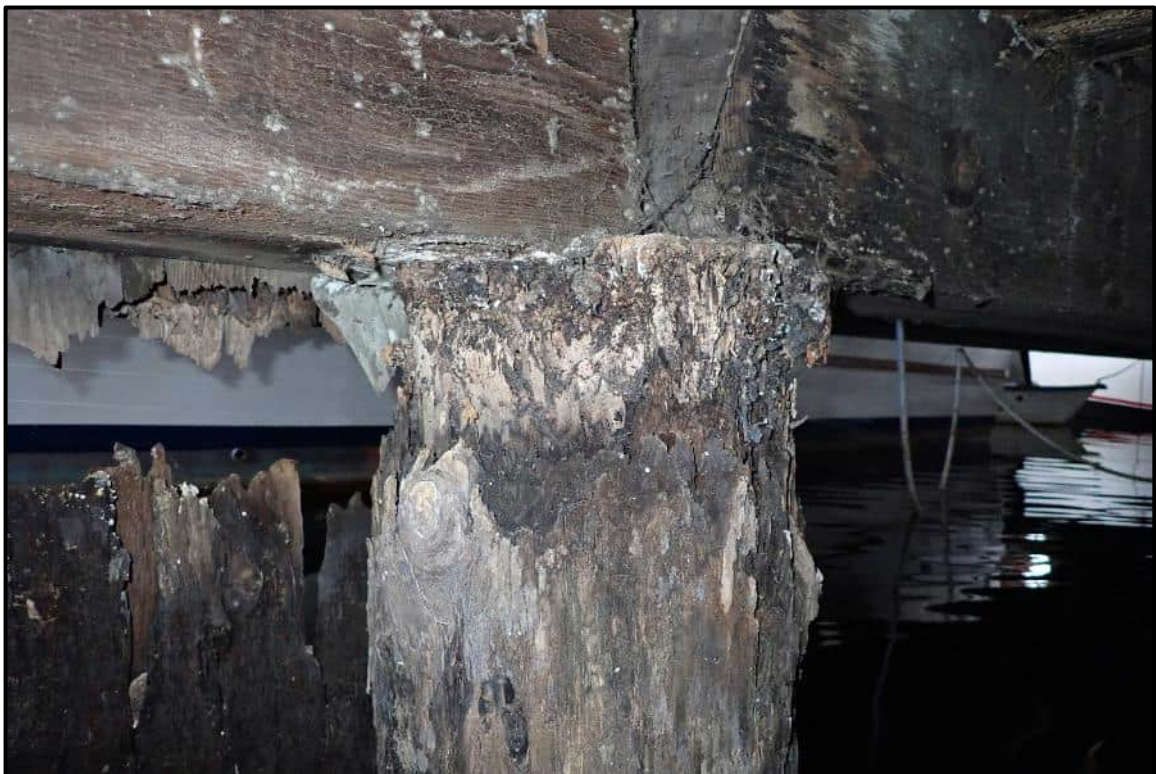
Advanced deterioration was also observed at the 27 timber piles supporting the inshore-most platform at Dock C, primarily due to fungal rot. Section loss up to 35 percent was observed at 15 timber piles, section loss between 35 and 50 percent was observed at two timber piles (Photo 3-4), and section loss greater than 50 percent was observed at an additional two timber piles (Photo 3-5). The presence of fungal rot at both the top of pile and bottom of pile cap resulted in reduced bearing at 6 pile locations. The most severe cases of bearing loss were accompanied by crushing and rotation of the lower 12 in. by 12 in. timber cap (Photo 3-6).

Photo 3-4: Timber pile with major section loss due to fungal rot at top of pile.
