# Salmon Bay Marina Docks A, B, C Closure

## Supporting Documentation

# **SALMON BAY MARINA: SITE OBSERVATIONS**

## **SITE OBSERVATIONS, LITERATURE REVIEW, AND DISCUSSION**

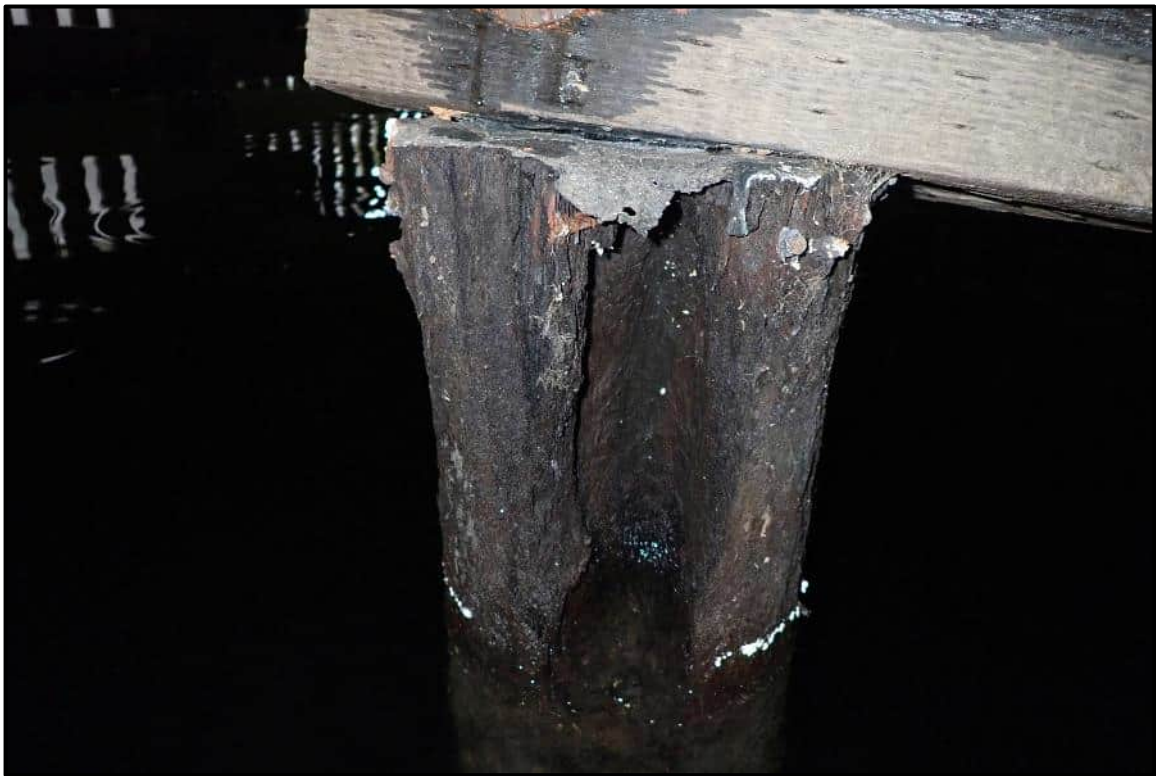
Advanced deterioration was also observed at the 27 timber piles supporting the inshore-most platform at Dock C, primarily due to fungal rot. Section loss up to 35 percent was observed at 15 timber piles, section loss between 35 and 50 percent was observed at two timber piles (Photo 3-4), and section loss greater than 50 percent was observed at an additional two timber piles (Photo 3-5). The presence of fungal rot at both the top of pile and bottom of pile cap resulted in reduced bearing at 6 pile locations. The most severe cases of bearing loss were accompanied by crushing and rotation of the lower 12 in. by 12 in. timber cap (Photo 3-6).

Photo 3-5: Timber pile with severe section loss due to fungal rot through core of pile.

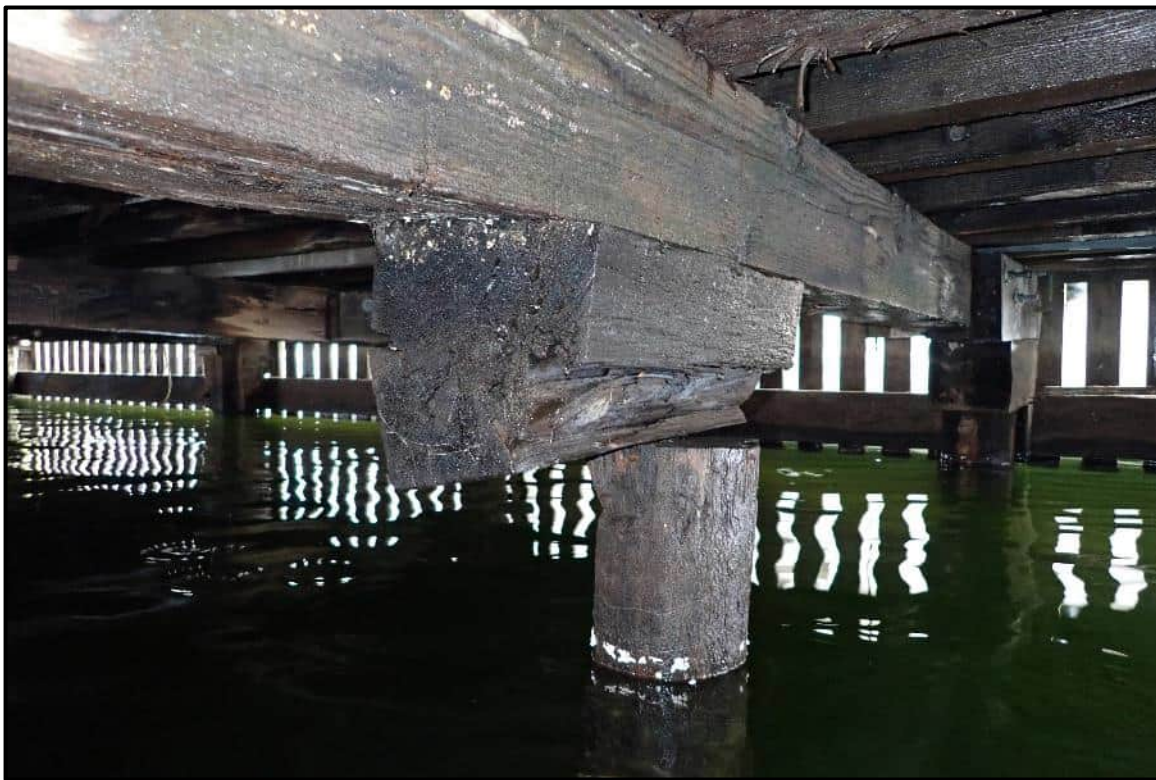
Photo 3-6: Severe reduction in bearing due to rotation and crushing of lower timber cap shimming the connection between the pile and pile cap.

- Repair of nine timber piles with severe section loss along the walkway and at the inshore platform of Dock C.
- Replacement of severely corroded connection hardware at six locations along the wave screens.
- Restoration of bearing at the pile/post interface at six locations along the wave screens.
- Replacement of crushed/rotated timber pile caps above three timber piles at the inshore platform of Dock C.

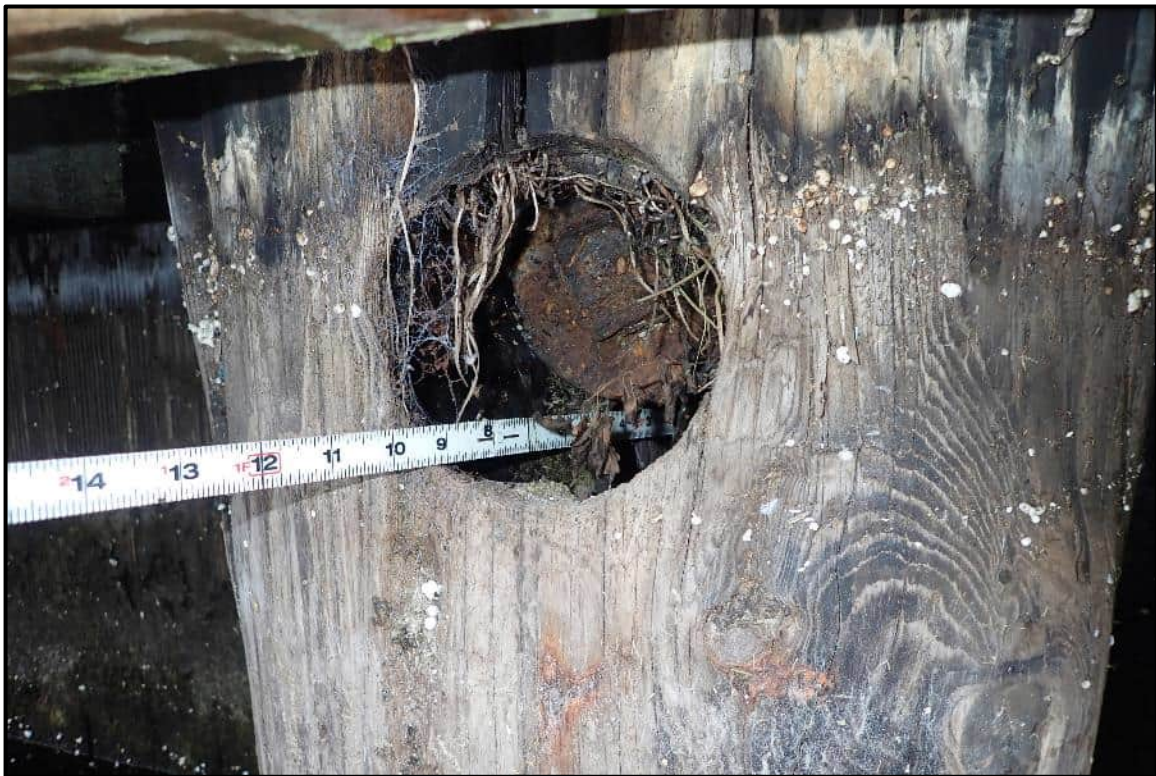
A total of 27 timber piles supports the timber walkway running the length of timber sheet pile bulkhead between Dock A and Dock C. The inshore timber piles exhibit minor fungal rot above and below water. Section loss up to 35 percent was observed at one timber pile, section loss between 35 and 50 percent was observed at two timber piles, and section loss greater than 50 percent was observed at an additional five timber piles (Photo 3-7). The timber piles with severe section loss exhibited other severe deterioration, including splitting and breakage within the top 54 in. of pile (Photo 3-8). Additionally, the timber sheet pile bulkhead was examined during inspection of the walkway piles. The timber sheeting exhibits isolated minor deterioration between walkway piles 1 and 27. The bulkhead was largely obscured by marine growth below water. Above water, and where cleaned for detailed inspection, the sheet piles showed no signs of advanced deterioration.

Photo 3-7: Timber pile with severe section loss due to fungal rot at top of pile along timber bulkhead.

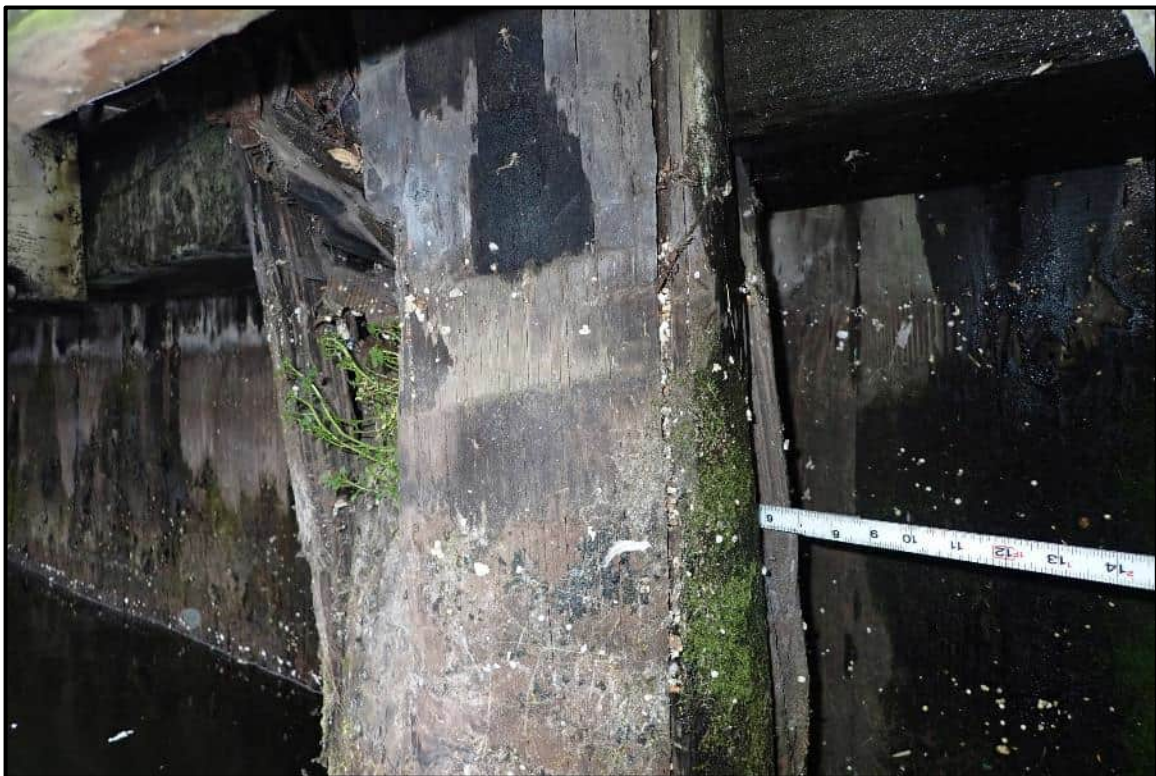
Photo 3-8: Timber pile with severe section loss and splitting at top of pile due to fungal rot along timber bulkhead.

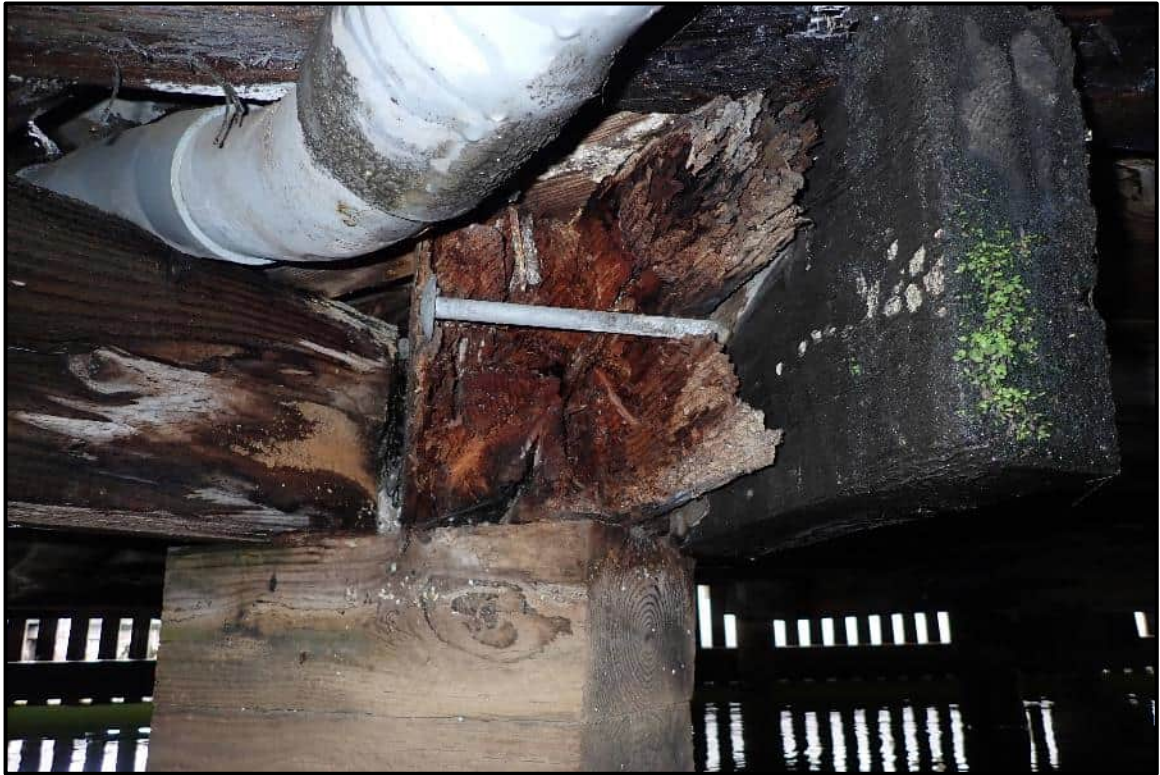
The timber piles supporting the inshore platform at Dock C, as well as along the bulkhead and offshore wave screens, show greater levels of section loss and quantities of severe defects. Increased levels of fungal rot at these locations, attributable to the lower top of pile elevations, has resulted in increased localized deterioration. Exposure of the timber grain to standing moisture and has, over the years, softened the fibers of the material and reduced the rigidity of the cross-section. With the piles unable to dry, the saturated fibers crush and deform under compressive loads, evidenced by the similarly impacted timber elements that have since rotated and crushed under normal loading (Photo 4-1 and Photo 4-2). Conversely, the timber piles along the docks extend well above the waterline. The ends of the timber piles are safeguarded, covered by the protective enclosures housing the boat slips. This accounts for the lack of fungal rot in the timber piles along the three docks.

Photo 4-1: Dock C, Inshore Platform - Timber pile cap with severe section loss at its end due to rot.

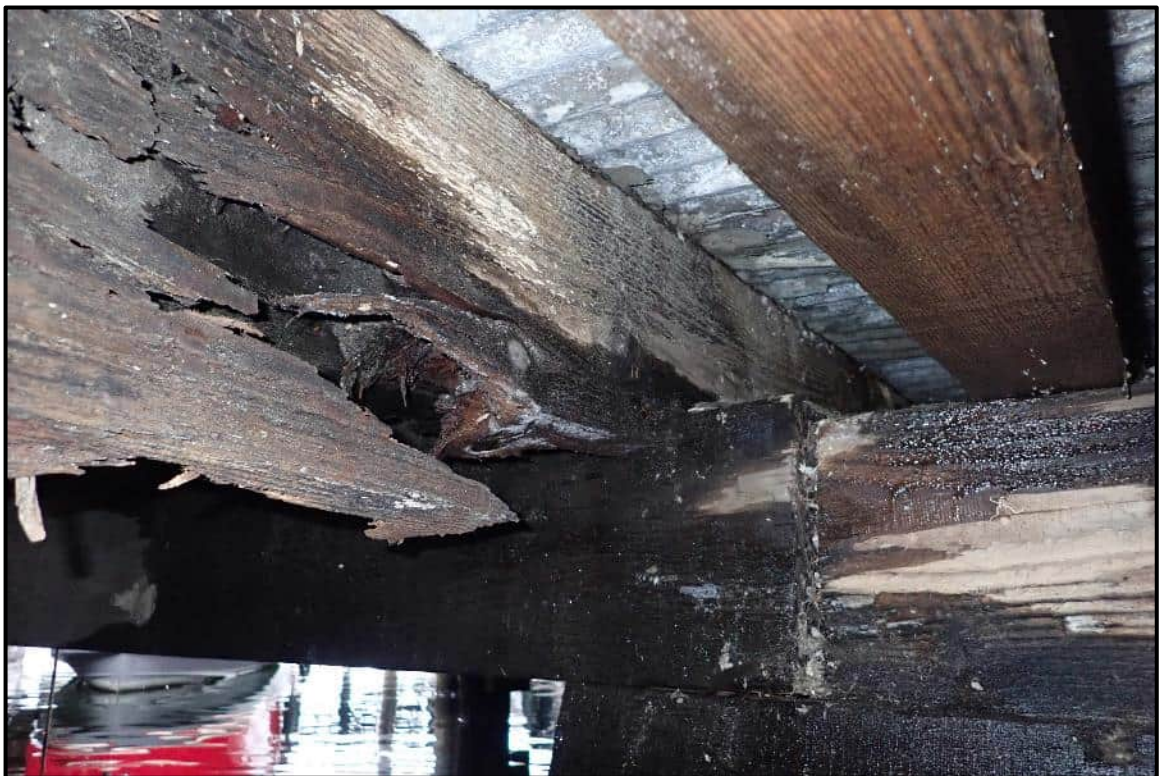
Photo 4-2: Dock C, Inshore Platform - Timber stringer crushing between the deck above and timber pile cap below due to rot.

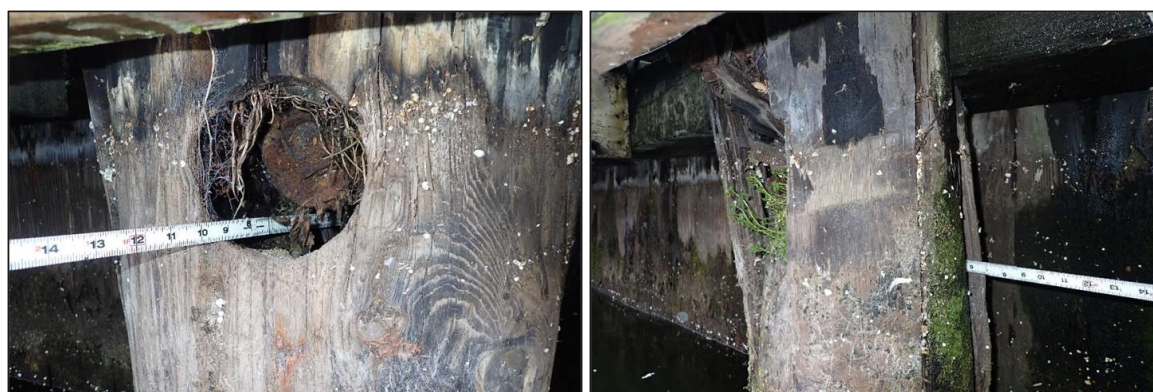
Structure	Bent	Row	Deterioration Length (in.)	Pile Repair	Top Connection
Bulkhead	3	-	60	Timber post w/timber fish plates (see Figure 7)	Section H
Bulkhead	4	-	24		Section H
Bulkhead	10	-	24		Section H
Bulkhead	17	-	36		Section H
Bulkhead	23	-	36		Section H
Dock C	4	A.5	30	12" x 12" timber block (see Figure 7)	Section B
Dock C	5	A.5	6		Section B
Dock C	5.5	C	12		Section B
Dock B	Wavescreen	-A.25	24	Timber post w/timber fish plates (see Figure 7)	1 " dia. thru bolt

**Figure 5 – Photos of bulkhead connections showing section loss (due to fungal rot)**

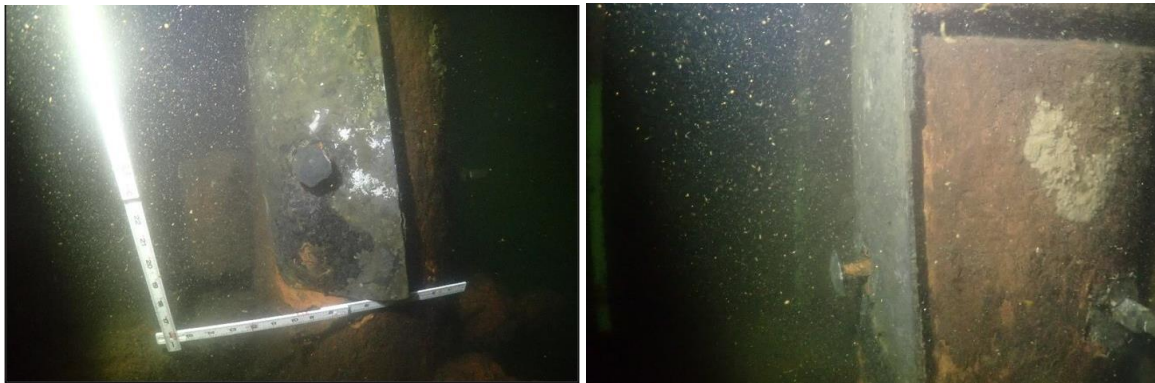
- II. Replacement of severely corroded connection hardware at six locations along the wave screen (see Figure 8 showing the current condition):

**Figure 8 – Photos of severely corroded connection hardware at the wave screens.**

Structure	Bent	Row	Repair
Dock B	Wavescreen	A'.5	Furnish and install 1 " dia. bolt, and install new timber fish plates (see Figure 9)
Dock B	Wavescreen	A'.25	
Dock B	Wavescreen	A.3	
Dock B	Wavescreen	B.2 BAT	
Dock B	Wavescreen	C.3	
Dock B	Wavescreen	C.9

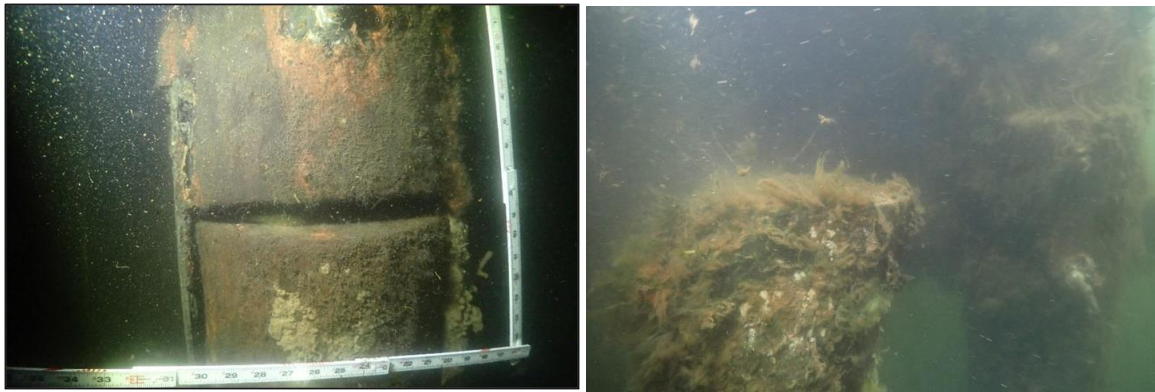
III. Restoration of bearing at the pile/post interface at six locations along the wave screens (see Figure 10 showing the current condition):

**Figure 10 - Photos of the pile/post interface at the wave screens**

Structure	Bent	Row	Repair
Dock B	Wavescreen	A'.5	To receive new fishplate repair (above), - only installation of Shims (see Figure 11)
Dock B	Wavescreen	A.3 BAT	Restoration of bearing (see Figure 11)
Dock B	Wavescreen	B.2	To receive new fishplate repair (above), - only installation of Shims (see Figure 11)
Dock B	Wavescreen	C.3	
Dock B	Wavescreen	C.9	
Dock B	Wavescreen	D.25 BAT	Restoration of bearing (see Figure 11)

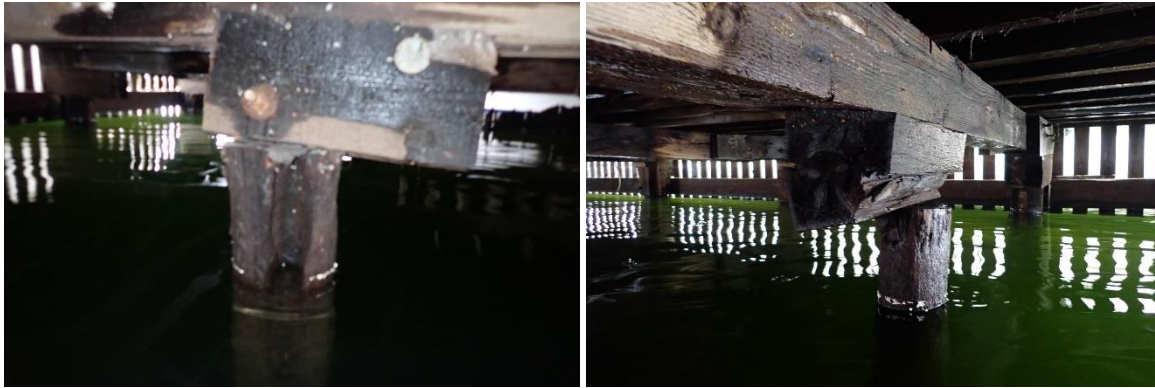
- IV. Replacement of crushed/rotating timber pile caps above three timber piles under the inshore platform at Dock C (see Figure 12 showing the current condition, and see Figure 13 for the repair schematic)).

Figure 12 – Photos of the timber pile caps at the inshore platform of Dock C

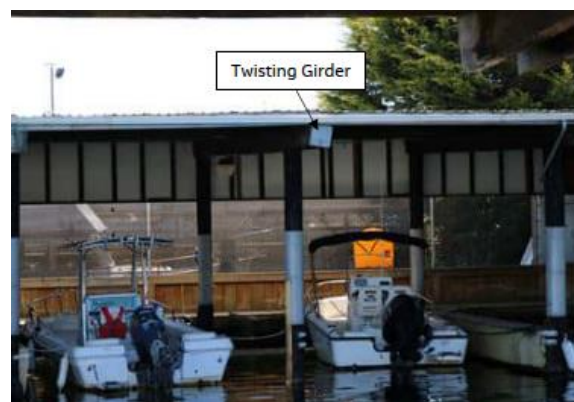
There are locations, especially at the exposed girder ends or at locations of roof leaks where water intrusion is occurring. Some girders have large horizontal splitting and others are twisting intermittently throughout the three docks. Some timber piles exposed to the weather are showing signs of the creosote leaching out of them.

Figure 17 – Example of Twisting Members

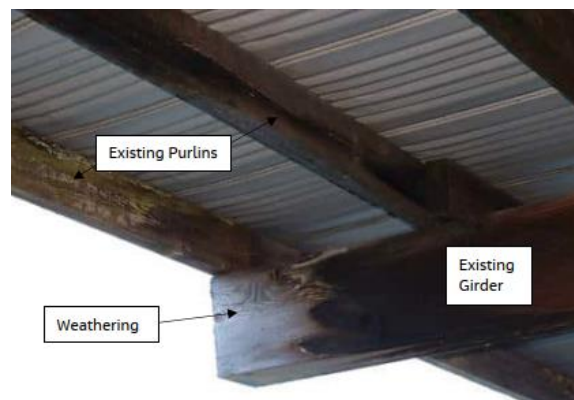
Figure 18 – Example of Weathering at Exposed Ends of a Girder

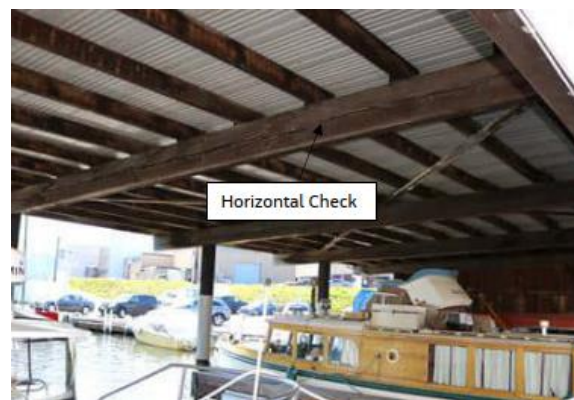
Figure 19 – Example of Large Horizontal Checks in a Girder

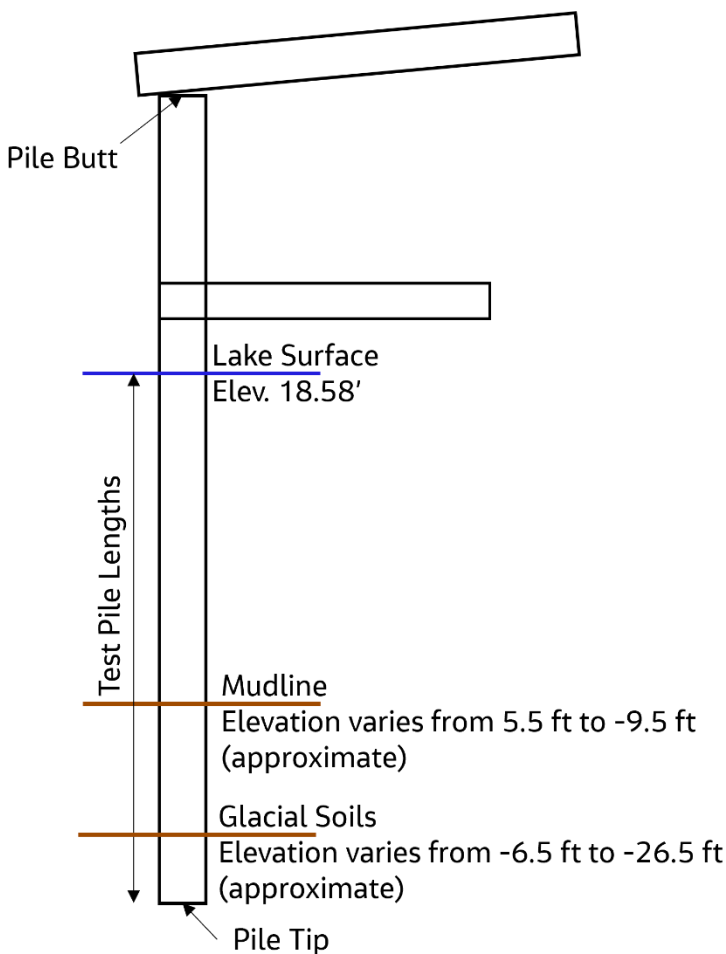
**Figure 7 – Illustration of the Original Test Piles (Datum is NAVD 88 for All Elevations)**

Preliminary analysis shows that the existing piles are structurally deficient for supporting a new roof. New materials will be required if the roof is replaced. See the Feasibility Assessment Report, Jacobs 2024, for the preliminary analysis results.

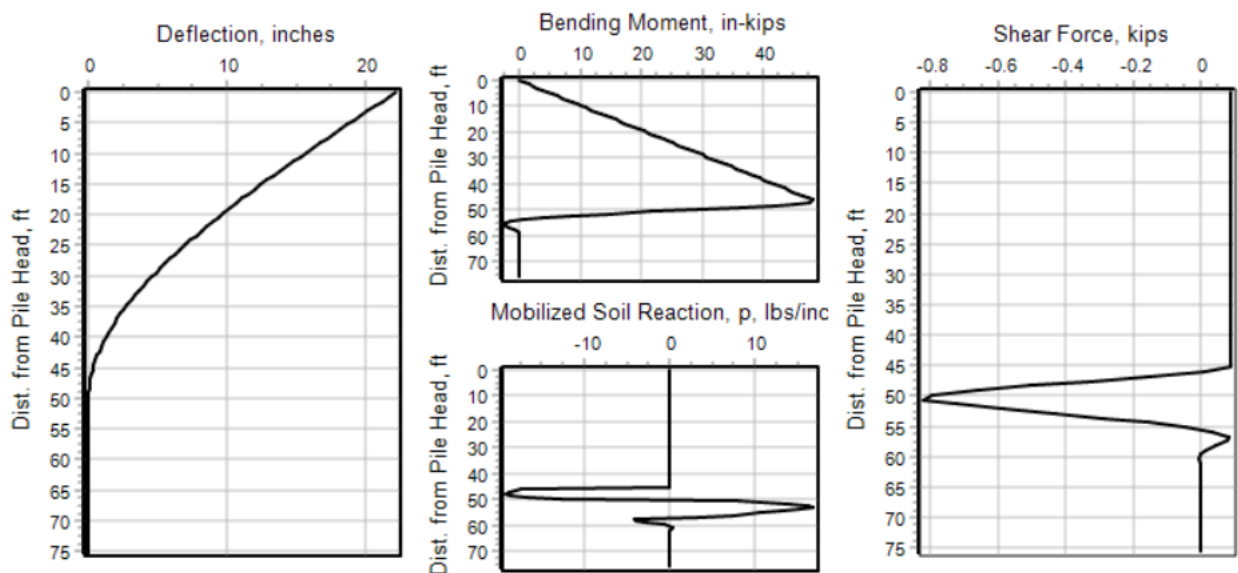
Figure 6 - LPILE Results

Lateral spreading controls demands with a maximum moment of approximately 50 kip-ft. For the existing 8" diameter timber piles, the lateral spreading causes a stress of approximately 12,000 psi. From an NDS timber capacity analysis, the piles can handle a bending stress of 3,240 psi. The existing piles are overstressed, with a D/C ratio of 3.7, noting that a D/C ratio exceed 1.00 is considered over capacity. This indicates that the existing piles will fail due to bending if a design seismic event occurs.

The LPILE analysis indicates that the existing timber piles may be embedded far enough into the solid soil to remain stable during a seismic event. But they will not withstand the bending forces that are caused by that same seismic event.
