# DUWAMISH

LOWER DUWAMISH RIVER HABITAT RESTORATION PLAN  
AN INVENTORY OF PORT OF SEATTLE PROPERTIES

ADOPTED PLAN, JULY 7, 2009

PREPARED BY  
**Seaport Planning Group**

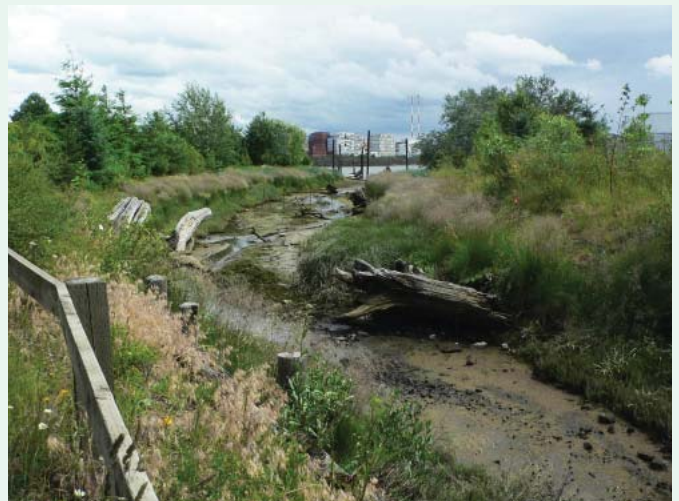
Existing restoration at terminal 105

The Terminal 105 restoration project was constructed in 1995 at approximately river mile 0.0. The aim of the project was to test how a restored estuarine habitat could be configured to fit industrial shoreline areas, without impeding important waterway access. The side channel intertidal habitat area is oriented perpendicular to the shoreline to provide essential environmental attributes without foreclosing industrial access to adjacent shoreline areas. Approximately 9,400 cubic yards of previously placed fill were removed to create a 0.6 acre intertidal channel approximately 1,300 feet in length. During construction, an underground fuel tank and a buried vault filled with paint cans and solvent wastes was discovered and removed. Following grading, the restoration site received 0.3 acres of native riparian trees and shrubs and more than 1,100 marsh plants. All site vegetation work was accomplished by community participants. The restoration project is illustrated at low tide in the photo above. Note the extent of tidal influence indicated by the wetted bank line. The site is inundated twice daily by tidal water about five feet in depth. Today the site provides 210 feet of shoreline, a fishing pier, picnic tables and shelter and a launch for hand-carried boats.

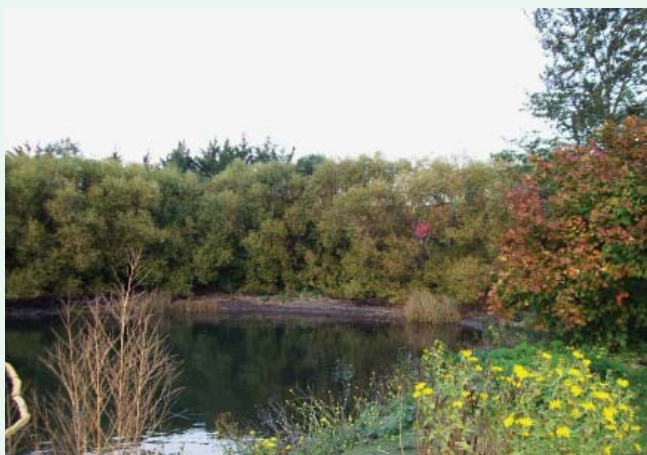
Existing restoration at terminal 108

Located at river mile 0.6, the Terminal 108 site consists of approximately 1.2 acres of combined public shoreline access and intertidal fish and wildlife habitat. The Port excavated approximately 0.6 acres of existing filled upland area in 1988 to create a 0.4 acre intertidal habitat restoration site, surrounded with approximately 0.2 acres of native riparian vegetation. This restoration project served as compensation for construction of a new container cargo pier in the East Waterway. The restored intertidal mud/sand substrate and emergent and riparian vegetation at Terminal 108 offset the disruption of approximately 0.4 acres of low intertidal and shallow subtidal industrial bulkhead area in the East Waterway. The restored site produces seven to nine times more invertebrate food prey items, essential to juvenile migratory fish, than the site altered by the cargo pier construction. In addition, the restored fish and wildlife habitat area is surrounded by public use improvements, allowing citizens to benefit from the restored riparian area, which replaced a formerly paved industrial area.

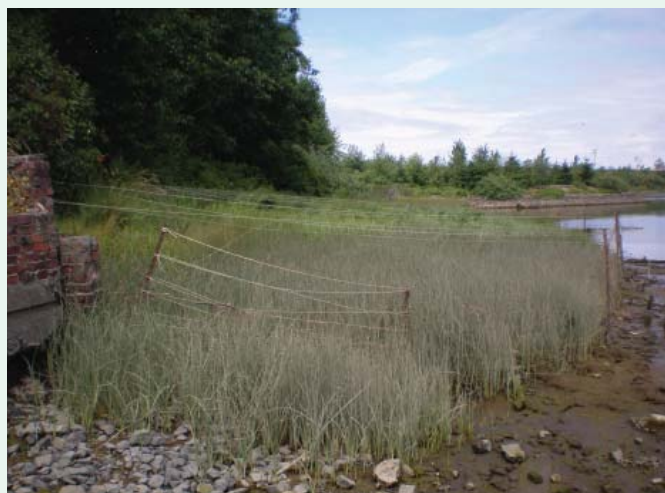
Existing restoration at terminal 107

Located along the west margin of one of the two historic discharge channels for the Duwamish River, the Terminal 107 site represents one of the least disturbed shoreline areas in the present Duwamish Waterway. Completed in 2000, the Port improved approximately 7.2 acres of upland area by removing previous industrial,

commercial and residential structures, including 4,500 tons of concrete debris. The Port also constructed 0.3 acres of intertidal habitat at a former auto wrecking yard located on the south margin of the site through removal of 5,500 tons of fill. Approximately 20,000 square feet of marsh area was also restored, demonstrating successful establishment of marsh vegetation in an aquatic area that was formerly absent of emergent vegetation. Currently the Terminal 107 public shoreline access site includes approximately 1,100 linear feet of shoreline and 1,400 linear feet of pathways, with shoreline viewing areas. The north end of the terminal is adjacent to a 1.8 acre habitat restoration area, Herring's House, which was constructed in 2001 by the City of Seattle.

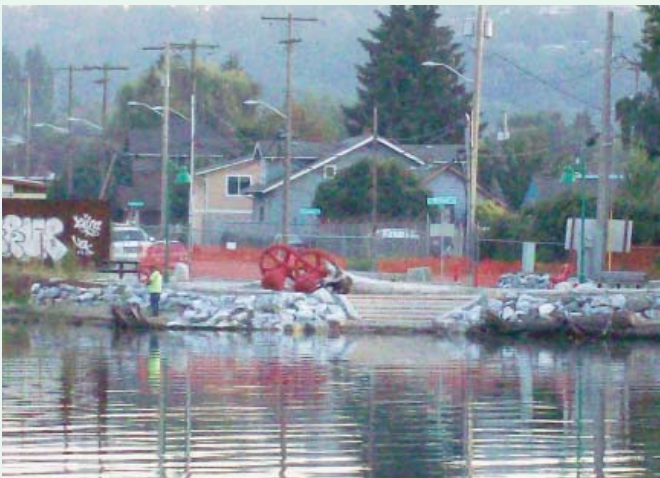
Existing restoration at Portland Street

The Port constructed 17,000 square feet of public shoreline access northeast of the South Portland Street/Eighth Avenue South intersection in the summer of 2008. The site included approximately 345 linear feet of eroding, rubble-filled bank line prior to regrading. The finished site includes an upland public use area with seating, tables and steps to the water line. Upland improvements are complemented by marsh vegetation, native riparian vegetation and large woody debris, demonstrating application of non-structural shoreline stabilization techniques. The downstream, (north) end of the recently completed Eighth Avenue/South Park public shoreline access site includes additional opportunity

for fish and wildlife habitat restoration. The port is working with the Seattle Department of Transportation and Seattle Public Utilities, using funds provided by the Washington Department of Transportation, to plan and design approximately 9000 square feet of marsh and riparian restoration area. This restoration opportunity combines public right-of-way in South Riverside Drive with port-owned bank line and would provide important fish and wildlife habitat as well as a landscape complement to the upstream, adjacent existing public shoreline use area.

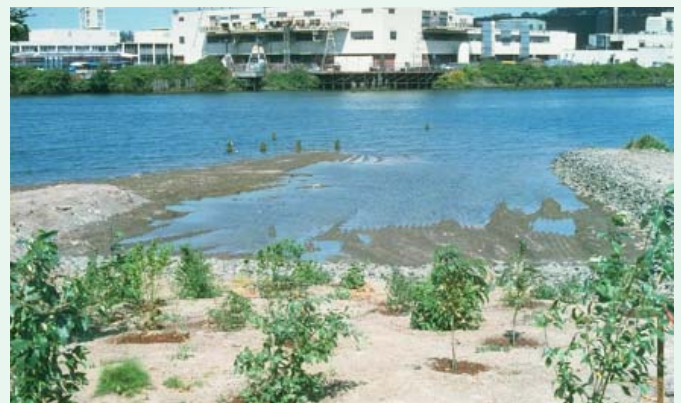
Existing Restoration at turning basin number 3

were established. Intertidal marsh plantings and native riparian shrubs and trees were well developed at the restoration site three years following completion of excavation and grading. Note the fence structures in the intertidal area. Once mature, the marsh plants will withstand waterfowl predation.

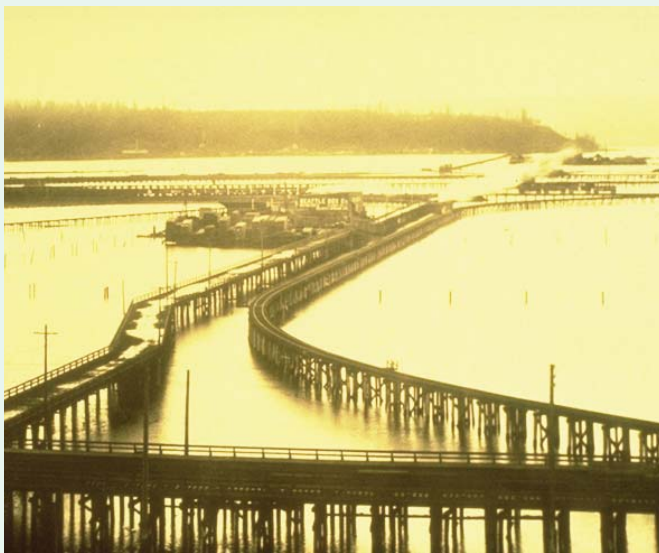
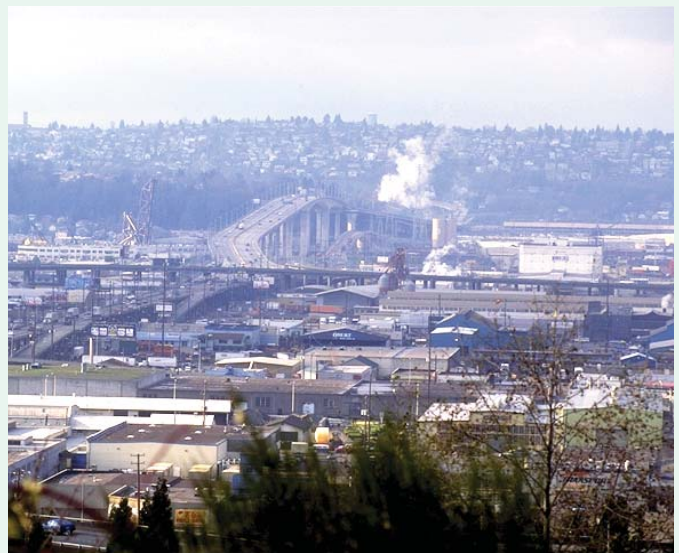
**FIGURES 3 (L) AND 5 (R).** DEPICT A WESTERLY PERSPECTIVE OF THE SPOKANE STREET CORRIDOR IN 1898 AND 1998

The Duwamish River is the name of the lower 12 miles (19 km) of Washington State's Green-Duwamish River System. The Green River mainstem is one of the most hydrologically altered large river systems in the Puget Sound ecosystem. In 1900 this entire estuary consisted of intertidal mud and sand flats, estuarine marsh, forested wetland and meandering shallow river channel (see Figure 2). The historic estuary included approximately 1,450 acres of intertidal sand and mud substrate, nearly 1,300 acres of intertidal marsh and approximately 1,450 acres of tidal swamp (or forested wetland). In addition, the meandering river channel included approximately 17 miles of riparian environment and estuarine floodplain. The combined intertidal and estuarine floodplain habitat area was approximately 5,300 acres. Figure 3 illustrates the extent of intertidal area in south Elliott Bay prior to large scale industrial development. Note piling supported rail lines and vehicle access to the west portion of south Elliott Bay.

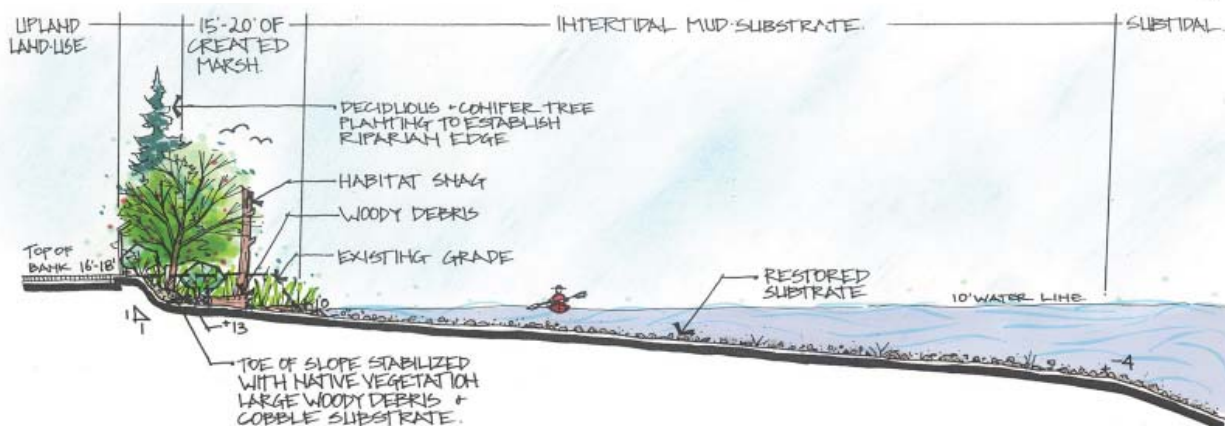
Marsh Bench Concept Section – Potential Restored Condition

other wildlife species. Marshes experience regular tidal inundation and include low marshes which are vegetated with aquatic vascular plants, and high marshes, which are vegetated with aquatic vascular plants and terrestrial plants.

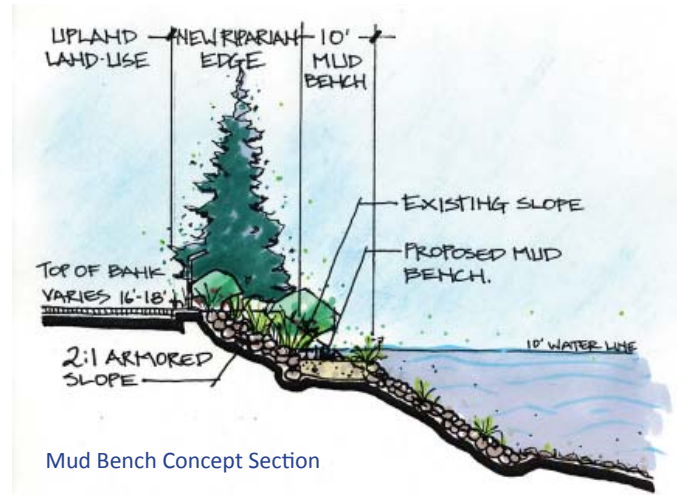
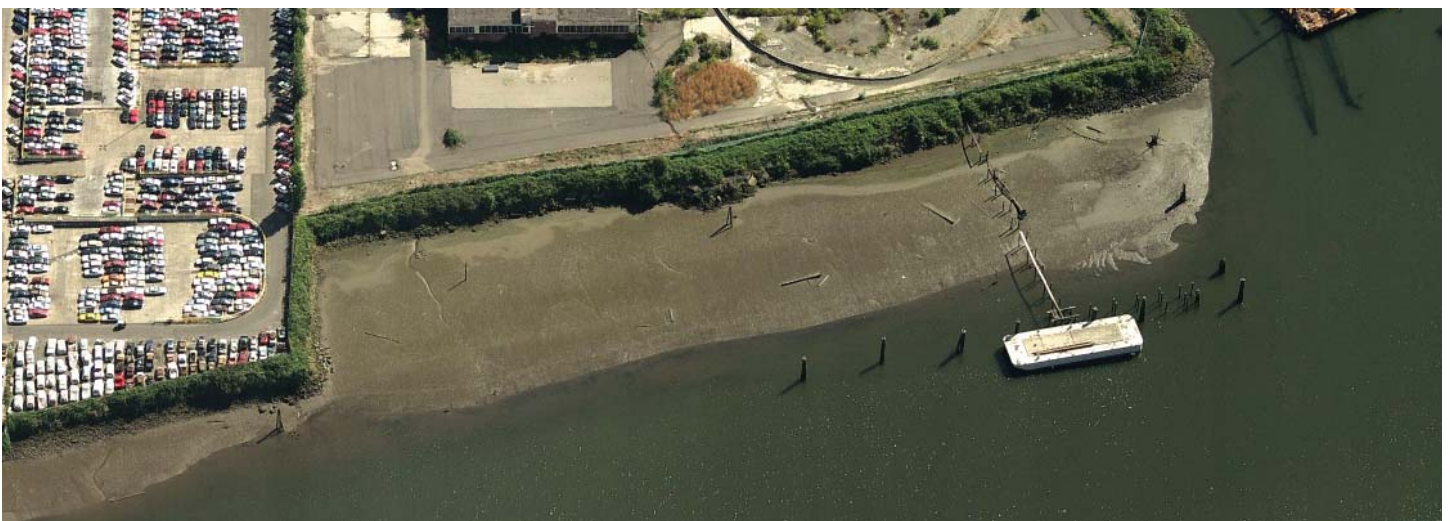
Because of the navigational use of the river, most mudflat restoration projects would involve excavation of the existing bank to create the appropriate tidal elevations. Where appropriate elevations already exist, less extensive bank cutting and regrading would be needed. In some locations a combination of bank cutting and filling in lower elevations would be needed to achieve the required mudflat elevations.

Existing mudflat at (River Mile 4.2)

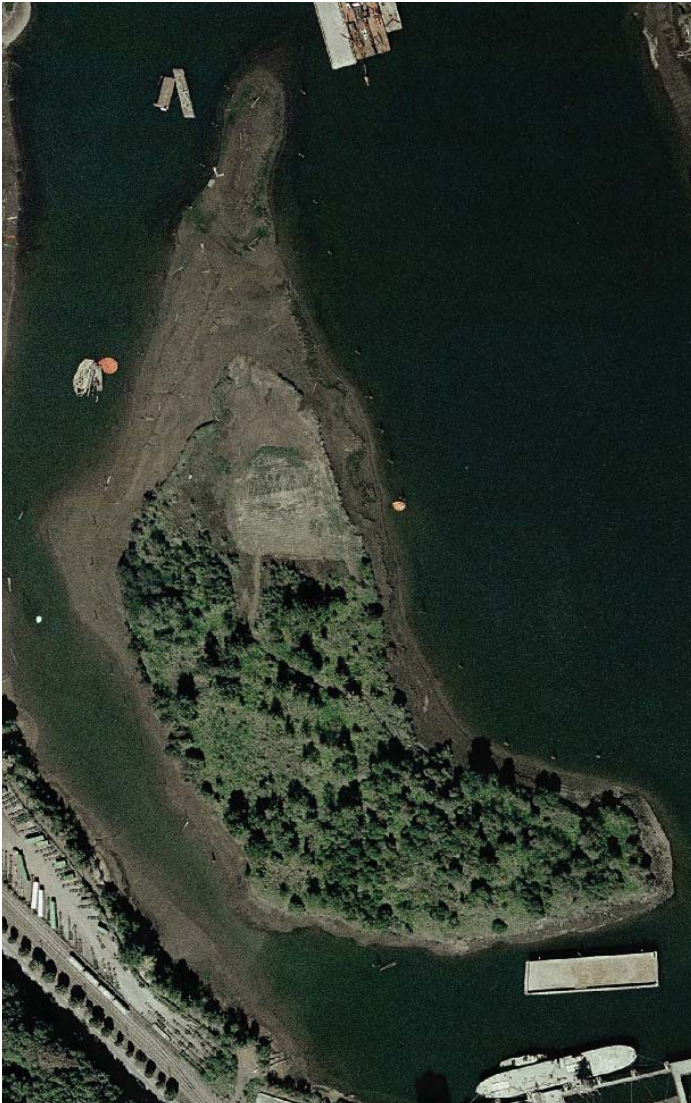
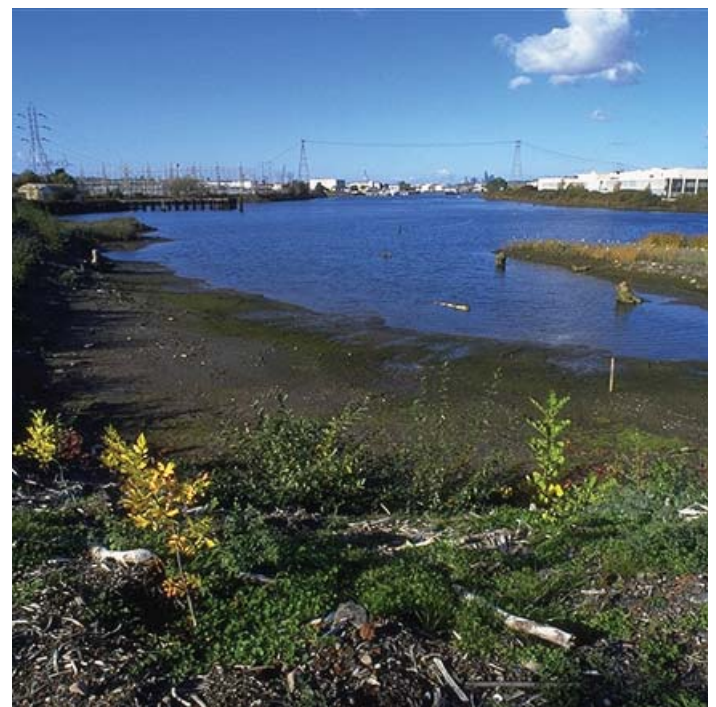
Hubs are large, well established habitats that tend to have a greater degree of long-term variability and stability than smaller habitats. Greater variability and stability increase the ability of the overall system to withstand and recover from disturbances (resistance and resilience). Although most potential restoration sites within the Lower Duwamish are too small to be considered true hubs by most ecologists, Kellogg Island and Turning Basin Number 3 likely serve in many ways as habitat Hubs in the Lower Duwamish due to their large size. These two sites, enhanced and expanded, could serve as habitat anchors, providing fish and other wildlife with abundant and diverse refuge and feeding areas.

Kellogg Island (above) and Turning Basin #3 (right) are existing habitat hubs that could be expanded and enhanced

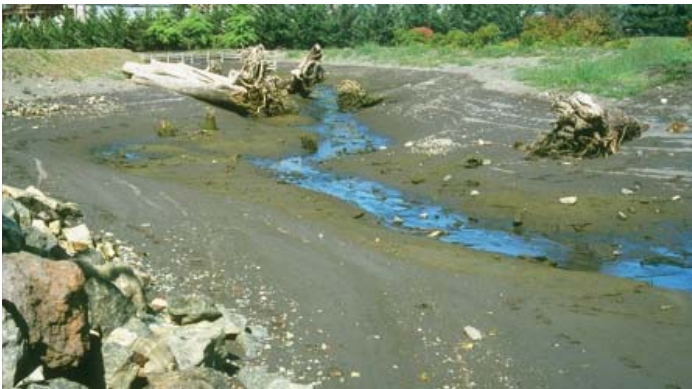
Pockets are small habitats. Although they provide habitat for fewer species and are less resistant to disturbances than larger ones, pockets still provide important habitat areas for wildlife and contribute to habitat continuity. Pockets are typically created at side channels, where the water has a chance to slow down and pool and where marsh vegetation or mudflats can be formed. Pools provide space, cover, and nutrition to fish as well as a place for fish to seek shelter during storms and other catastrophic events (Spence et al. 1996). Side channel mudflats also provide important resting areas for juvenile salmonids.

Restored pocket habitat at Terminal 105

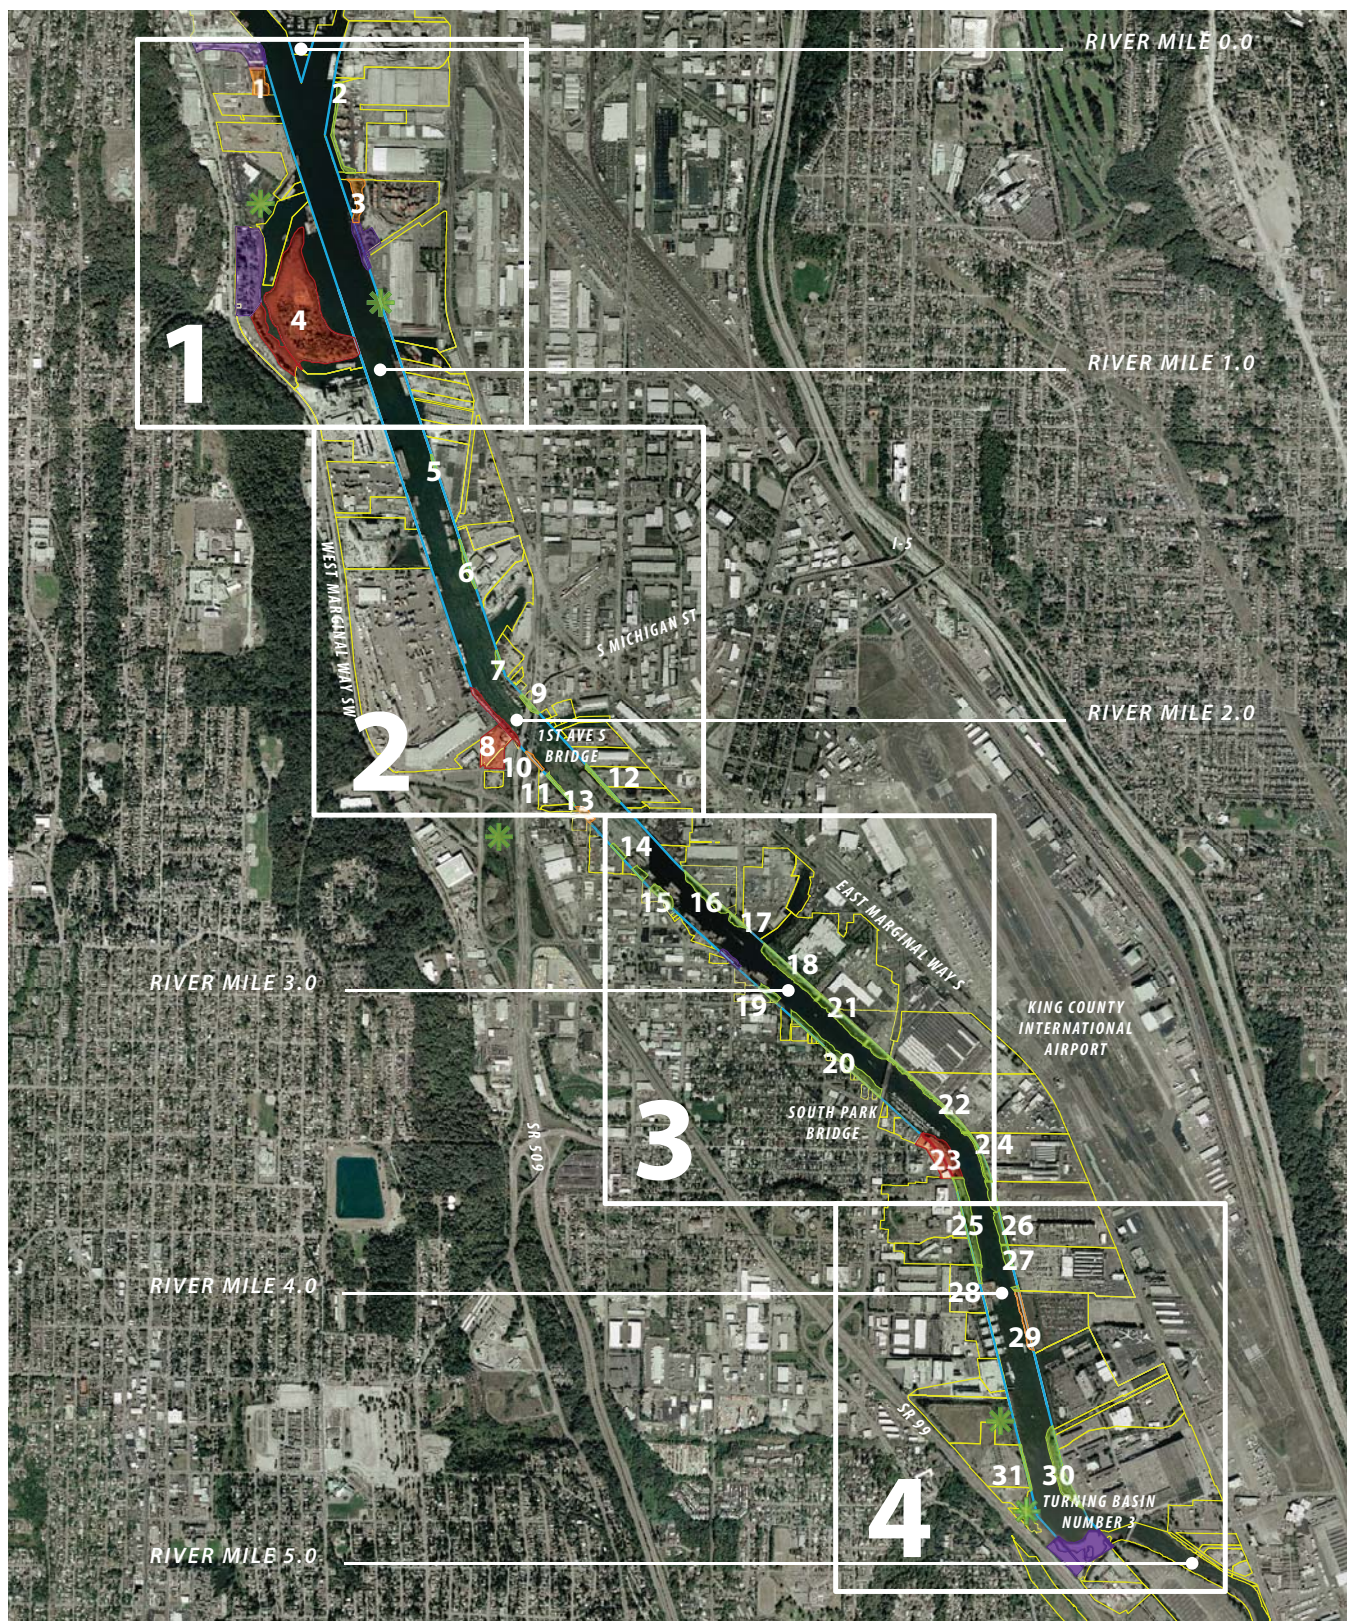
FIGURE 6. RESTORATION OPPORTUNITY SITE OVERVIEW

Individual opportunities described in this section outline the scope of potential restoration actions that could be constructed at particular sites, based on existing industrial use conditions and habitat features. Each of the habitat restoration opportunities are presented as a planning/concept design and apply to Port-owned shoreline and aquatic area property only. Subsequent site-specific design for particular sites will require detailed survey information, civil engineering/geo-technical analysis and additional biological analysis. In addition, all potential shoreline and aquatic area restoration sites will require soil and sediment contamination investigations. Soil and sediment characterization is essential in light of Superfund coordination and decision-making needs in the Duwamish Waterway. These site-specific evaluations, combined with habitat objectives identified for the location, will determine the dimension and extent of particular restoration actions.

Despite constraints, at least 31 viable restoration opportunities have been identified along the waterway on the Port of Seattle’s “ribbon” and terminal properties (Figure 6). The overall emphasis of the Plan is on maximizing the potential for restoring mudflats, marshes and riparian buffers on “ribbon parcels” and underutilized terminal areas.

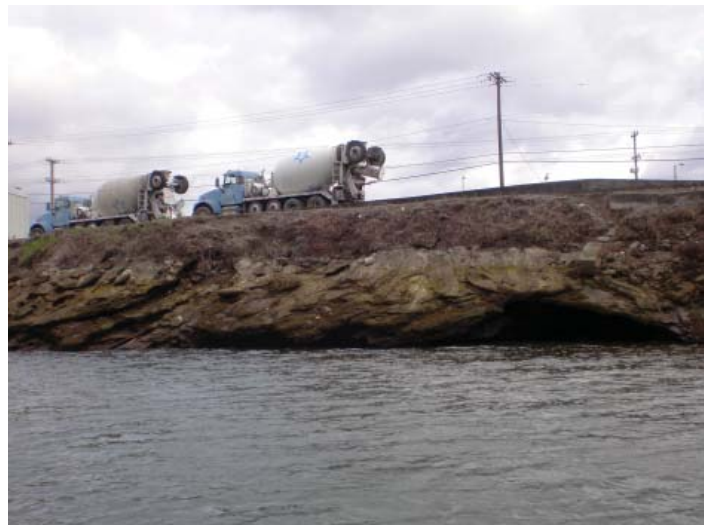
Artificially hardened and eroded bank at east side slip (River Mile 1.8)

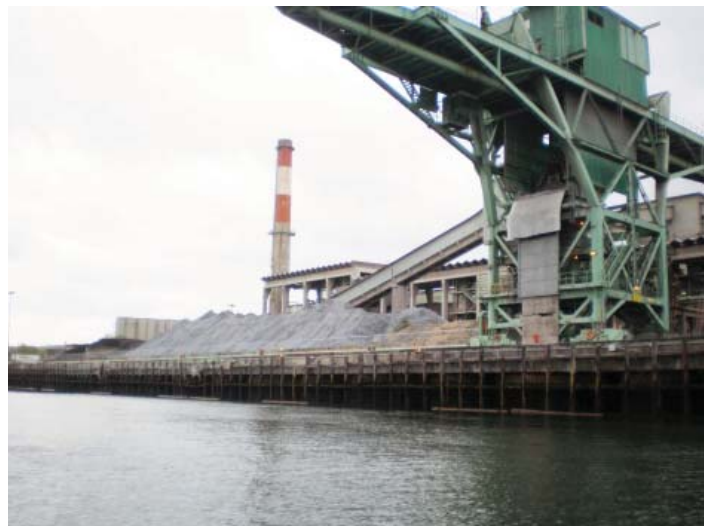
Large scale water-dependent, marine industrial pier facility (River Mile 1.0)

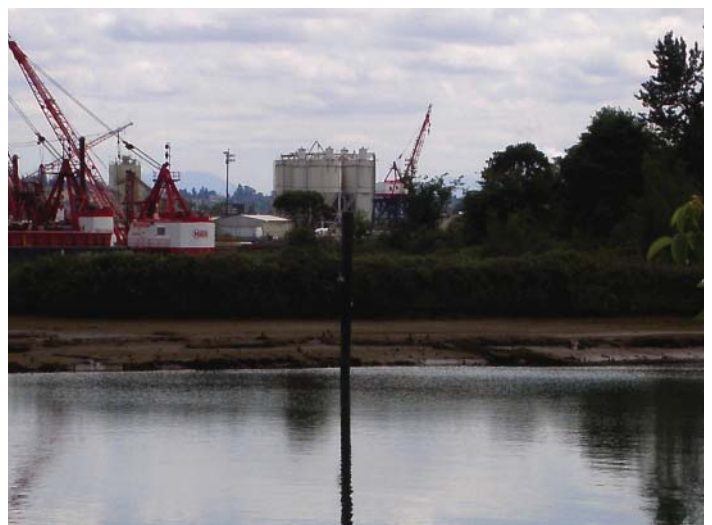
Currently the portion of the Duwamish Waterway adjacent to this site includes substantial exposed intertidal and shallow subtidal mud/sand substrate. Marsh vegetation was formerly abundant, but exists only in small pockets at present.

Potential restoration actions could include restoration of intertidal conditions in approximately 11.5 to 12 acres of the site. Previously placed dredged materials could be removed to expose sediments to tidal influence, between 10.5 and 13 feet MLLW. Emergent vegetation could also be installed throughout. Restoration actions could leave portions of the existing berm located at the east margin of the site in place to protect restored marsh areas from vessel-wake erosion. Large woody debris could be placed throughout the perimeter of the site as

Existing inter-tidal mud/sand substrate and marsh vegetation, Kellogg Island (River Mile 1.0)

- **Existing inter-tidal substrate and vegetation:** Kellogg Island includes approximately 1.2 acres, with approximately 4.3 acres between 11 to 13 feet MLLW and approximately 7.9 acres between 13 and 30-45 feet above MLLW. Area 11 to 13 feet above MLLW includes native and invasive marsh vegetation and riparian vegetation. Area above approximately 13 feet MLLW includes native and invasive upland vegetation. Area water-ward of existing berm includes native inter-tidal mud/sand substrate, with slope conditions approximately 10:1 throughout.

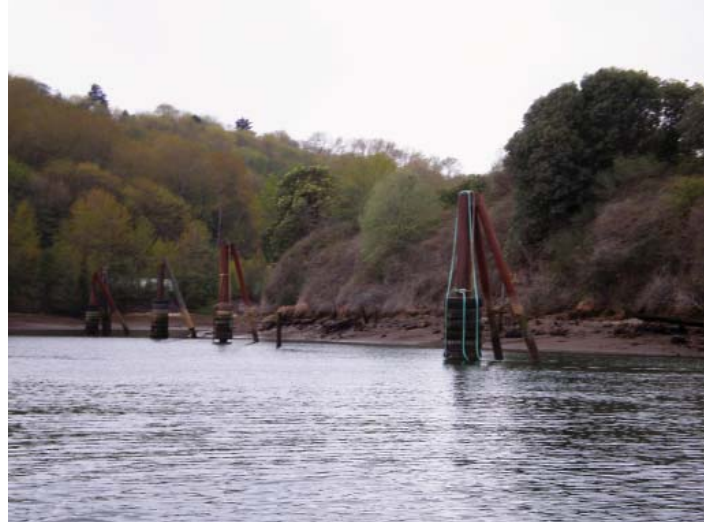
an additional substrate stabilization measure. Intertidal restoration at Kellogg Island could be guided by data describing site elevations and conditions prior to use as a dredged material disposal site. Removal of dredged sediments from the site may require excavation below 10.5 feet MLLW in some locations, due to the compression of underlying native sediments. Emergent and riparian plantings at the site could make the greatest possible use of the re-exposed native sediments. However, placement of additional fine grained sediments may be required to obtain appropriate elevations following removal of stock-piled dredged materials.

South Kellogg Island, illustrating existing dredged material site, with shoreline vegetation established at upper edge of dredged material deposit. Note barge moorage dolphins in adjacent sub-tidal area (River Mile 1.0)

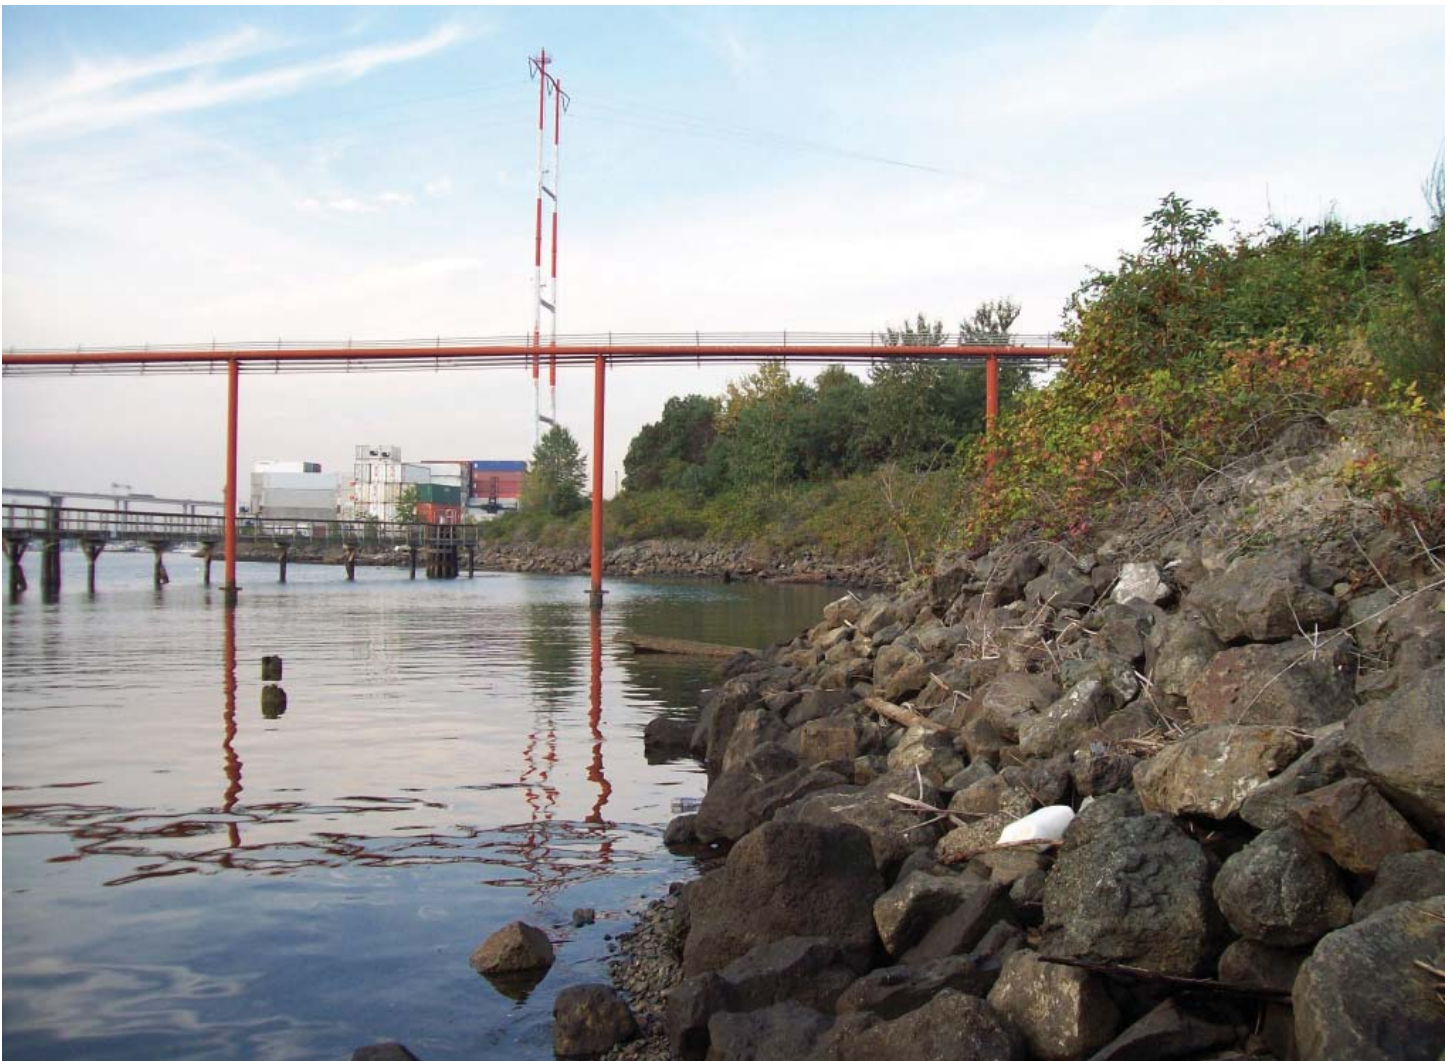
Terminal 108, riprap bank line, illustrating potential marsh and riparian vegetation pocket restoration site (River Mile 0.5)

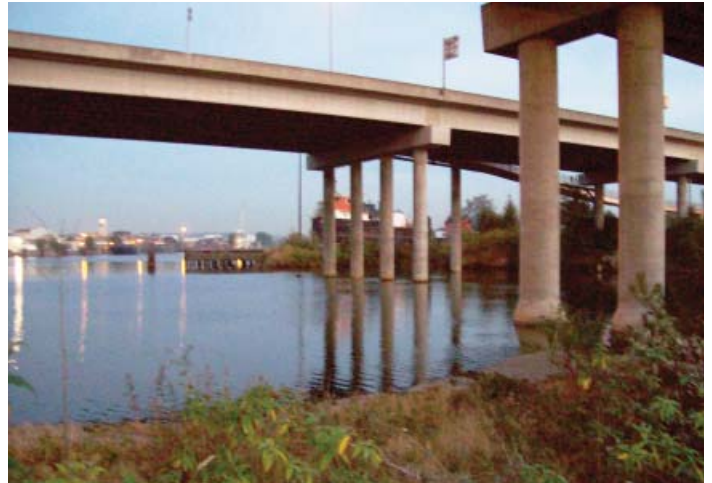
West bank line, First Avenue South Bridge, illustrating substantial habitat restoration opportunity, including partnership with City of Seattle (River Mile 2.1)

Currently, this site has a moderate area of unobstructed intertidal and shallow subtidal substrate. The upper and intertidal bank line consists of riprap and rubble, with an unstable and eroding intertidal slope. No riparian or marsh vegetation is present. Potential restoration actions could include excavation and regrading of approximately 75 linear feet of an existing riprap/rubble bank line to form a 3:1 slope bank line suitable for placement of native riparian vegetation. A top-of-bank berm could also be installed to eliminate surface water flow over top-of-bank and large woody debris, at an elevation of approximately eight to 12 MLLW, could be installed as toe-of-slope stabilization measure. Large woody debris could extend approximately 100 feet north along the Port-owned waterway boundary, across high intertidal portions of previously constructed WDOT restoration site. Approximately 175 linear feet of improvement is available at this site.

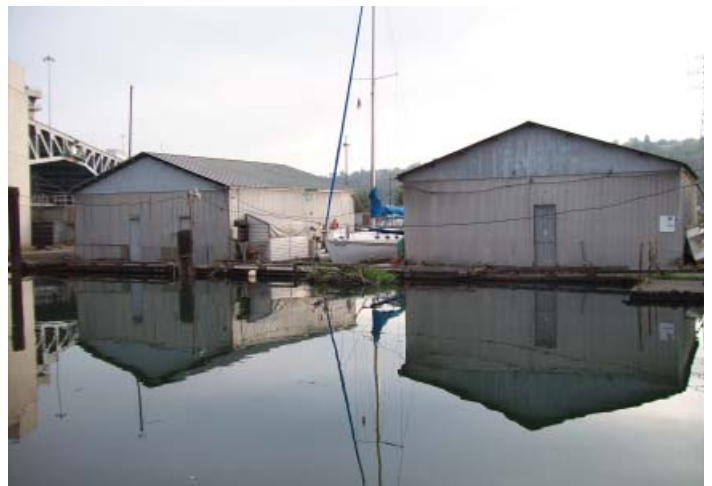
First Avenue South Bridge, illustrating potential restoration area between top-of-bank and floating moorage (River Mile 2.0)

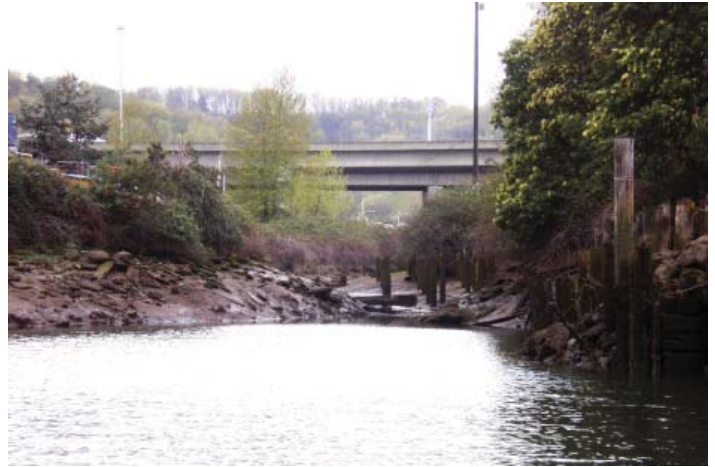
The Port is supportive of collaboration with adjacent property owners on restoration of the existing side channel at river mile 2.4 near Orchard Street and the 1st Avenue S Bridge to create high-functioning habitat pockets. Project 13 is located at the southeast corner of the existing side channel noted here. The side channel, approximately 525 feet long and including approximately 0.9 acres of intertidal sand/mud substrate, includes Port property in the approximately 160 feet wide inter-tidal area where the side channel joins with the Duwamish Waterway. Future clean-up and restoration in this area would provide significant fish and wildlife habitat attributes. Restoration at this site would require project coordination and partnership between the Port, private property owners, and, potentially, the City of Seattle, if the margins of adjacent public right-of-way areas were included in a potential restoration action.

Existing side channel, intertidal pocket, west shoreline, (River Mile 2.4). This area is located between projects 11 and 13. IT illustrates a potential restoration opportunity involving private property owners and the Port.

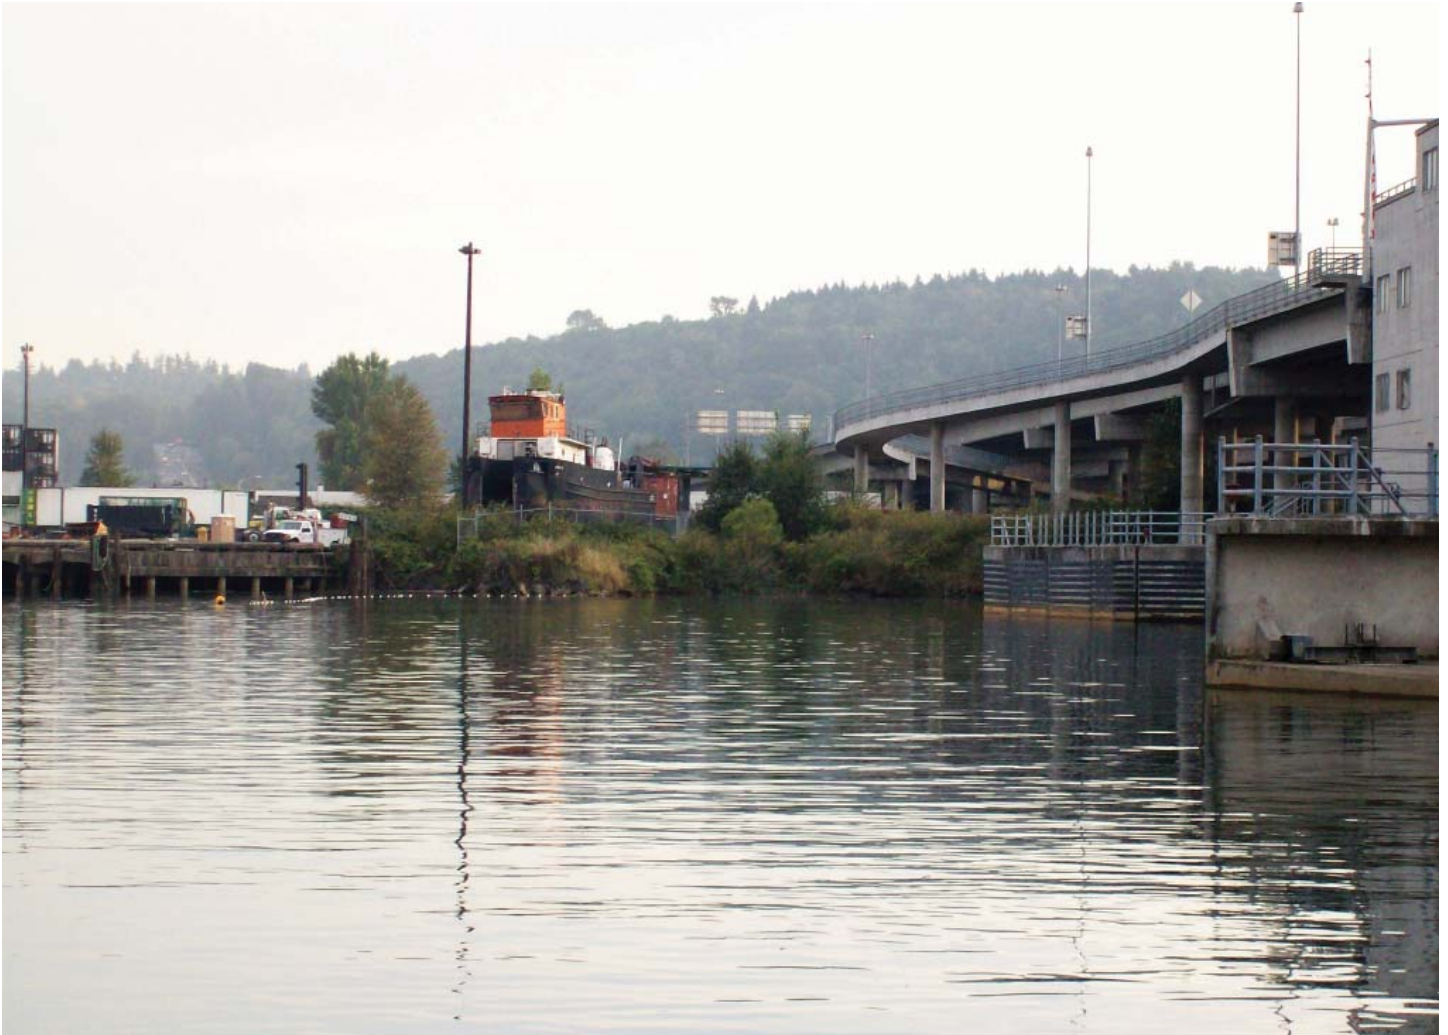
Illustrating potential habitat restoration noted in Site 11 and Site 12 descriptions.  
Note fishing net at center left, indicating active treaty tribe fishing access in Duwamish Waterway

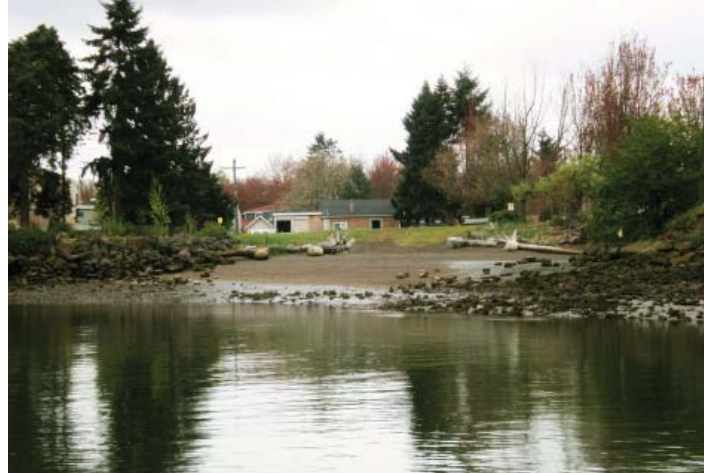
Existing Duwamish Waterway Park, illustrating continuing community effort to improve shoreline access and shoreline habitat (River Mile 3.1)

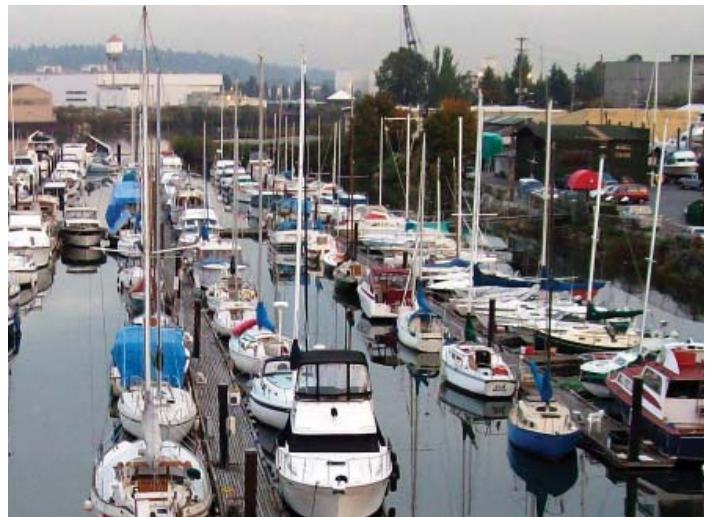
South Park Marina, illustrating over-water coverage (River Mile 3.5)

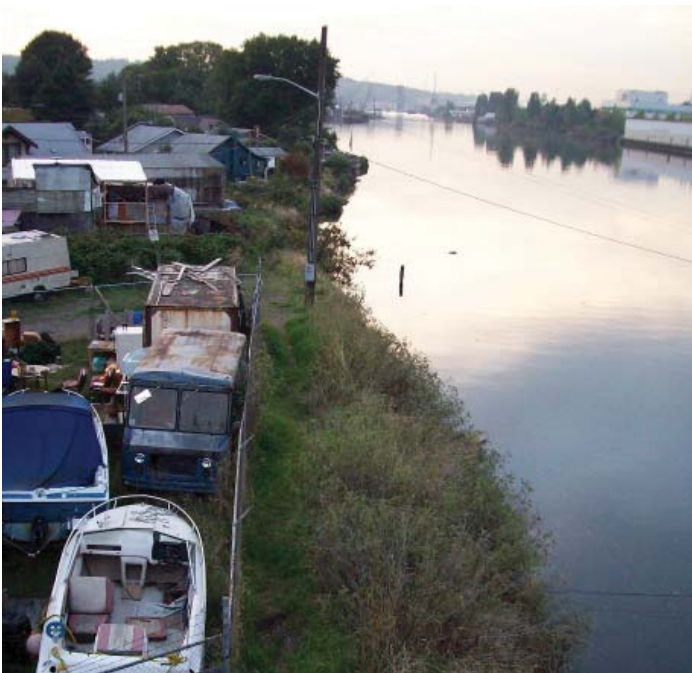
Illustrating South Park neighborhood/street-end restoration potential (River Mile 3.3)

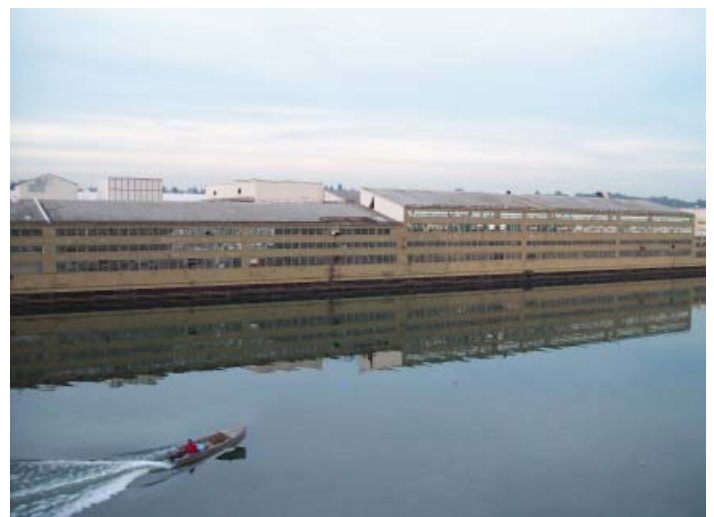
Illustrating industrial building edge of waterway and potential for partnership restoration action with Boeing (River Mile 3.5)

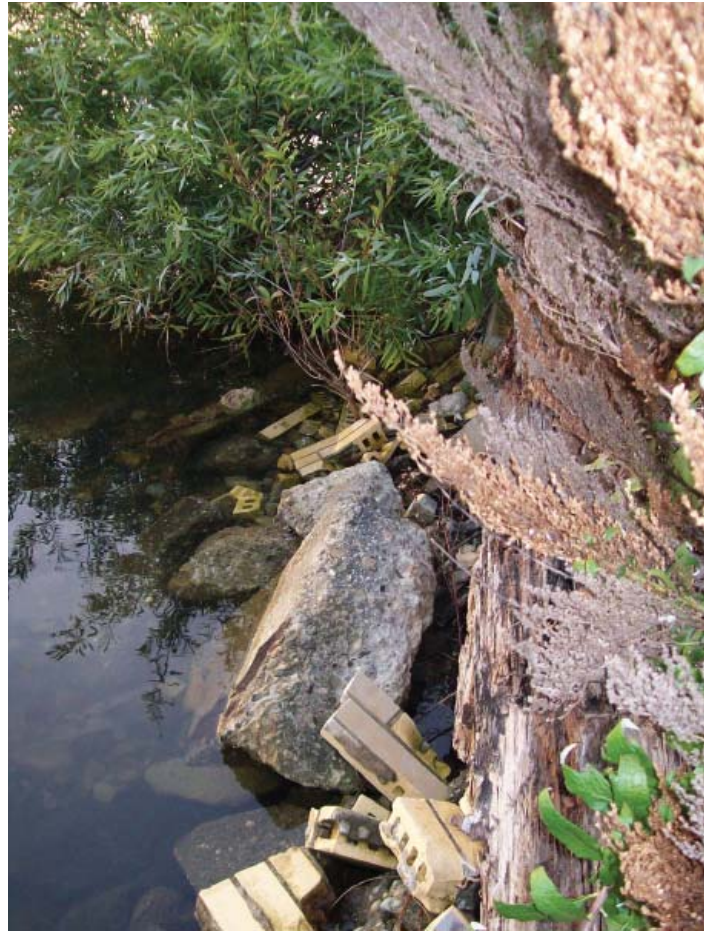
upper photograph: Existing rubble and industrial fill shoreline edge at Eighth Avenue South

This site currently has comparatively abrupt intertidal and shallow subtidal slopes, with a rocky/cobble substrate. No over water structures are present and no riparian or marsh vegetation is present. Potential restoration actions could include excavating and regrading of the Port-owned bank line and narrow upland strip to remove rubble and re-shape the profile. Native riparian vegetation could be planted from 13 feet to 20 feet MLLW. The top-of-bank could be moved landward approximately five to 10 feet. Riparian vegetation could provide a native shoreline feature at the northwest corner of Slip 4. Approximately 100 linear feet of bank line is available for improvement at this site.

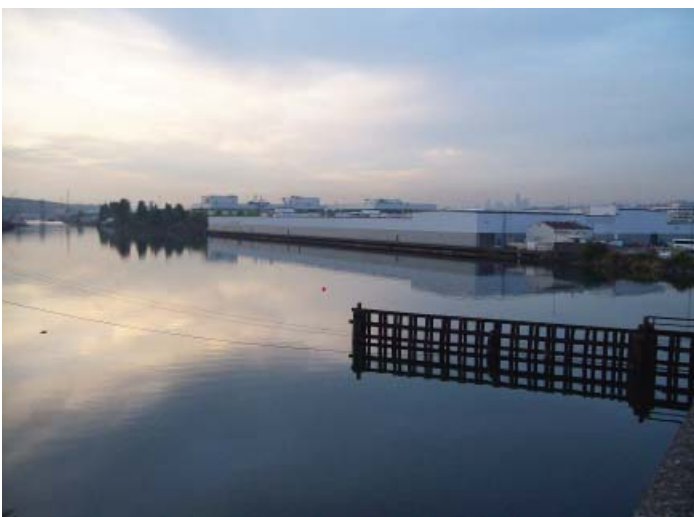
Illustrating potential habitat restoration at Project 22 site, with the potential for substantial expanded habitat in partnership with upland property owner (River Mile 3.5)

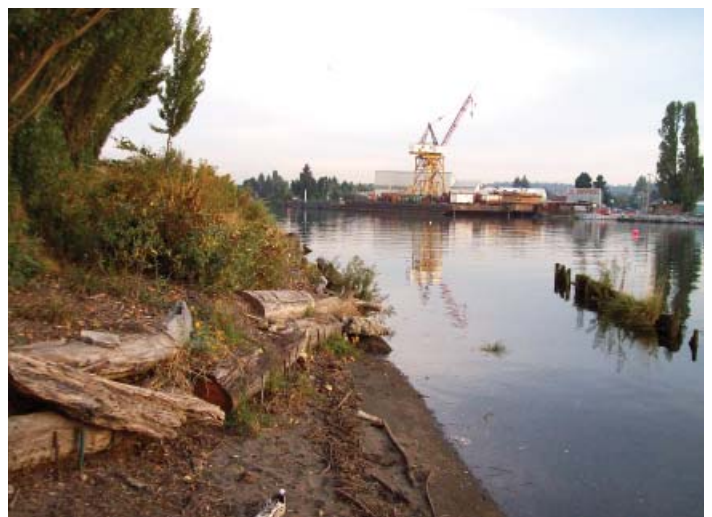
Existing Georgetown Eighth Avenue South street-end, illustrating potential partnership restoration opportunity with City of Seattle (River Mile 2.8)

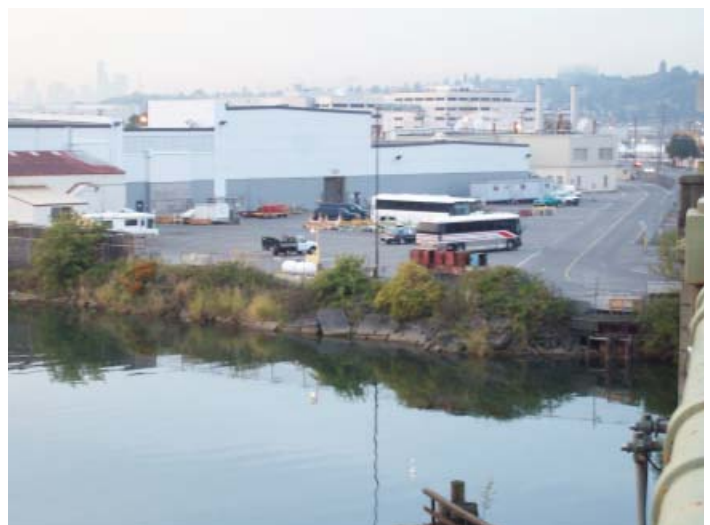
Illustrating present bank line conditions at River Mile 3.5, east bank line (refer to Project 22)

The margin of this site currently consists of a piling supported industrial building. Intertidal conditions extend beneath the structure and over-water coverage extends east of Port ownership area. However, no over-water structures present, in Port-owned aquatic area. Substantial intertidal and shallow subtidal exposed sand/mud substrate is present. However, no riparian or marsh vegetation is present. Potential restoration actions could include installation of continuous large woody debris, placed between plus two and four feet MLLW. Large woody debris serves as intertidal enhancement and protects adjacent upland structure from vessel wake energy. Approximately 1,100 linear feet of exposed sand/mud substrate is available for improvement at this site.

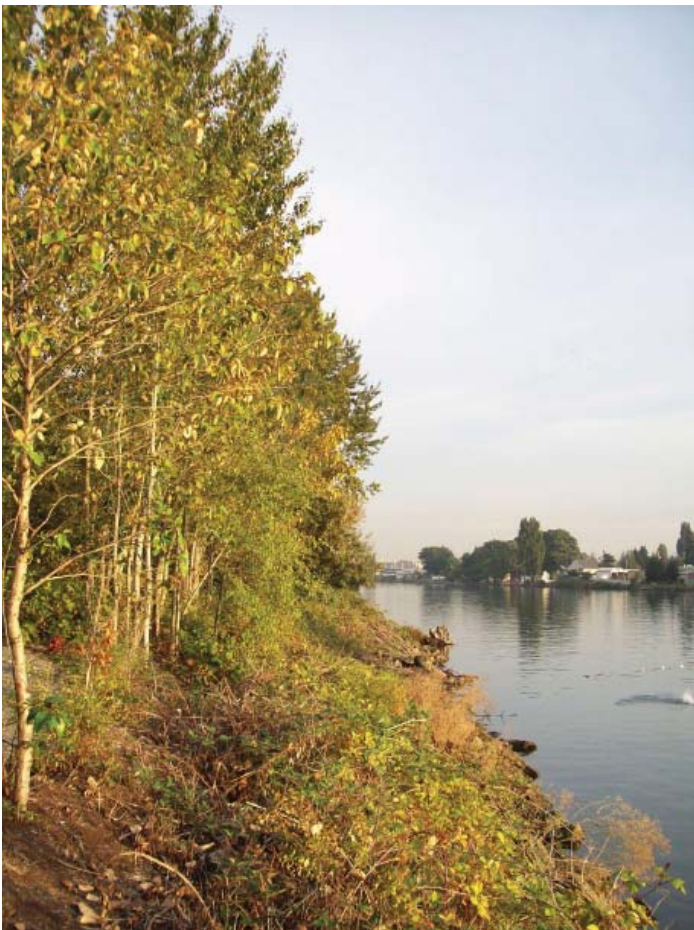
Project Site 18, illustrating existing vegetated top-of-bank. Note active Treaty fishing access at right margin of image

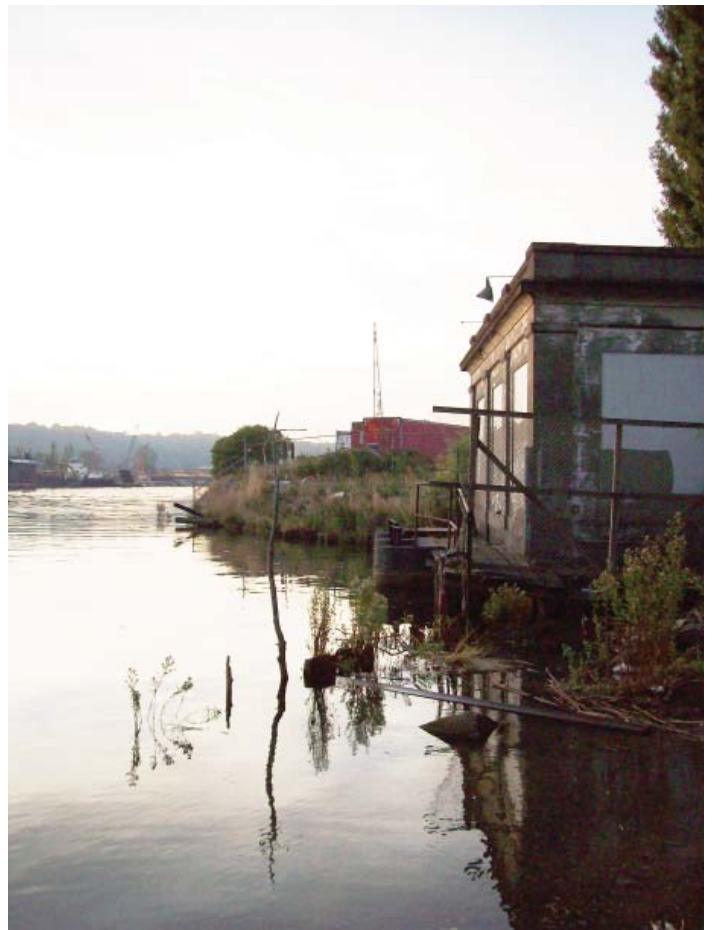
East bank line of waterway, including Eighth Avenue South street end, illustrating corridor and habitat pocket restoration potential in partnership with City of Seattle (River Mile 2.8)
