# DUWAMISH

LOWER DUWAMISH RIVER HABITAT RESTORATION PLAN  
AN INVENTORY OF PORT OF SEATTLE PROPERTIES

ADOPTED PLAN, JULY 7, 2009

PREPARED BY  
**Seaport Planning Group**

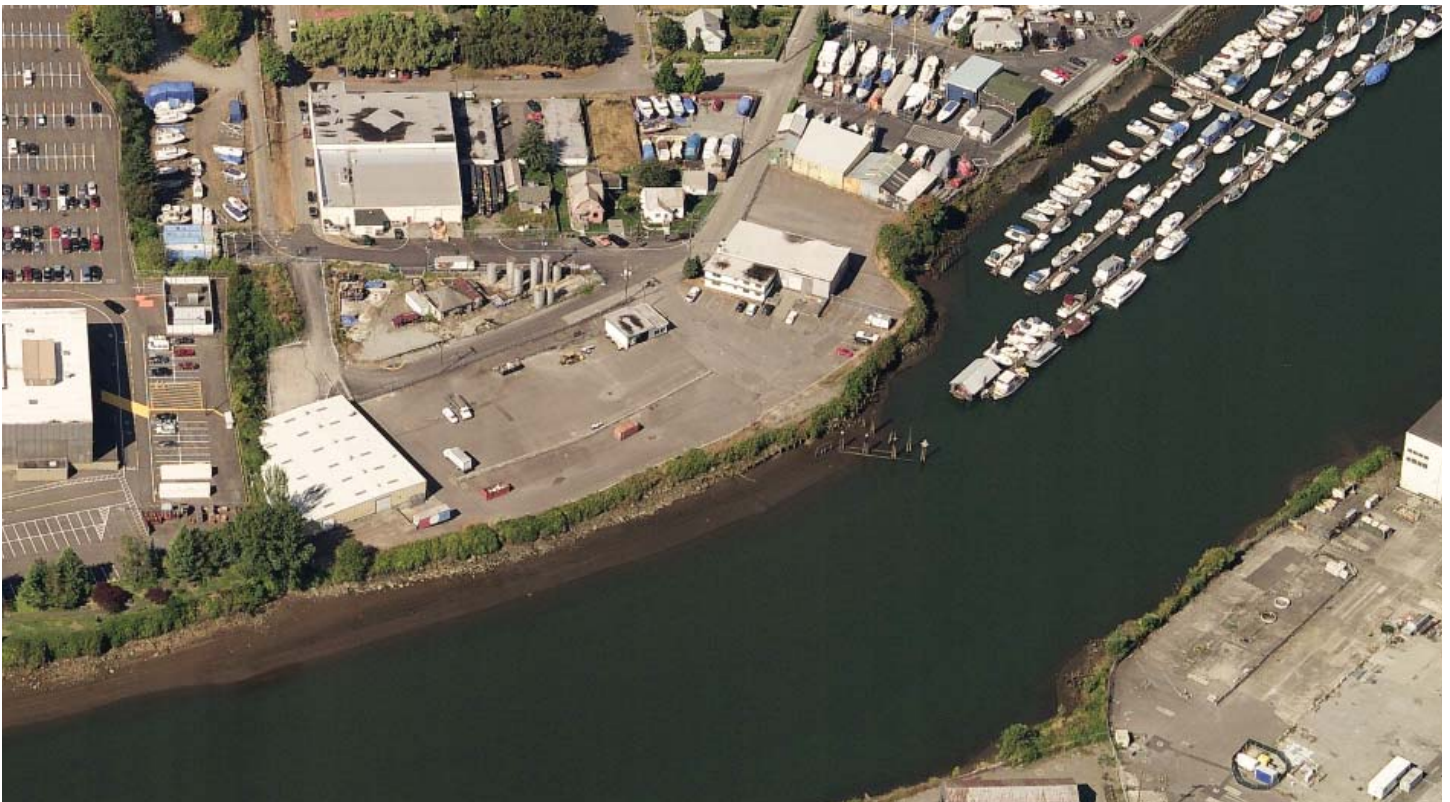
Illustrating Terminal 117 restoration potential (River Mile 3.7)

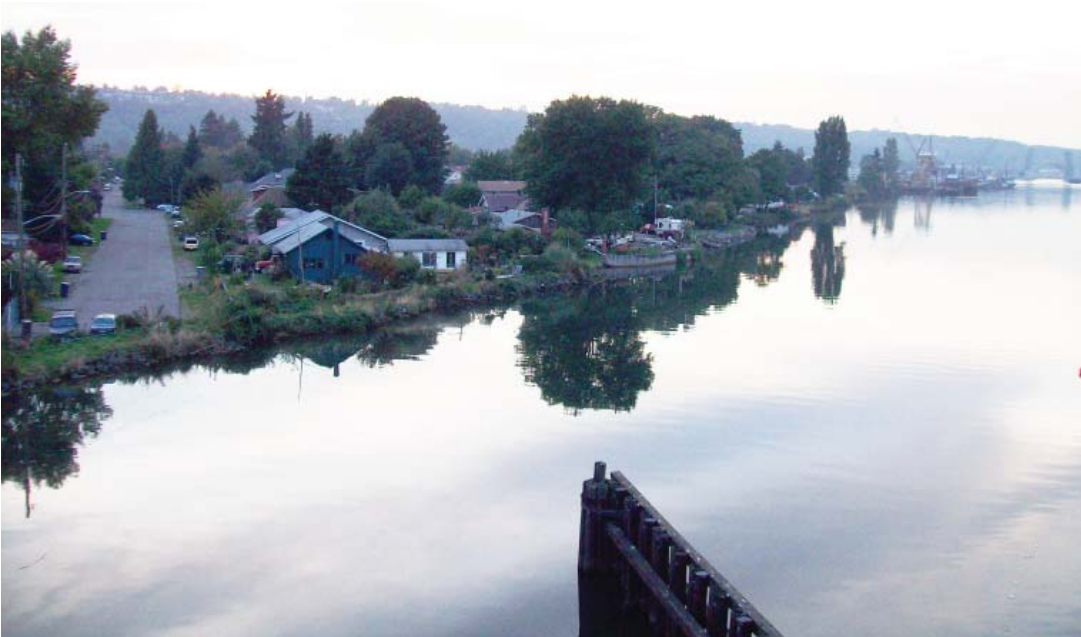
Illustrating South Park neighborhood/street-end restoration potential, Riverfront Revival Site (River Mile 3.3)

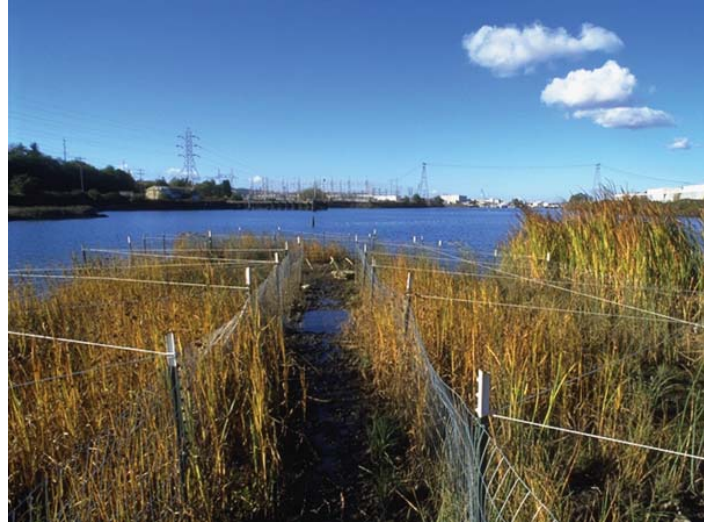
Illustrating successful establishment of marsh vegetation at Turning Basin Number Three restoration site (River Mile 4.6)

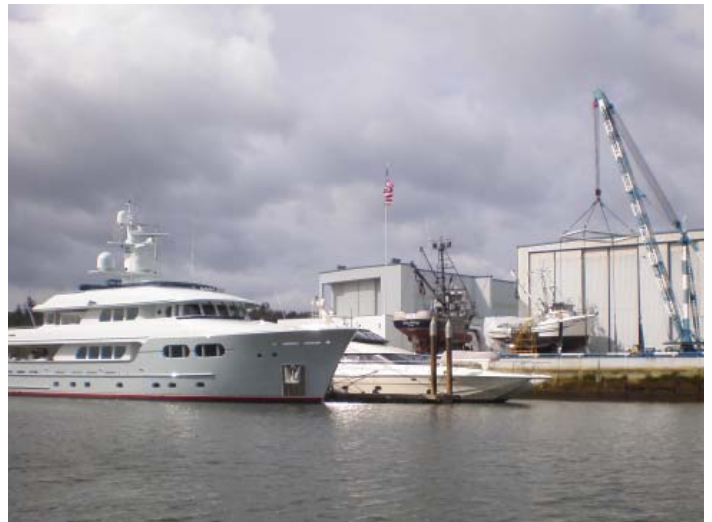
Existing marine industrial use, west shoreline (River Mile 4.4)

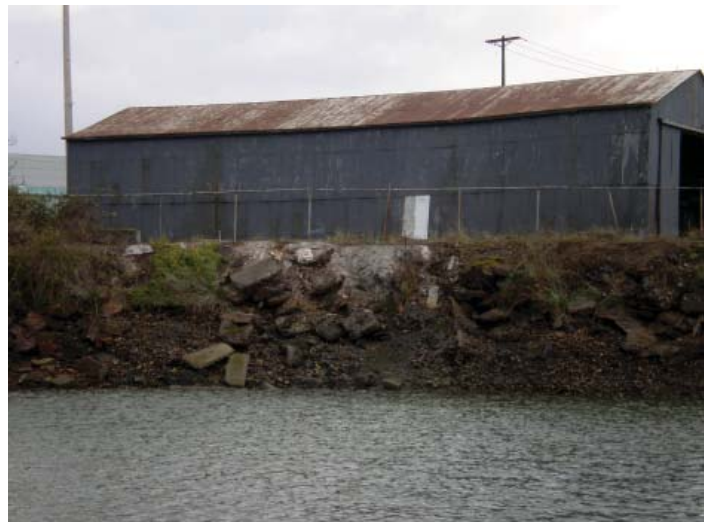
Illustrating rubble, industrial fill shoreline, east bank, (River Mile 3.8)

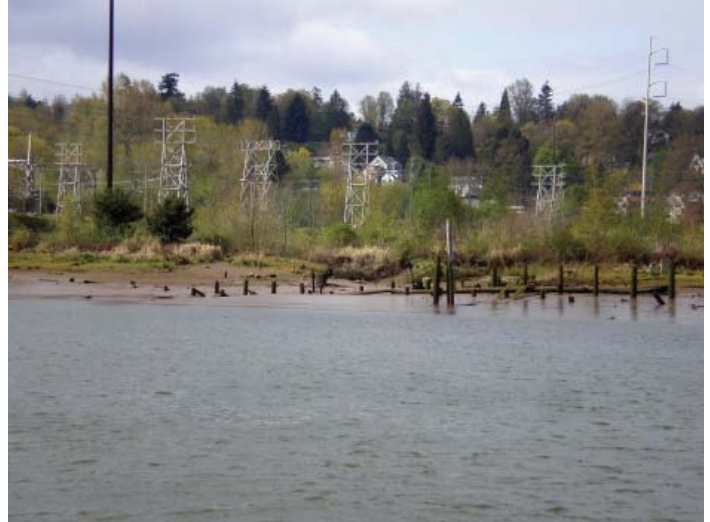
Illustrating shoreline and aquatic area restoration potential at west bank line, Turning Basin Number Three, (River Mile 4.6)

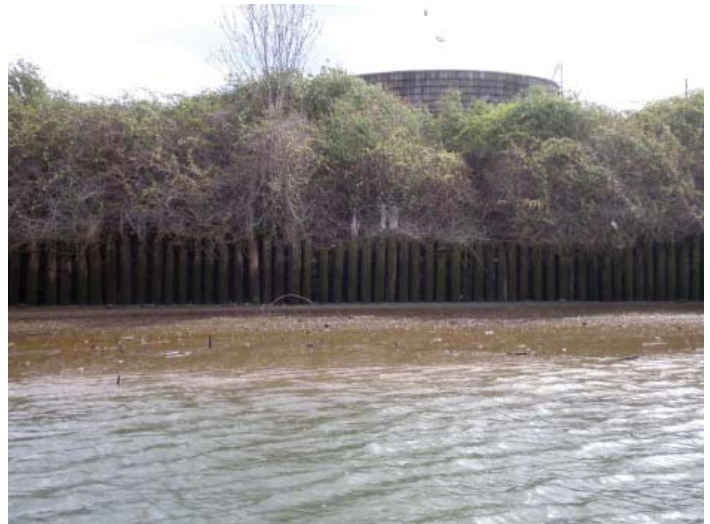
Existing creosote timber bulkhead, east bank line (River Mile 3.8)

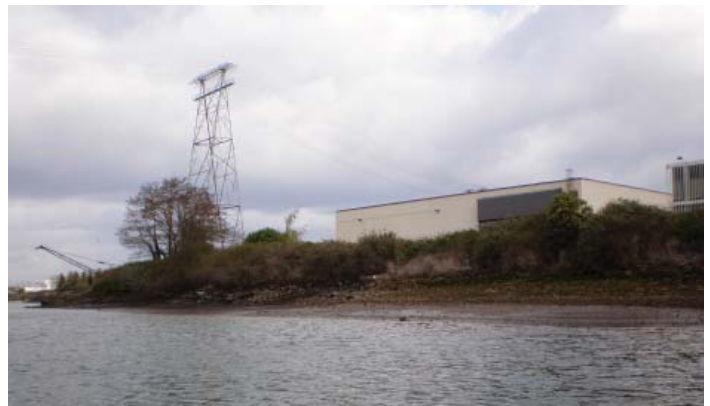
Illustrating potential marsh and riparian restoration site at east turning basin bank line (River Mile 4.6)

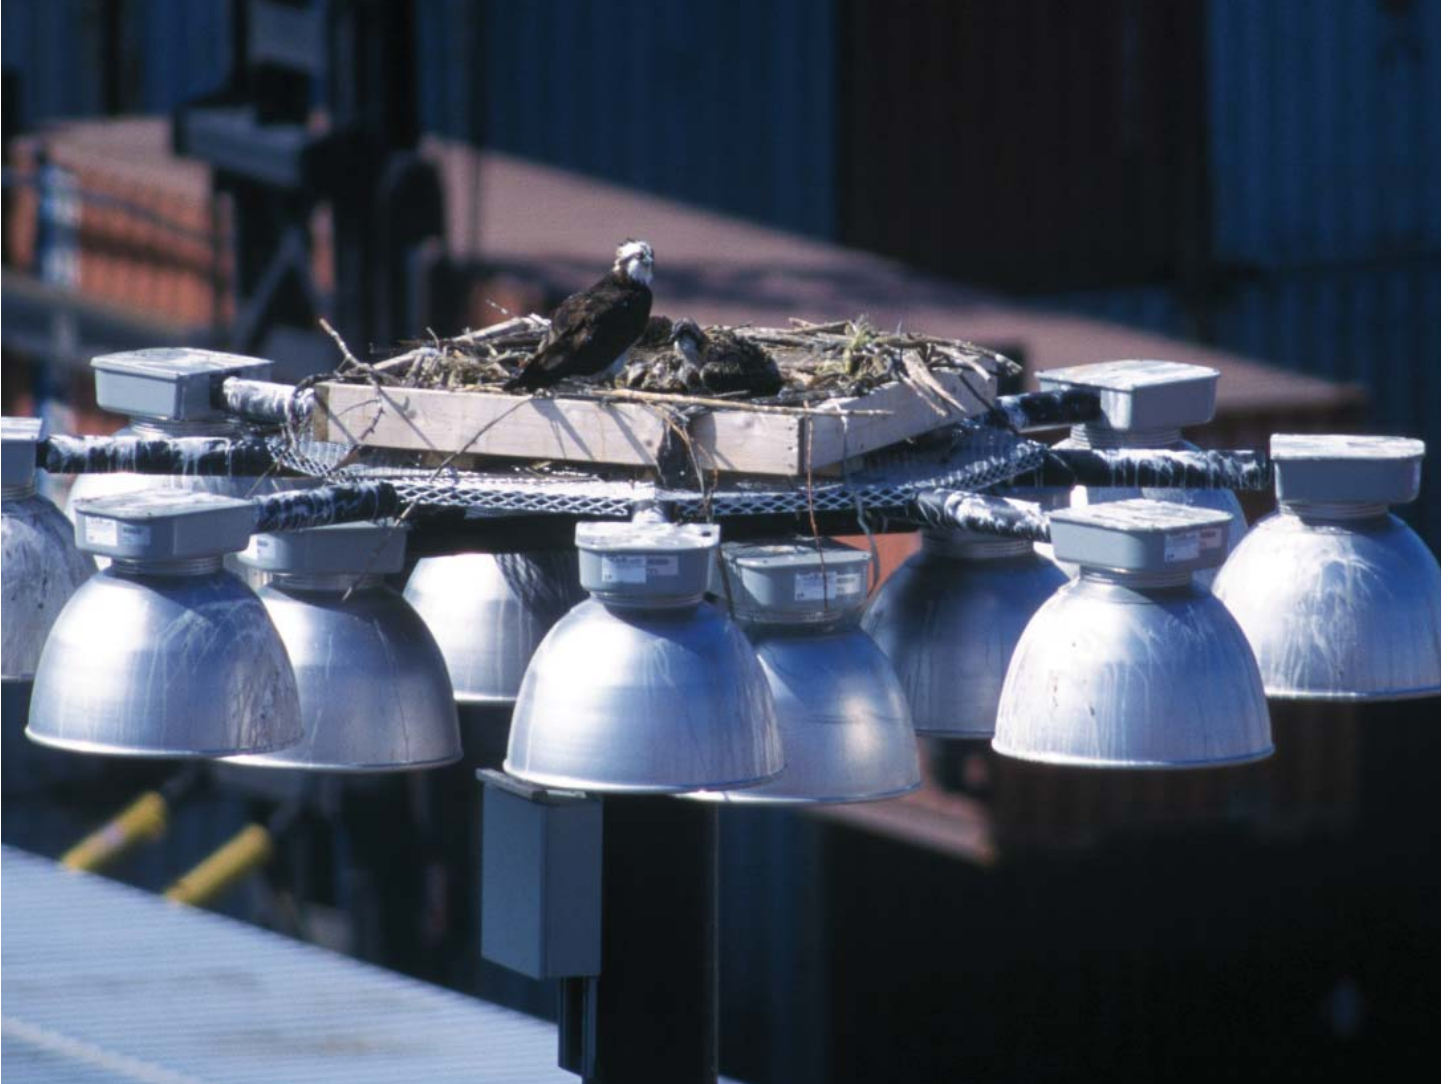
Osprey nest box, in place at Terminal 18, East Waterway  
Note: Five active Osprey nests are present in Duwamish Waterway

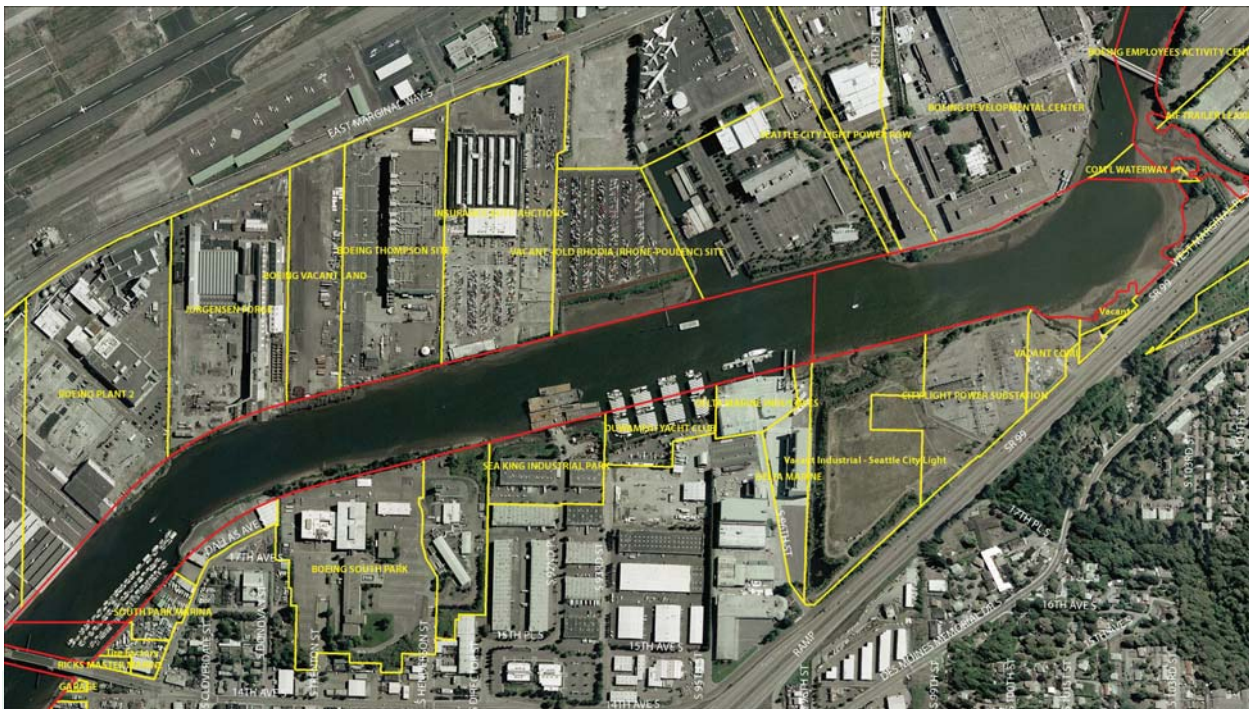
Section 4: 16th Avenue South to Turning Basin
