OYSTER SHELL STORMWATER TREATMENT SYSTEM

OYSTER SHELL TREATMENT – DOWNSPOUT BARRELS

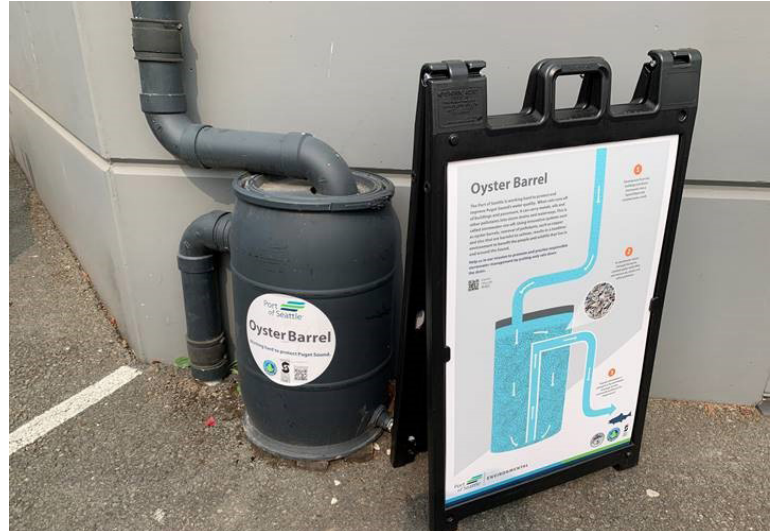
Figure 1. Oyster shell downspout barrel system and information sign at Terminal 102

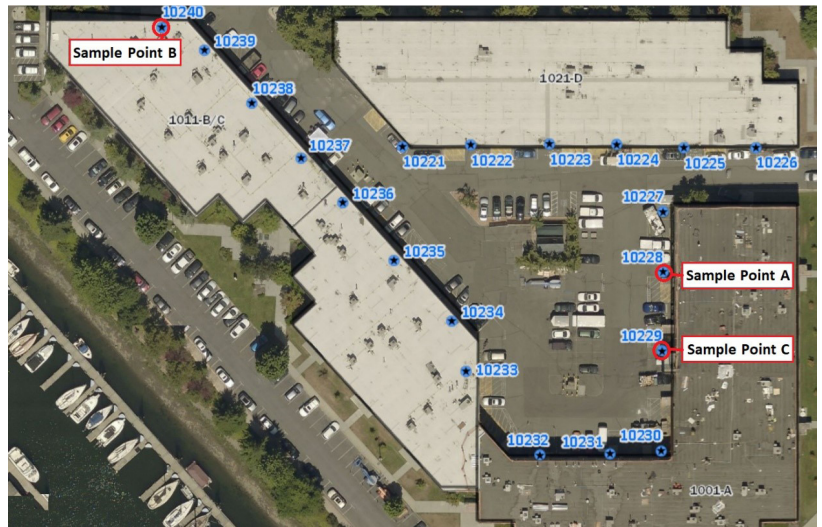
Figure 3. Oyster barrel locations at Terminal 102 displaying the three sample locations (numbered stars are downspouts)

To determine the effectiveness of this stormwater treatment, water quality monitoring is conducted and has been ongoing since the barrels were first installed in 2017. Two barrels were selected for sampling [Points A and B (Figure 3)] to represent effectiveness of the treatment system.

In September 2020, we began washing and reusing oyster shells using a media washing machine developed to remove sediment and 'refresh' the shells. To evaluate effectiveness of this effort, a new sampling point was added (Point C). The shells used in the Point C barrel are new oyster shells (i.e., have not been used for treatment prior to being put in barrels). The shells used in the barrels monitored as Points A and B, and all the other barrels, have been refreshed and monitoring data from this effort should be available in late 2021.

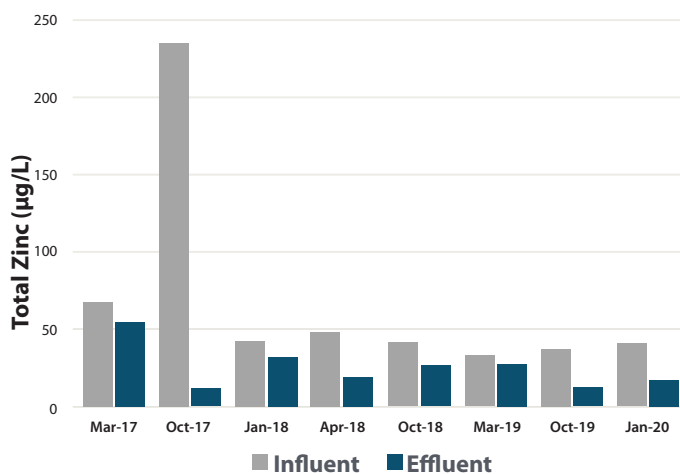
Figure 4. Average total zinc in roof runoff before treatment (influent) and after treatment (effluent) at Terminal 102 between March 2017 and January 2020

Effectiveness is determined by analyzing stormwater collected before (influent) and after (effluent) flowing through the oyster shell barrels. As shown in Figures 4 and 5, testing results suggest that oyster shell treatment reduces pollutants from roof runoff significantly, with an average reduction of 30% to 50% for metals and 50% for turbidity.

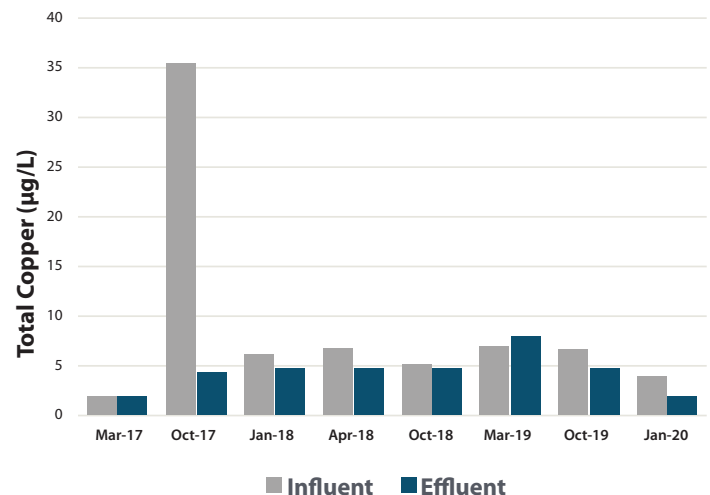
Figure 5. Average total copper in roof runoff before treatment (influent) and after treatment (effluent) at Terminal 102 between March 2017 and January 2020
